MITIGATION, PLANNING AND RESEARCH DIVISION

Funded by the Environmental Foundation of Jamaica

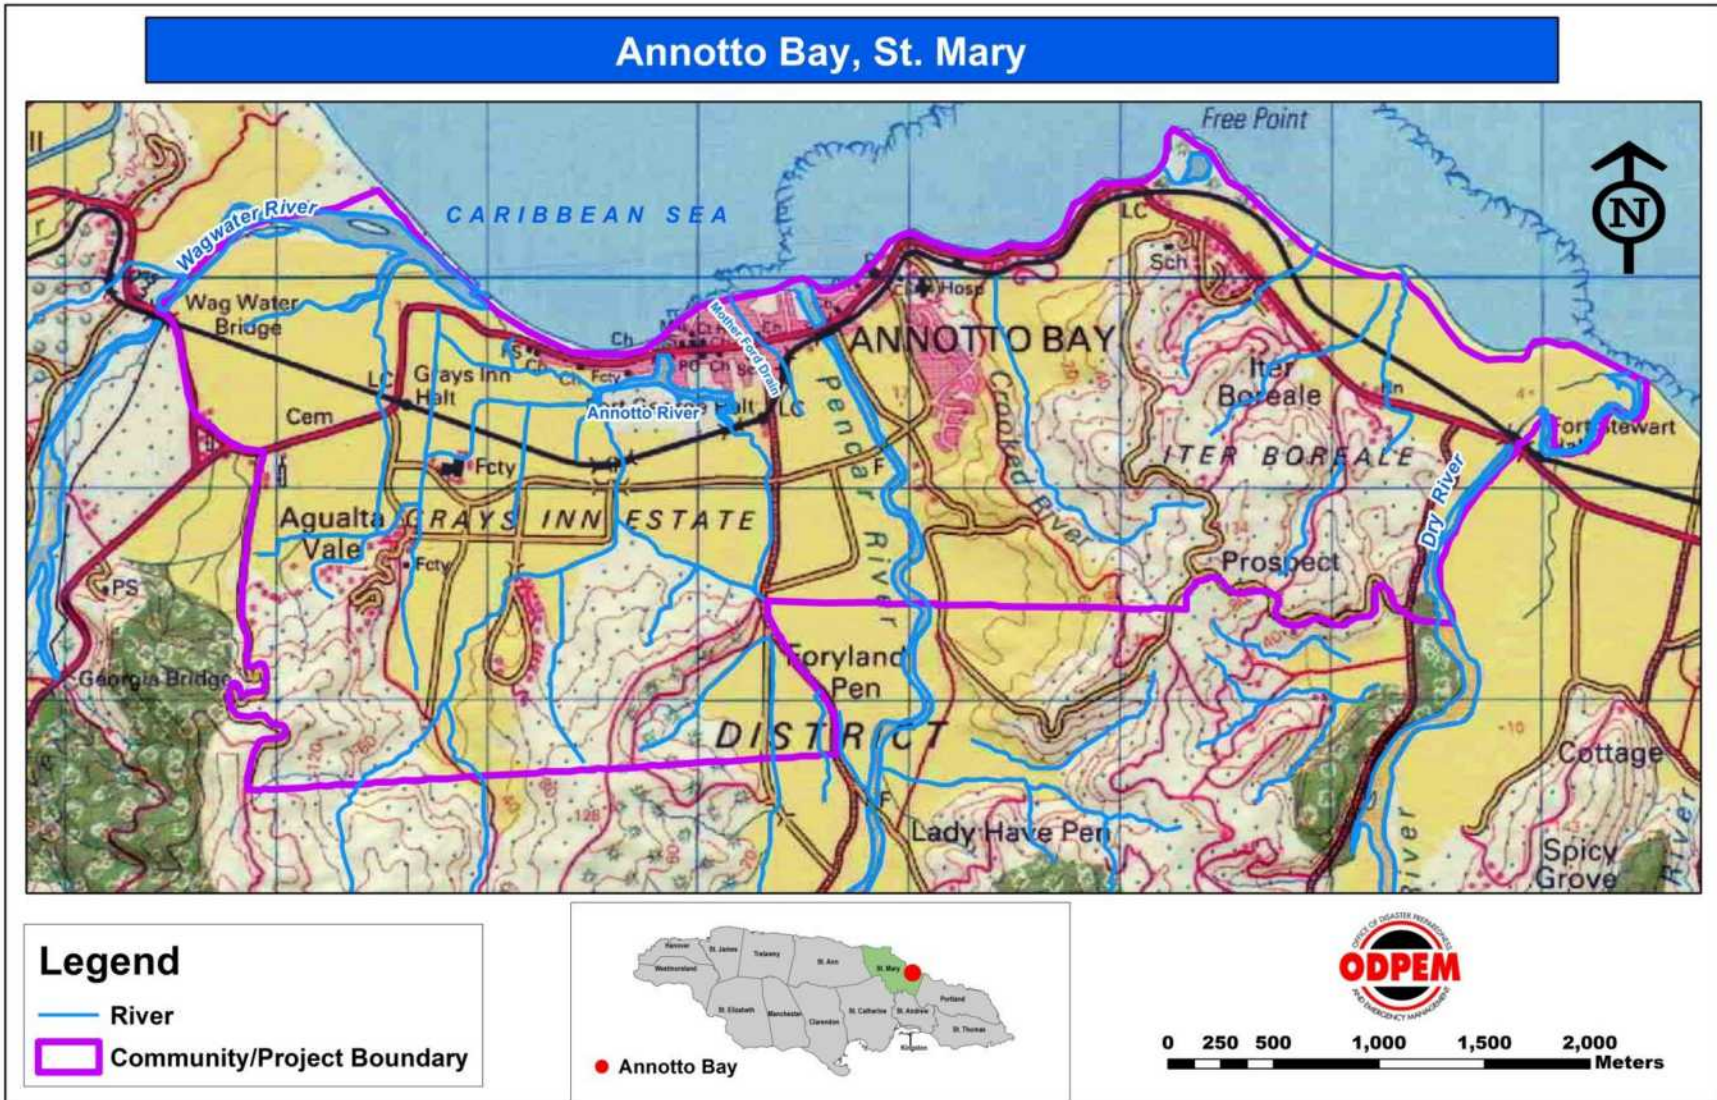
Figure 1: Topographic Map of Annotto Bay

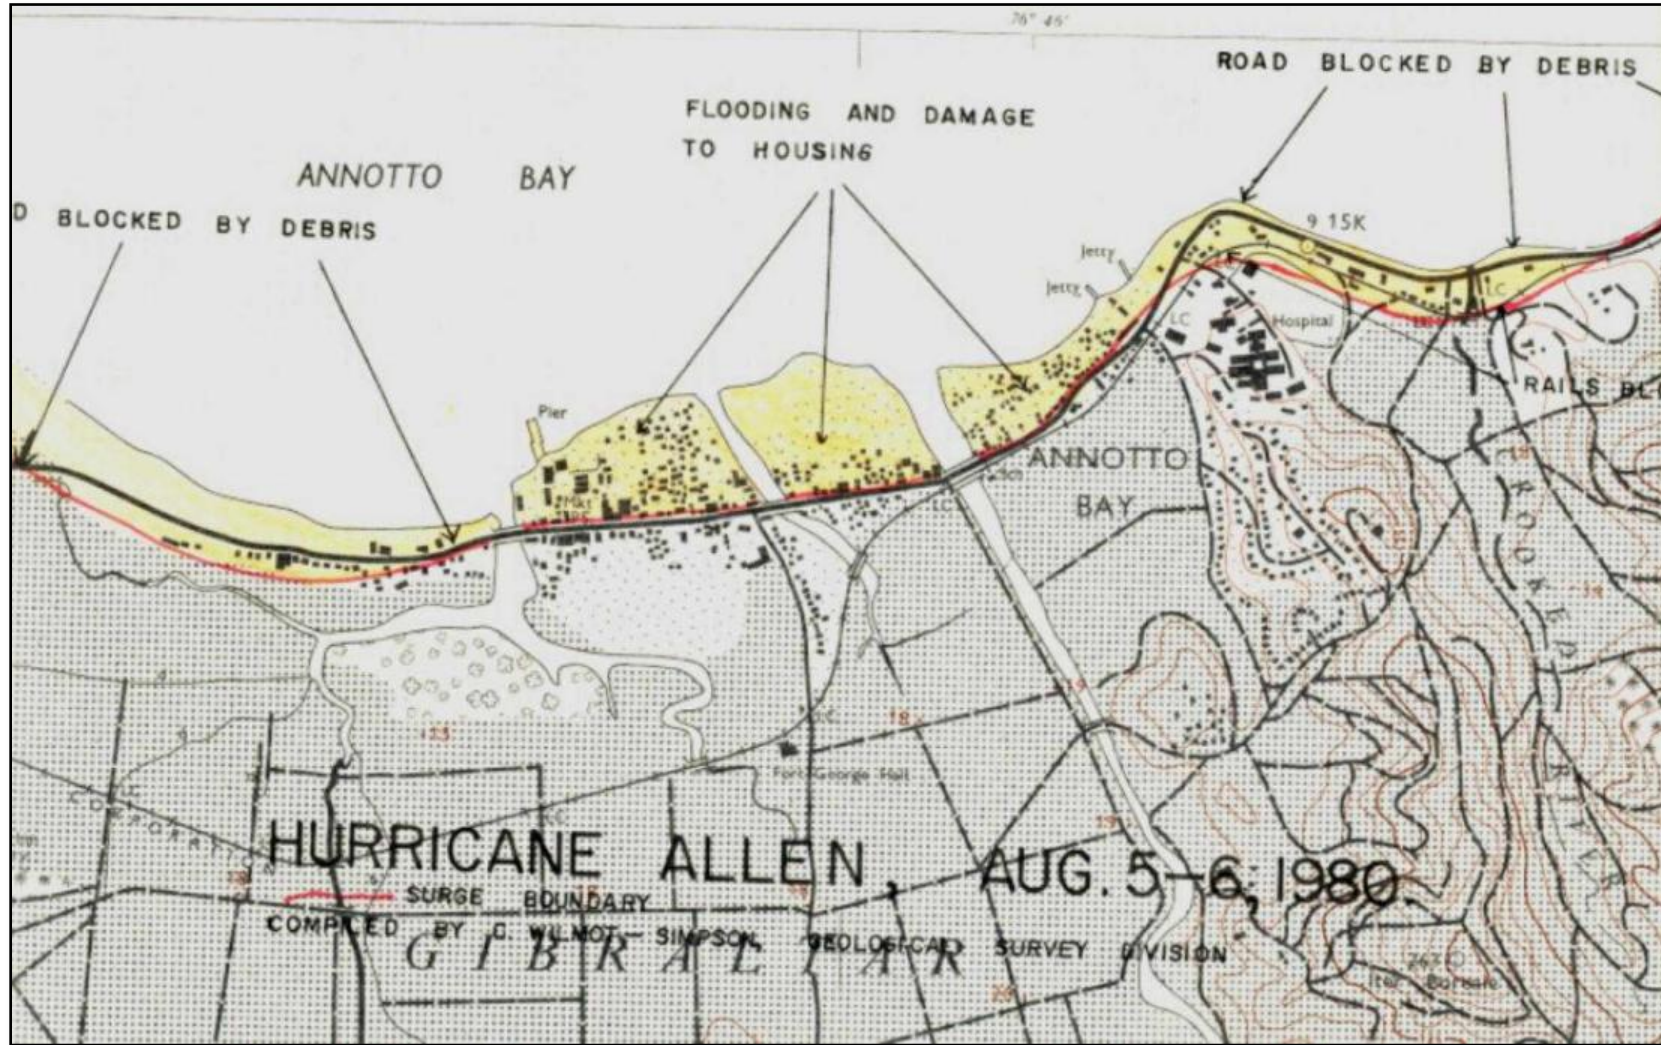
Figure 3: Hurricane Allen Storm Surge Boundary²

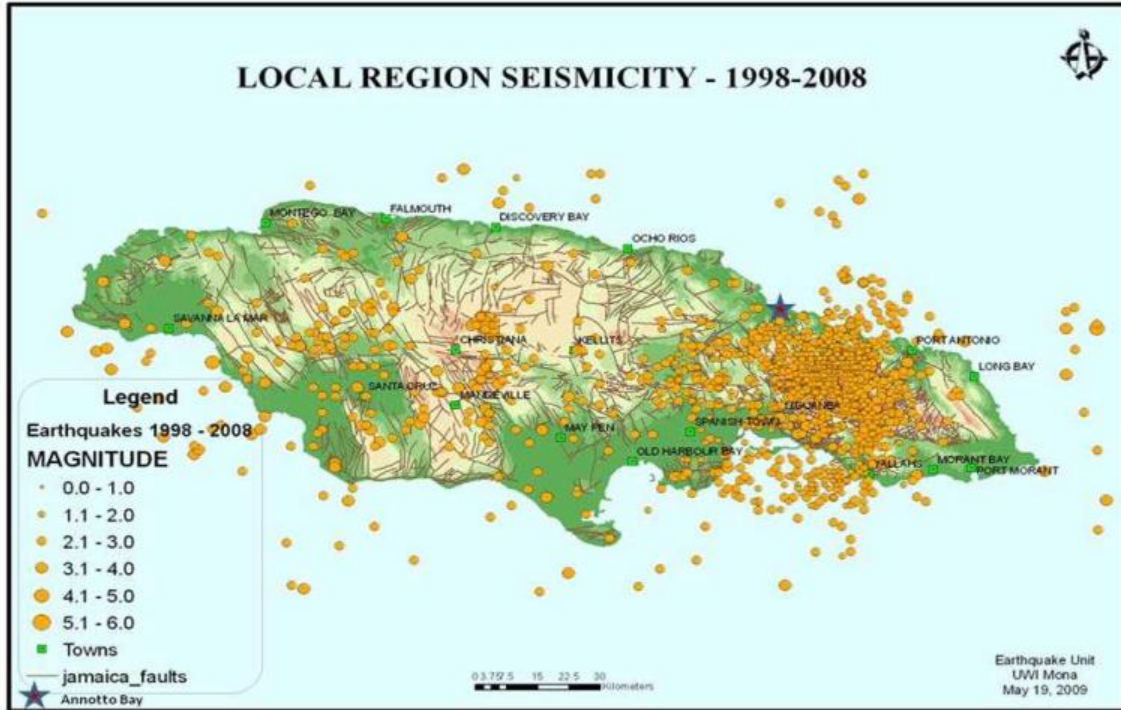
Figure 4: Epicentres of earthquakes in Jamaica during 1998-2008, highest frequency of events occurs in the north-eastern section of the island in close proximity to study area.

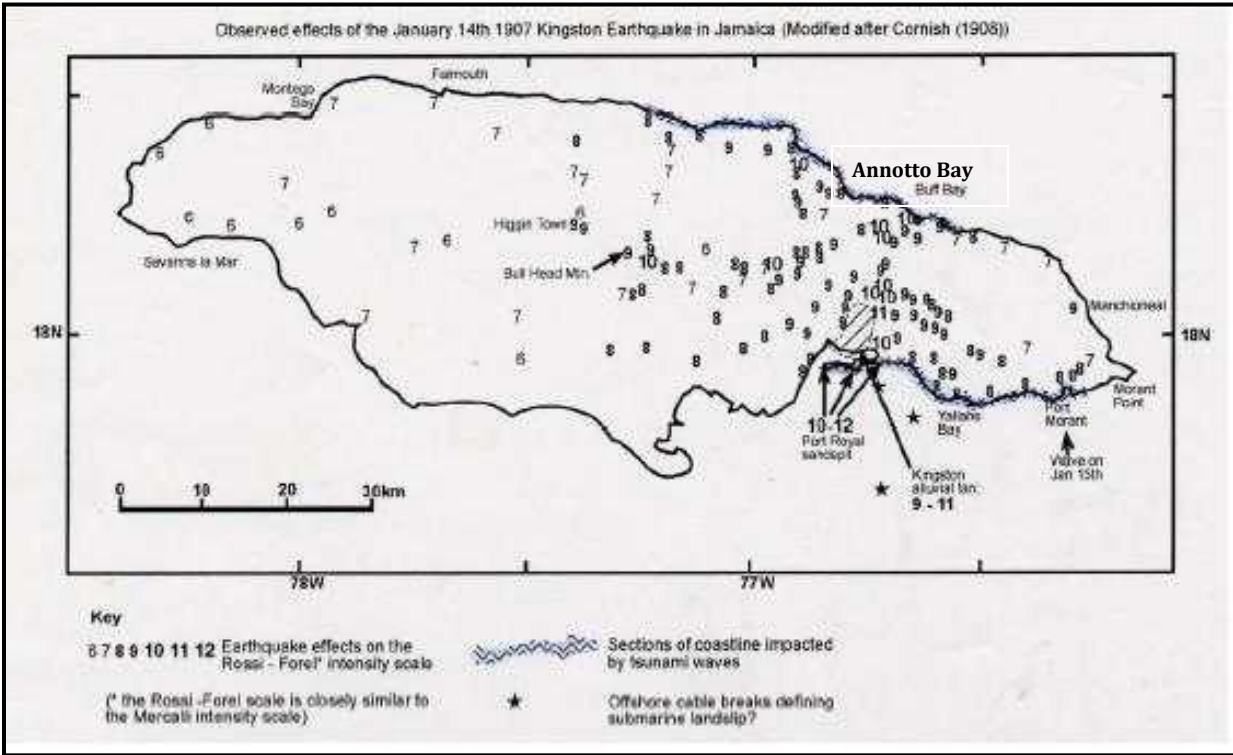
wFigure 5: Observed Effects of the January 1907 Earthquake in Jamaica

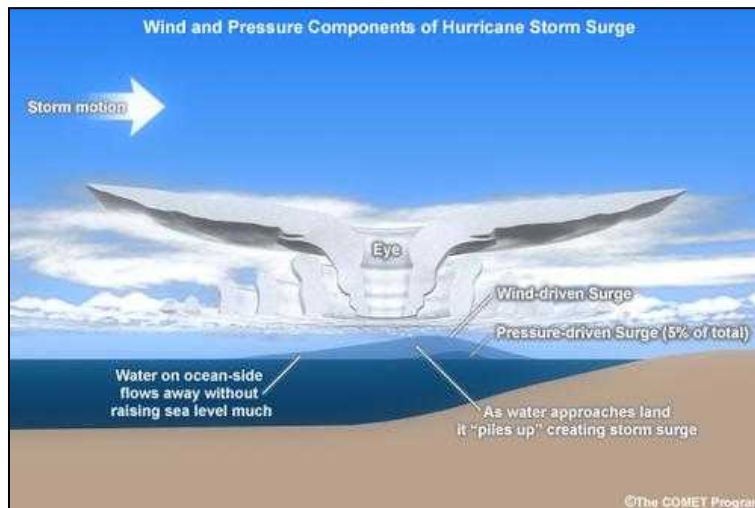
Figure 8: Wind and Pressure Components of Hurricane Storm Surge

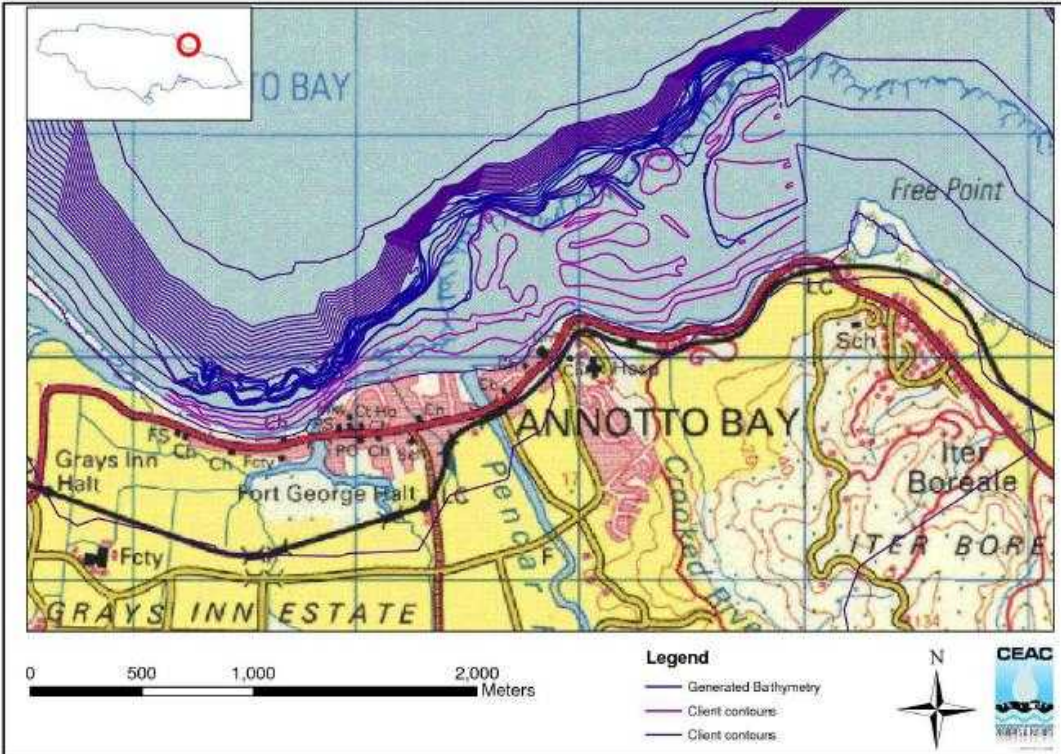
Figure 9: Bathymetric features north of Project site

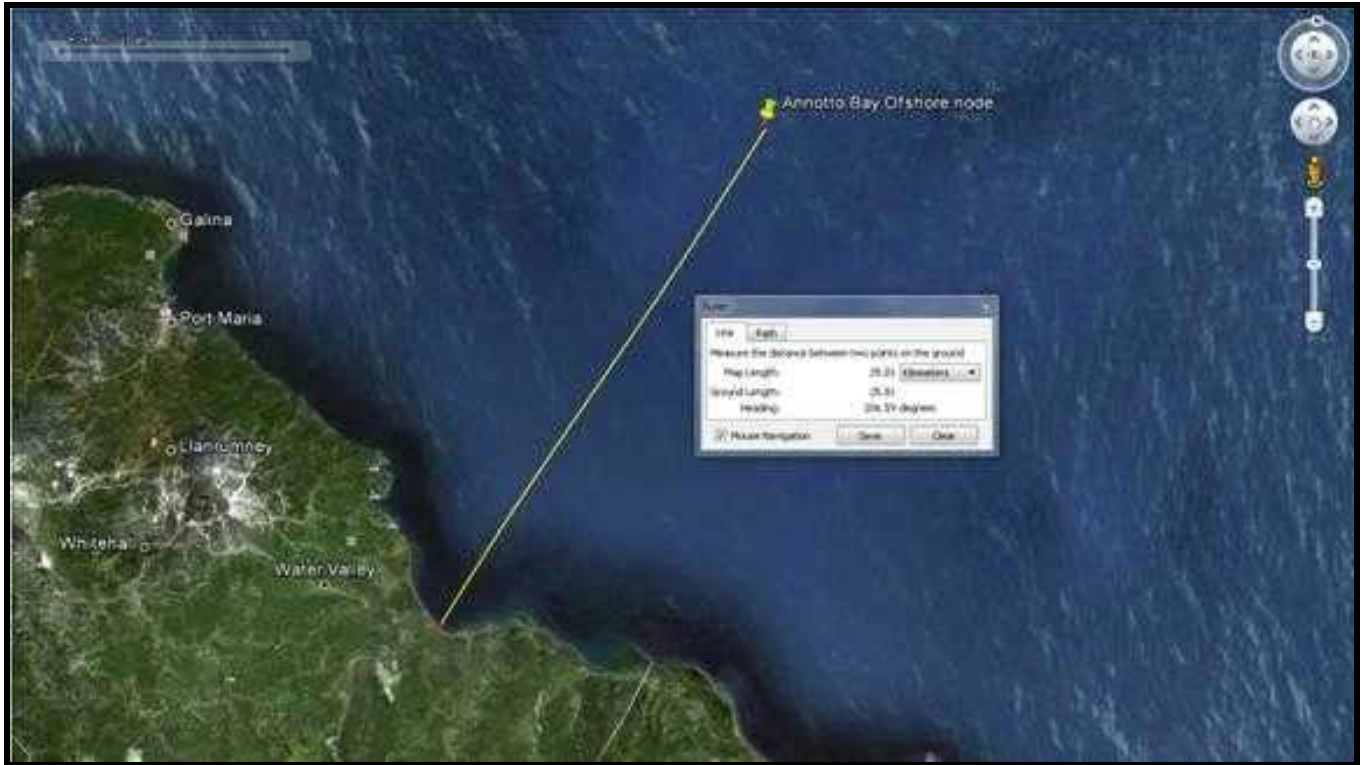
Figure 10: Location of Offshore Point Used for Extremal Analysis

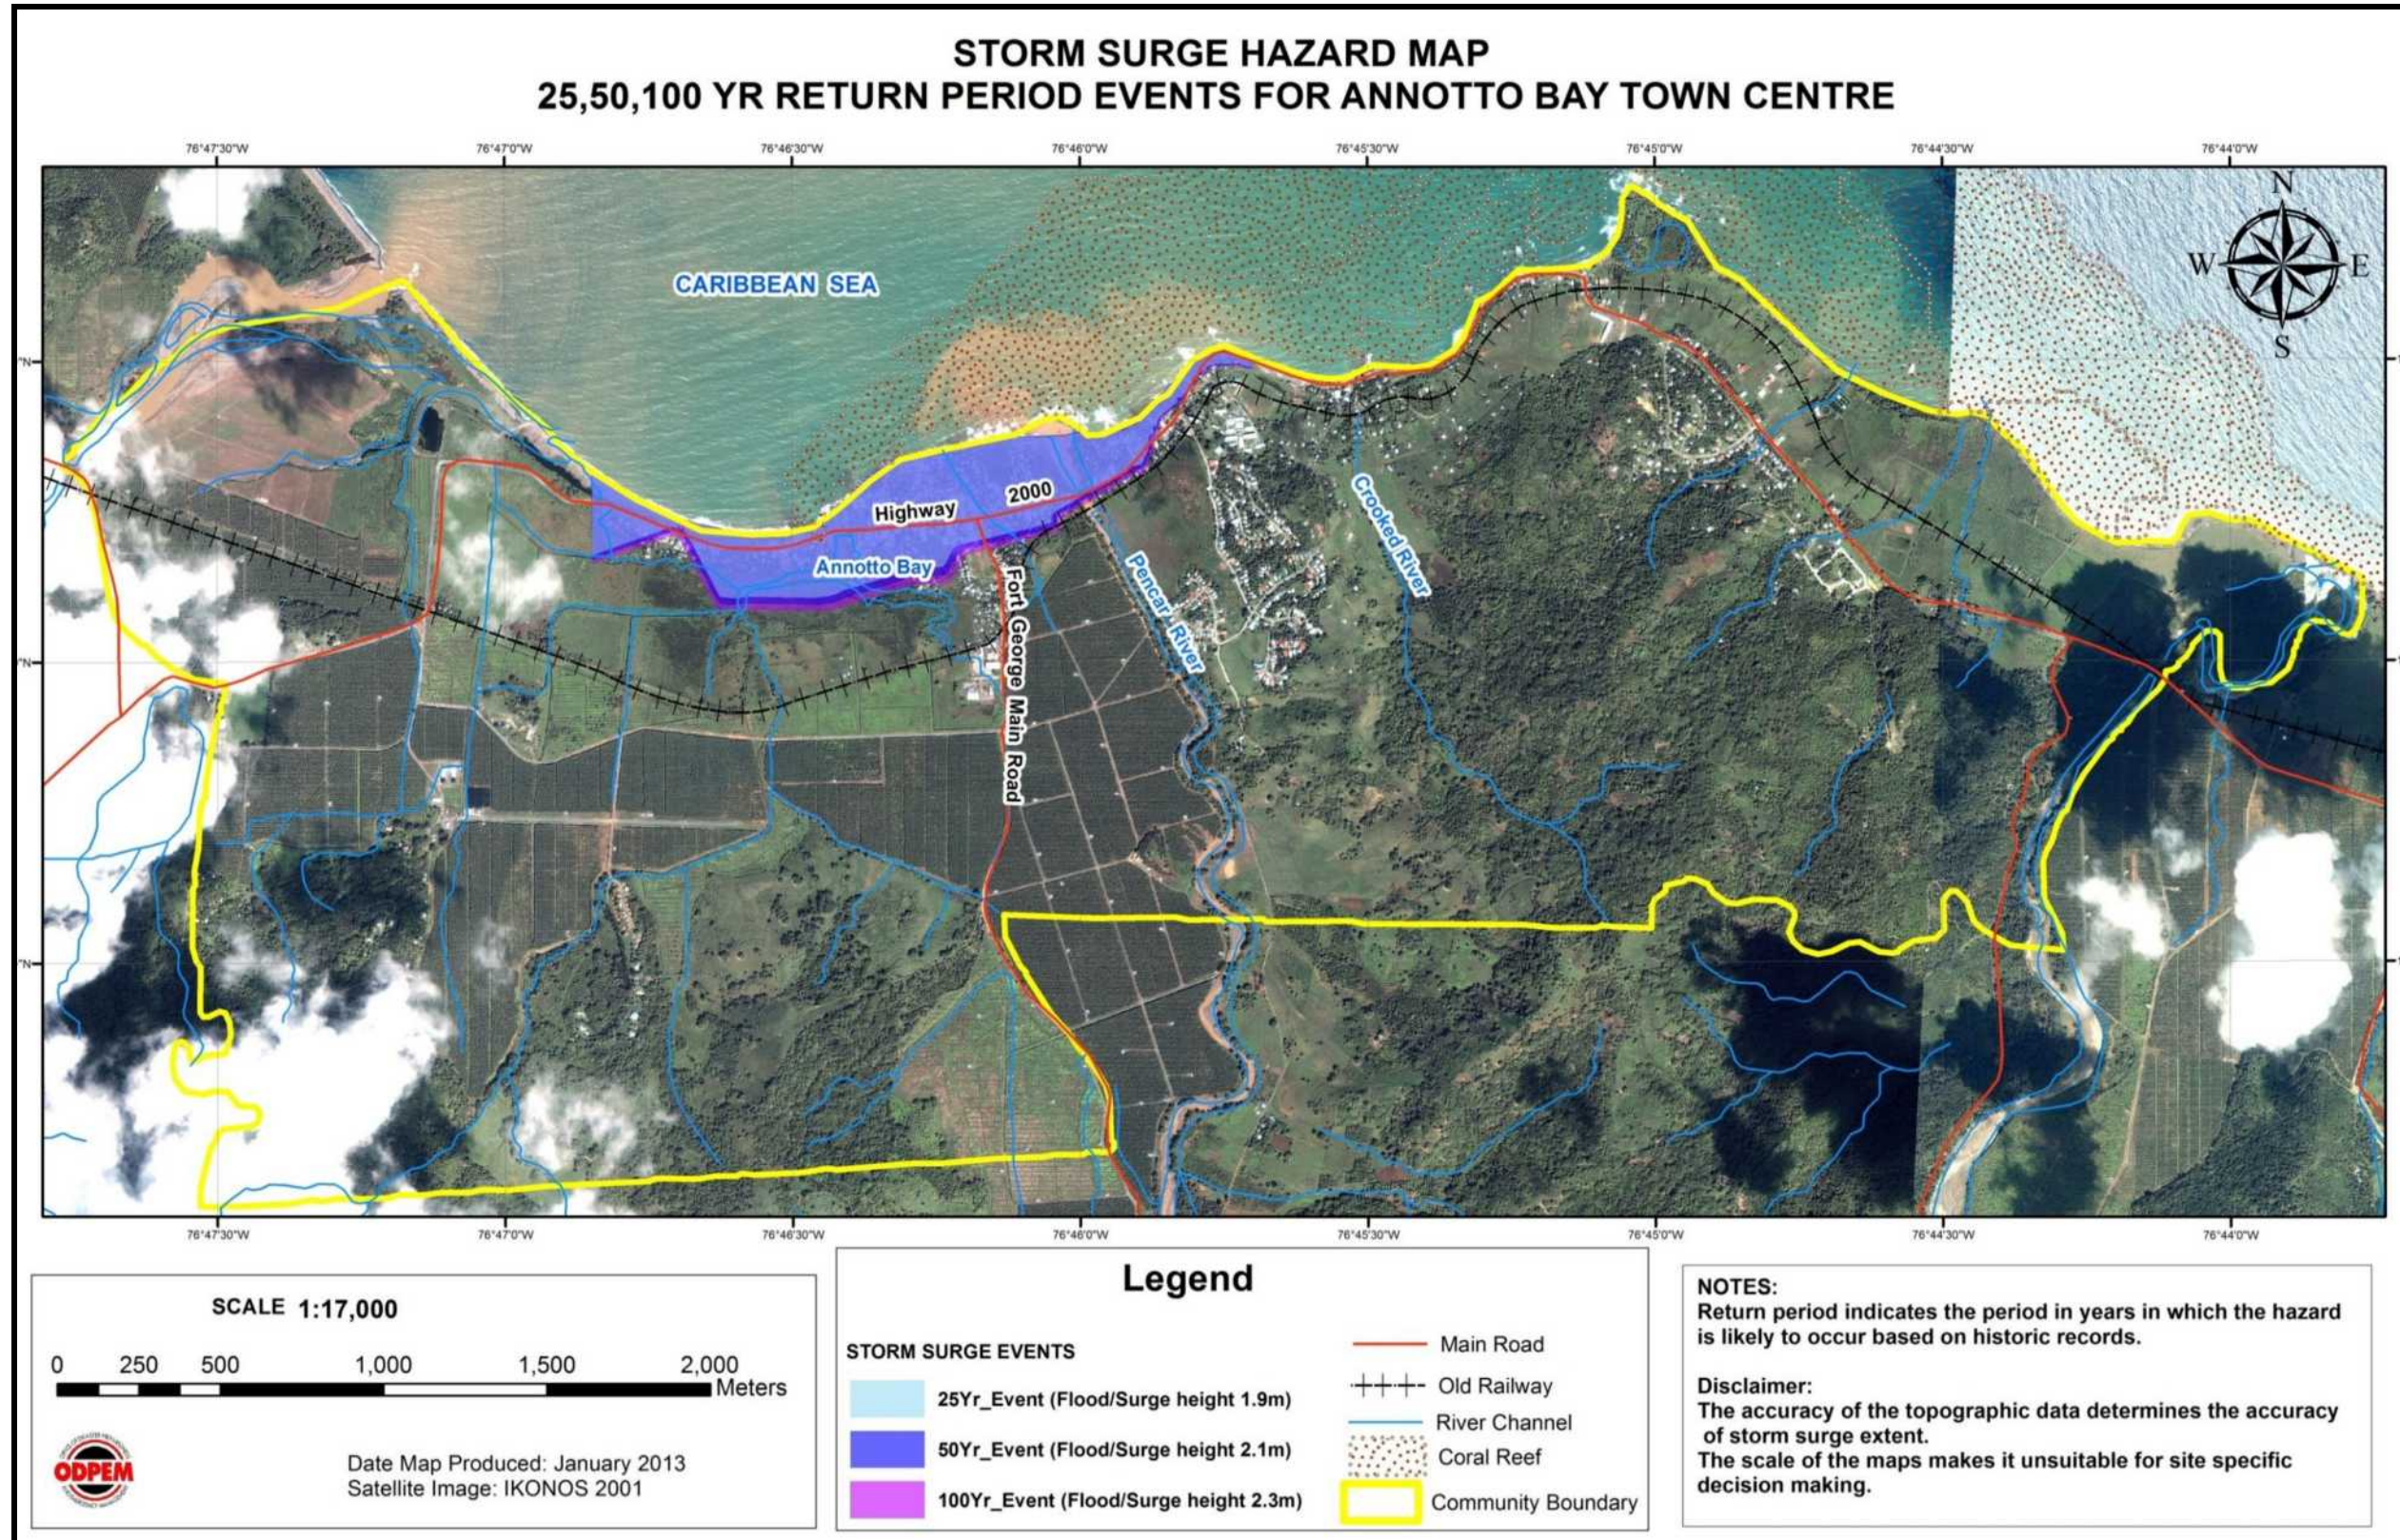
Figure 11: Storm Surge Hazard Map for Annotto Bay Town Centre (Master Sheet)

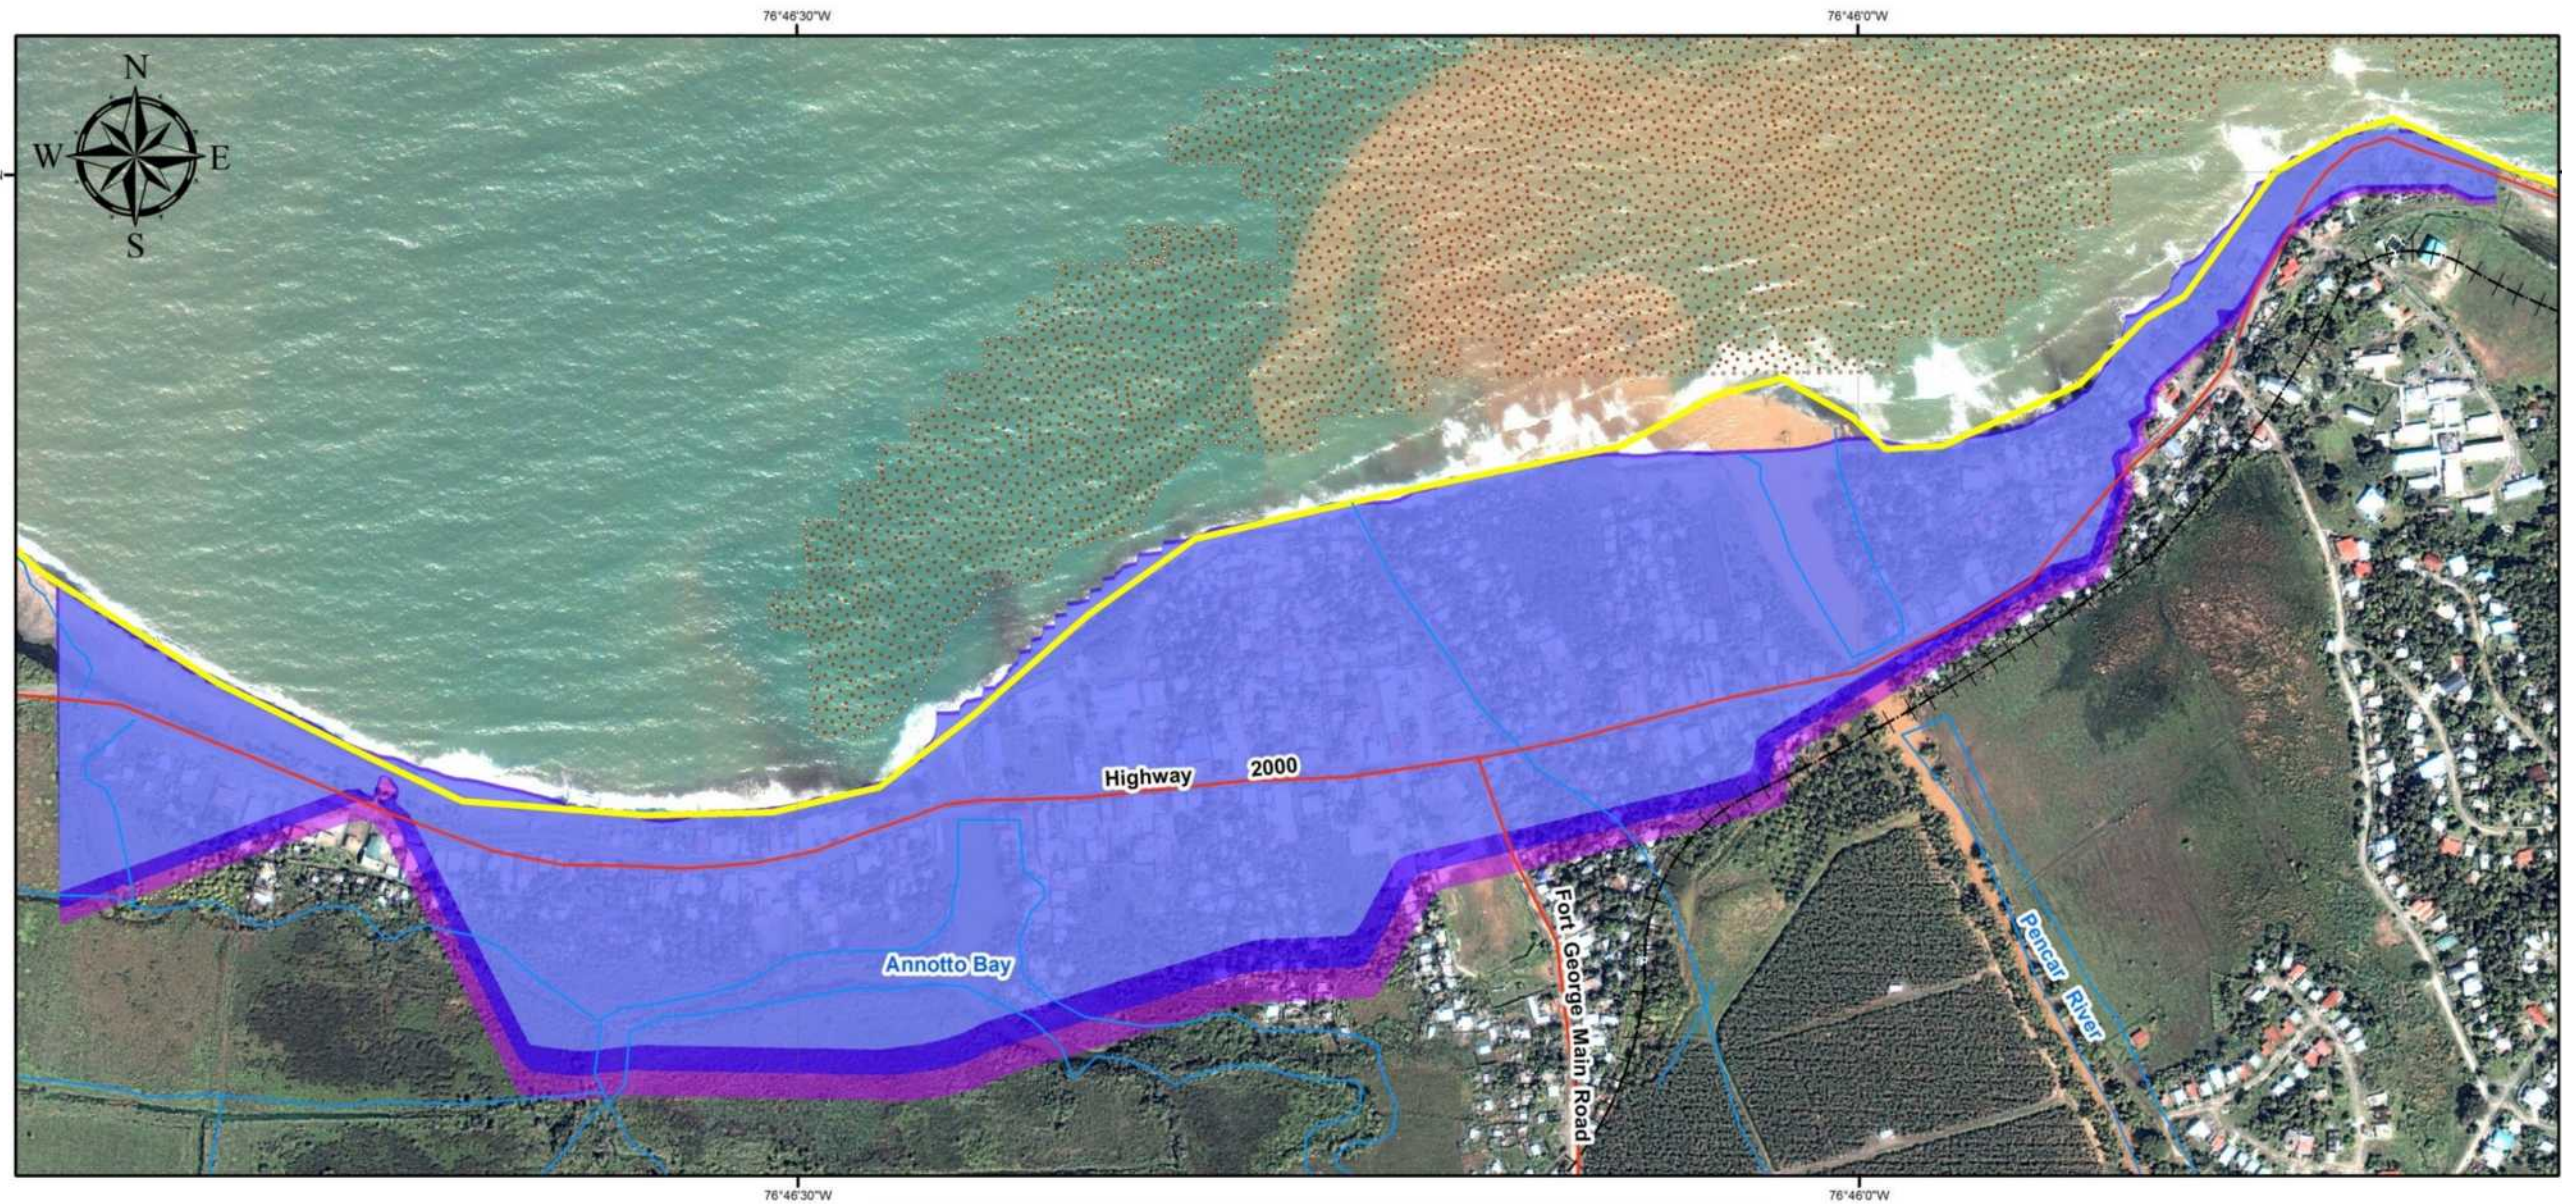
STORM SURGE HAZARD MAP 25,50,100 YR RETURN PERIOD EVENTS FOR ANNOTTO BAY TOWN CENTRE

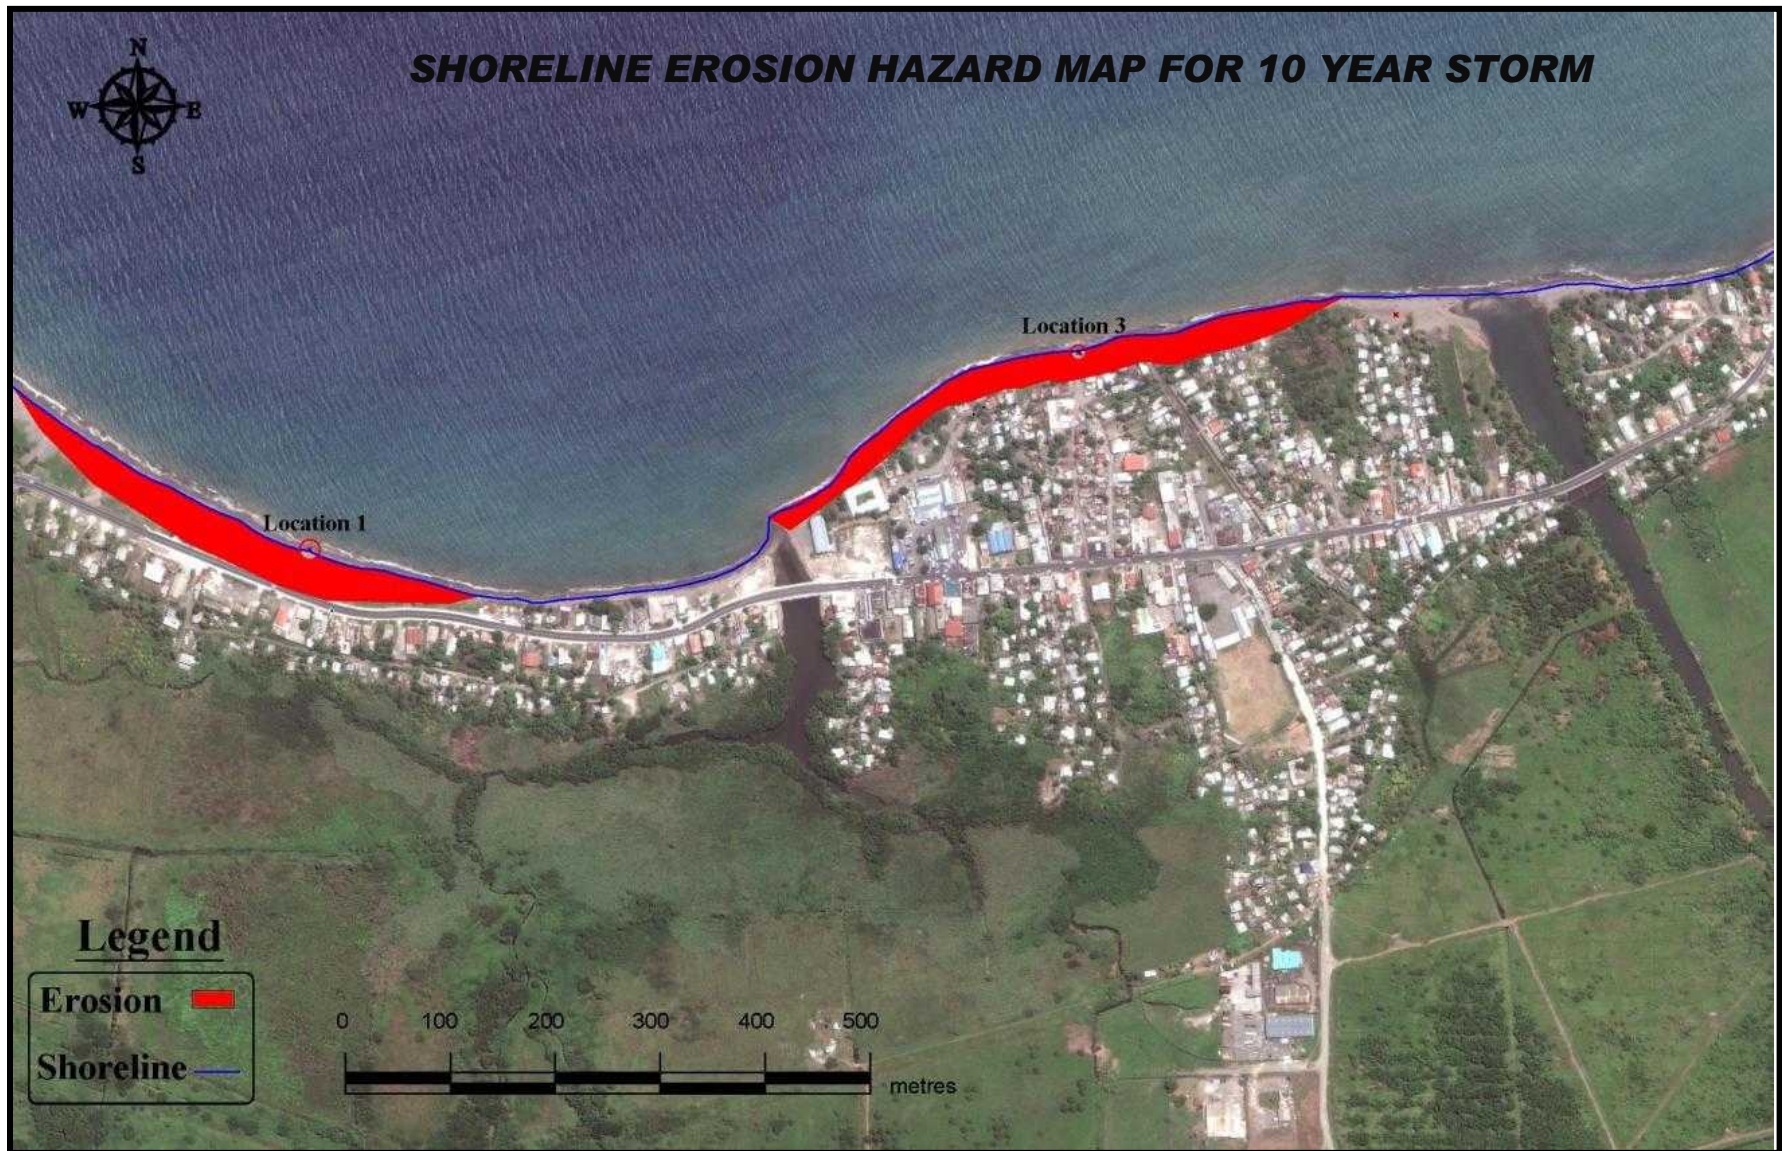
Figure 15: Shoreline Erosion Hazard Footprint

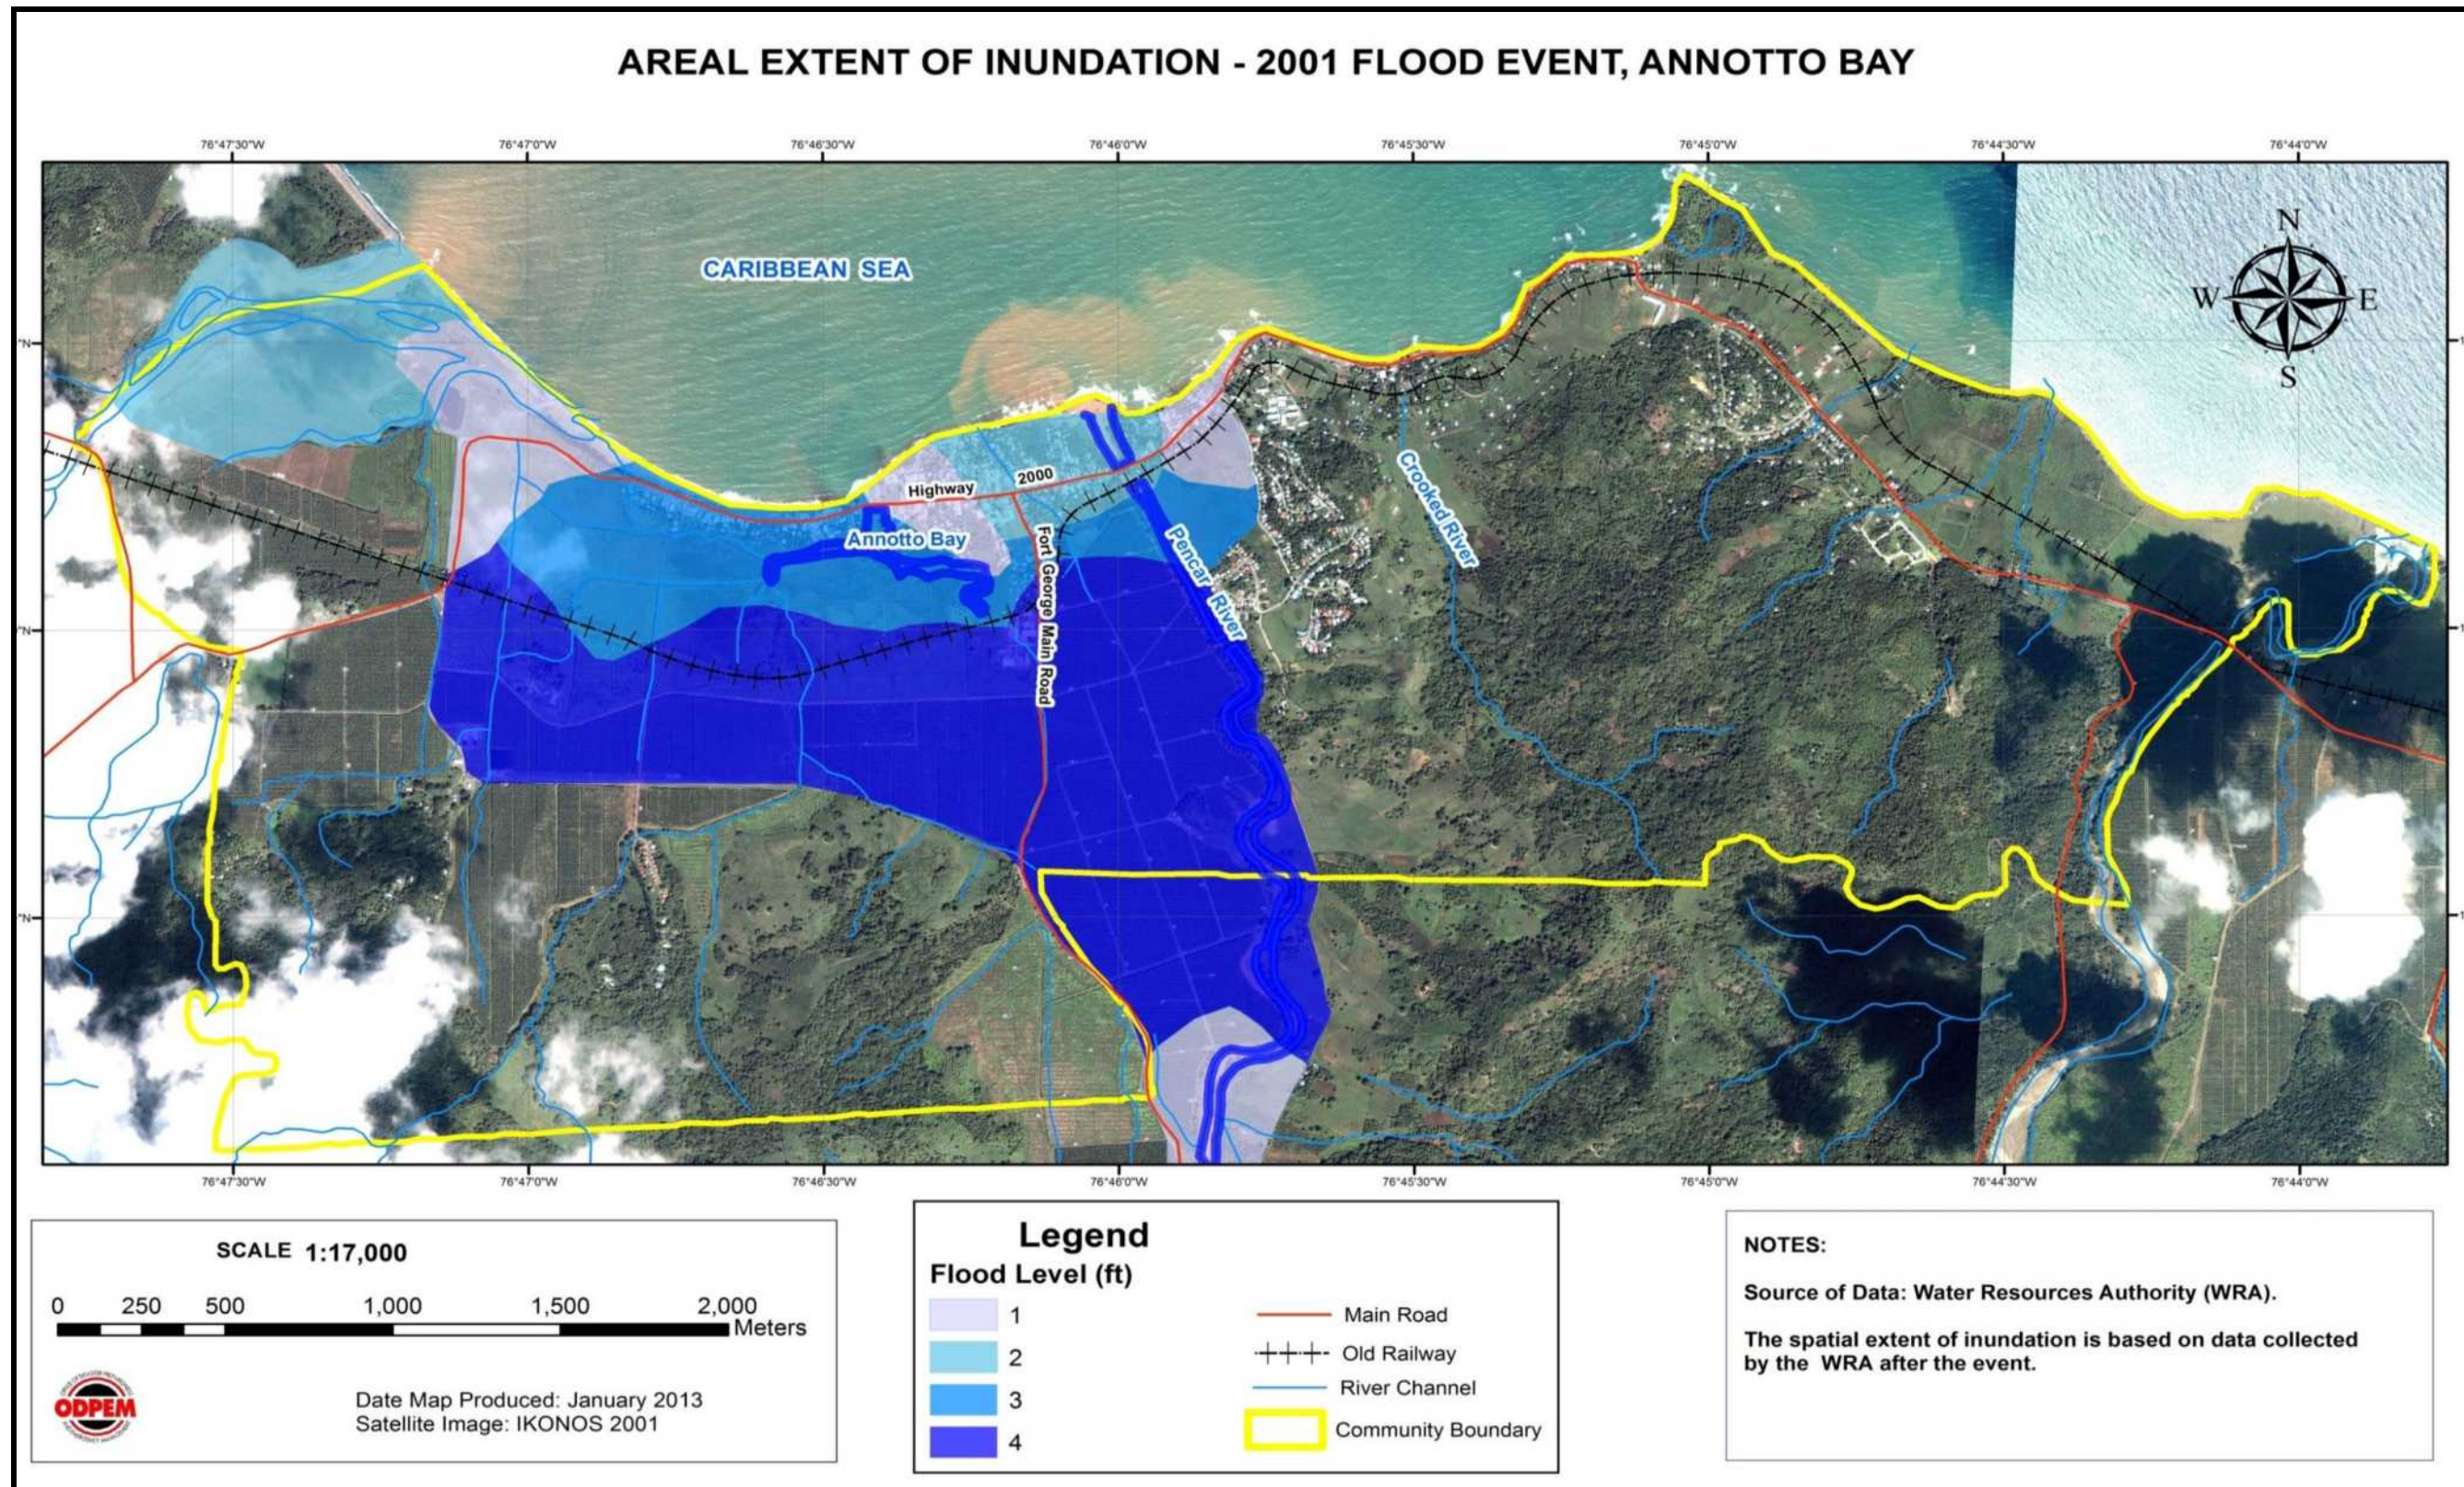
Figure 16: Flood Hazard Map showing inundation during the 2001 Flood Event in Annotto Bay

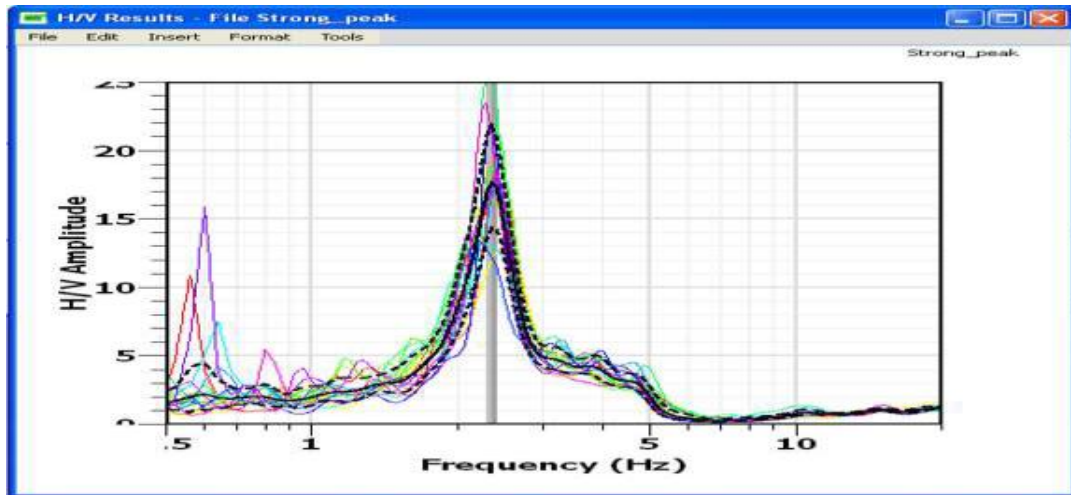
Figure 18: Typical output of the processed 3-component ambient ground motion signal to determine the fundamental frequency of a site.

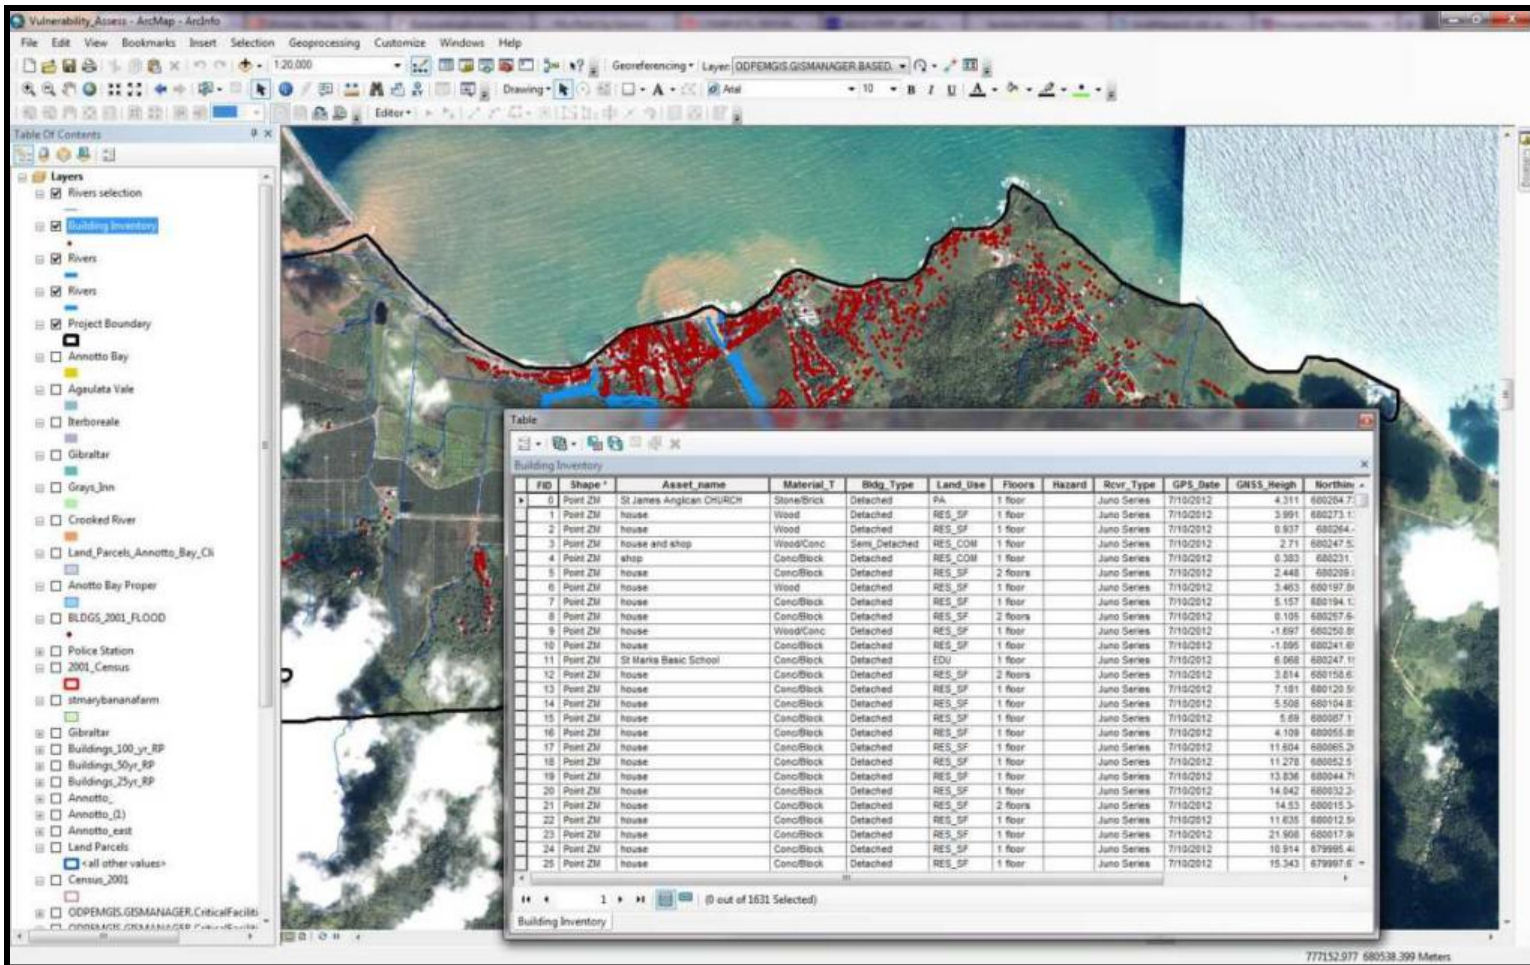
Figure 23: Illustration of Building Inventory with Attributes in GIS Environment
