MITIGATION, PLANNING AND RESEARCH DIVISION

Funded by the Environmental Foundation of Jamaica

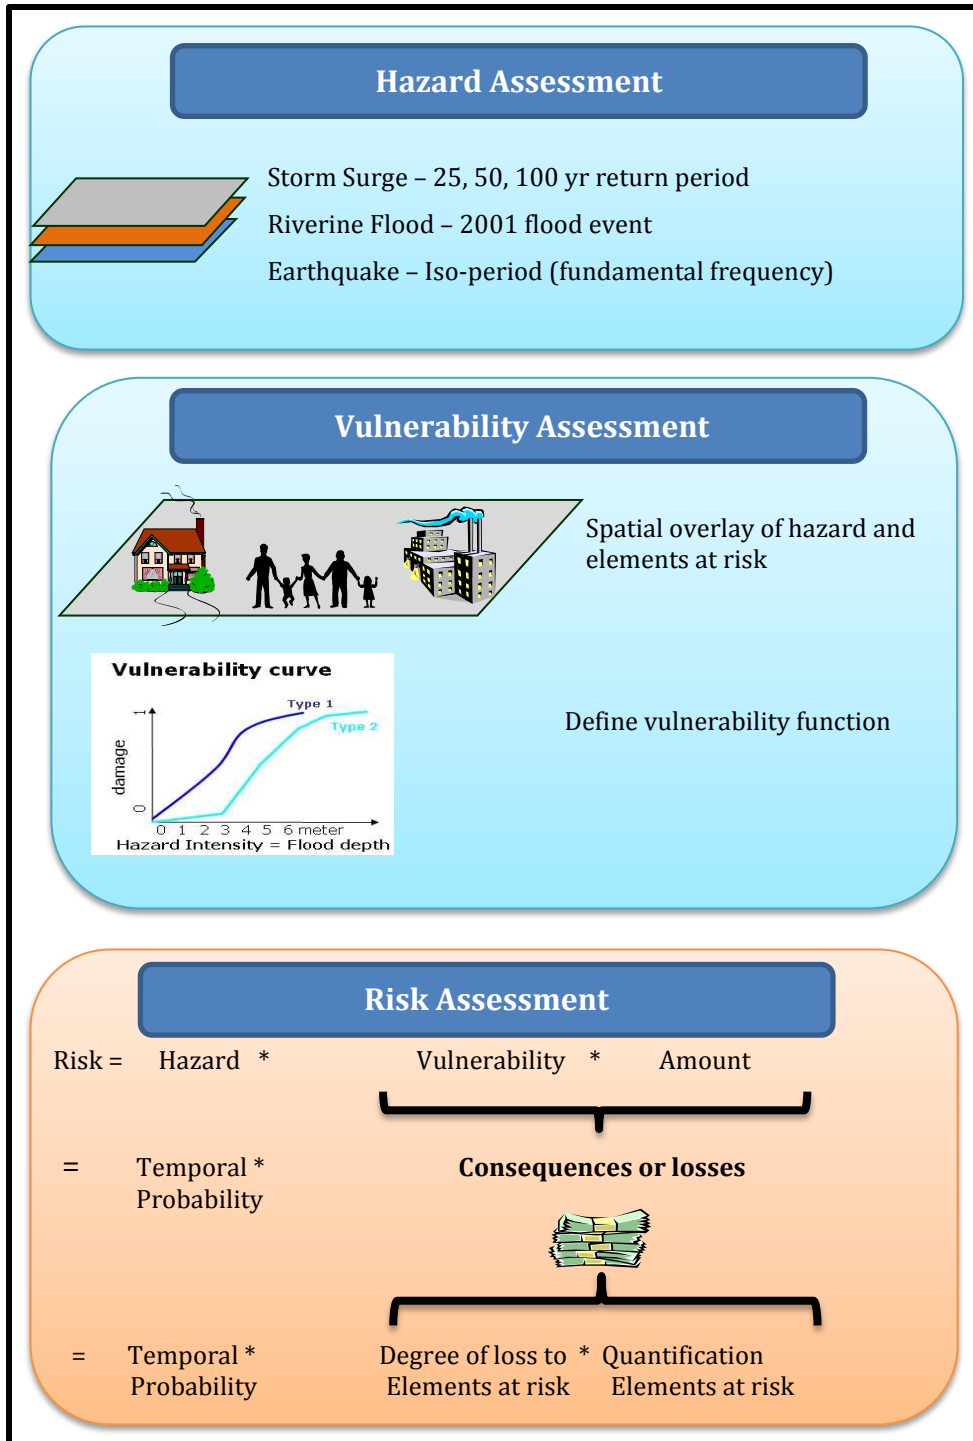
Figure 24: A summation of the Risk Assessment Methodology

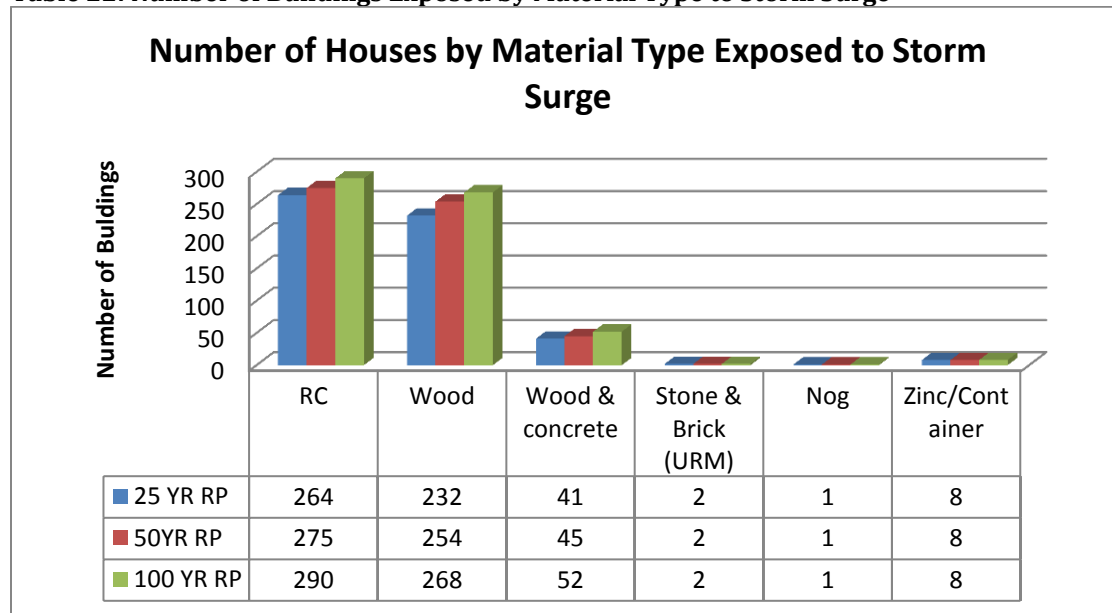
The recent passage of Hurricane Sandy, 2012 (see Figure 26) further reinforced the physical vulnerability of structures in the community, particularly seafront properties.

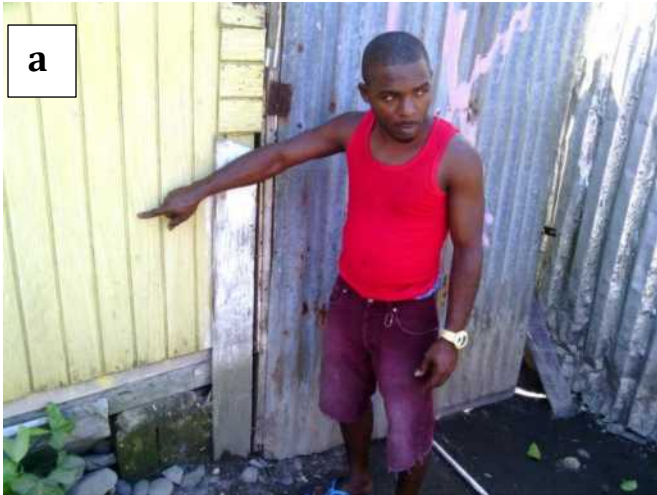
Plate 1: Resident showing Flood Height

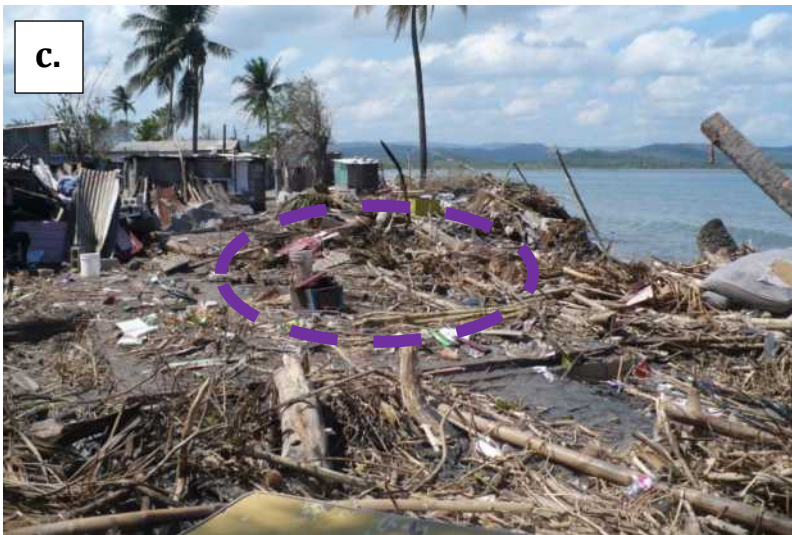
Plate 3: A house that was totally destroyed by hurricane

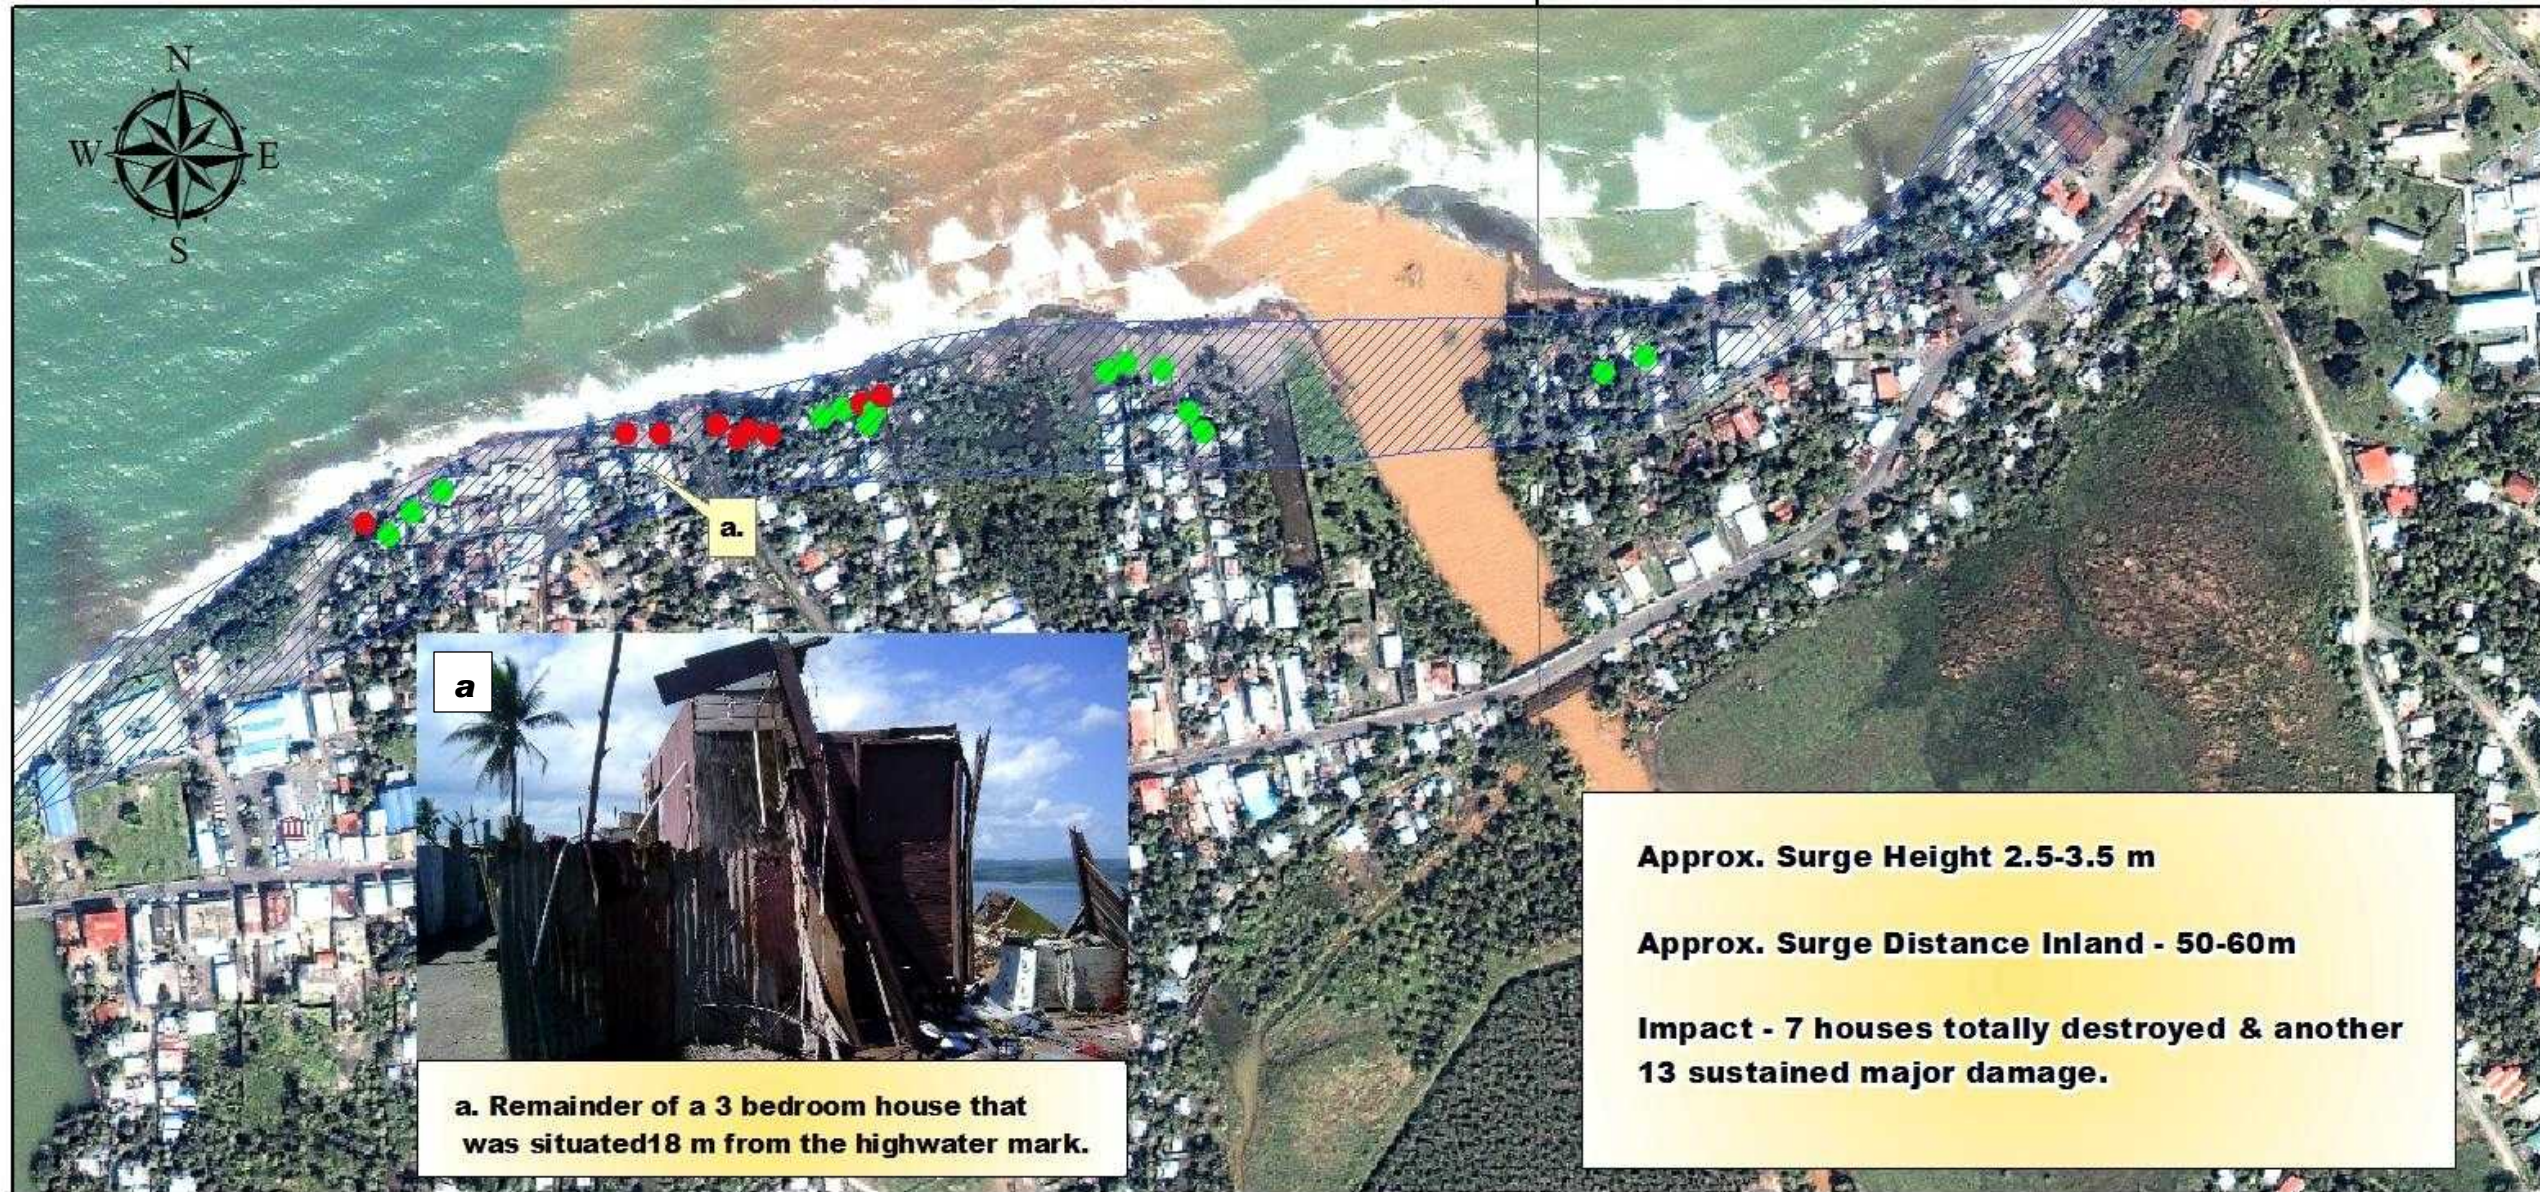
THE IMPACT OF HURRICANE SANDY IN 2012 ON ANNOTTO BAY

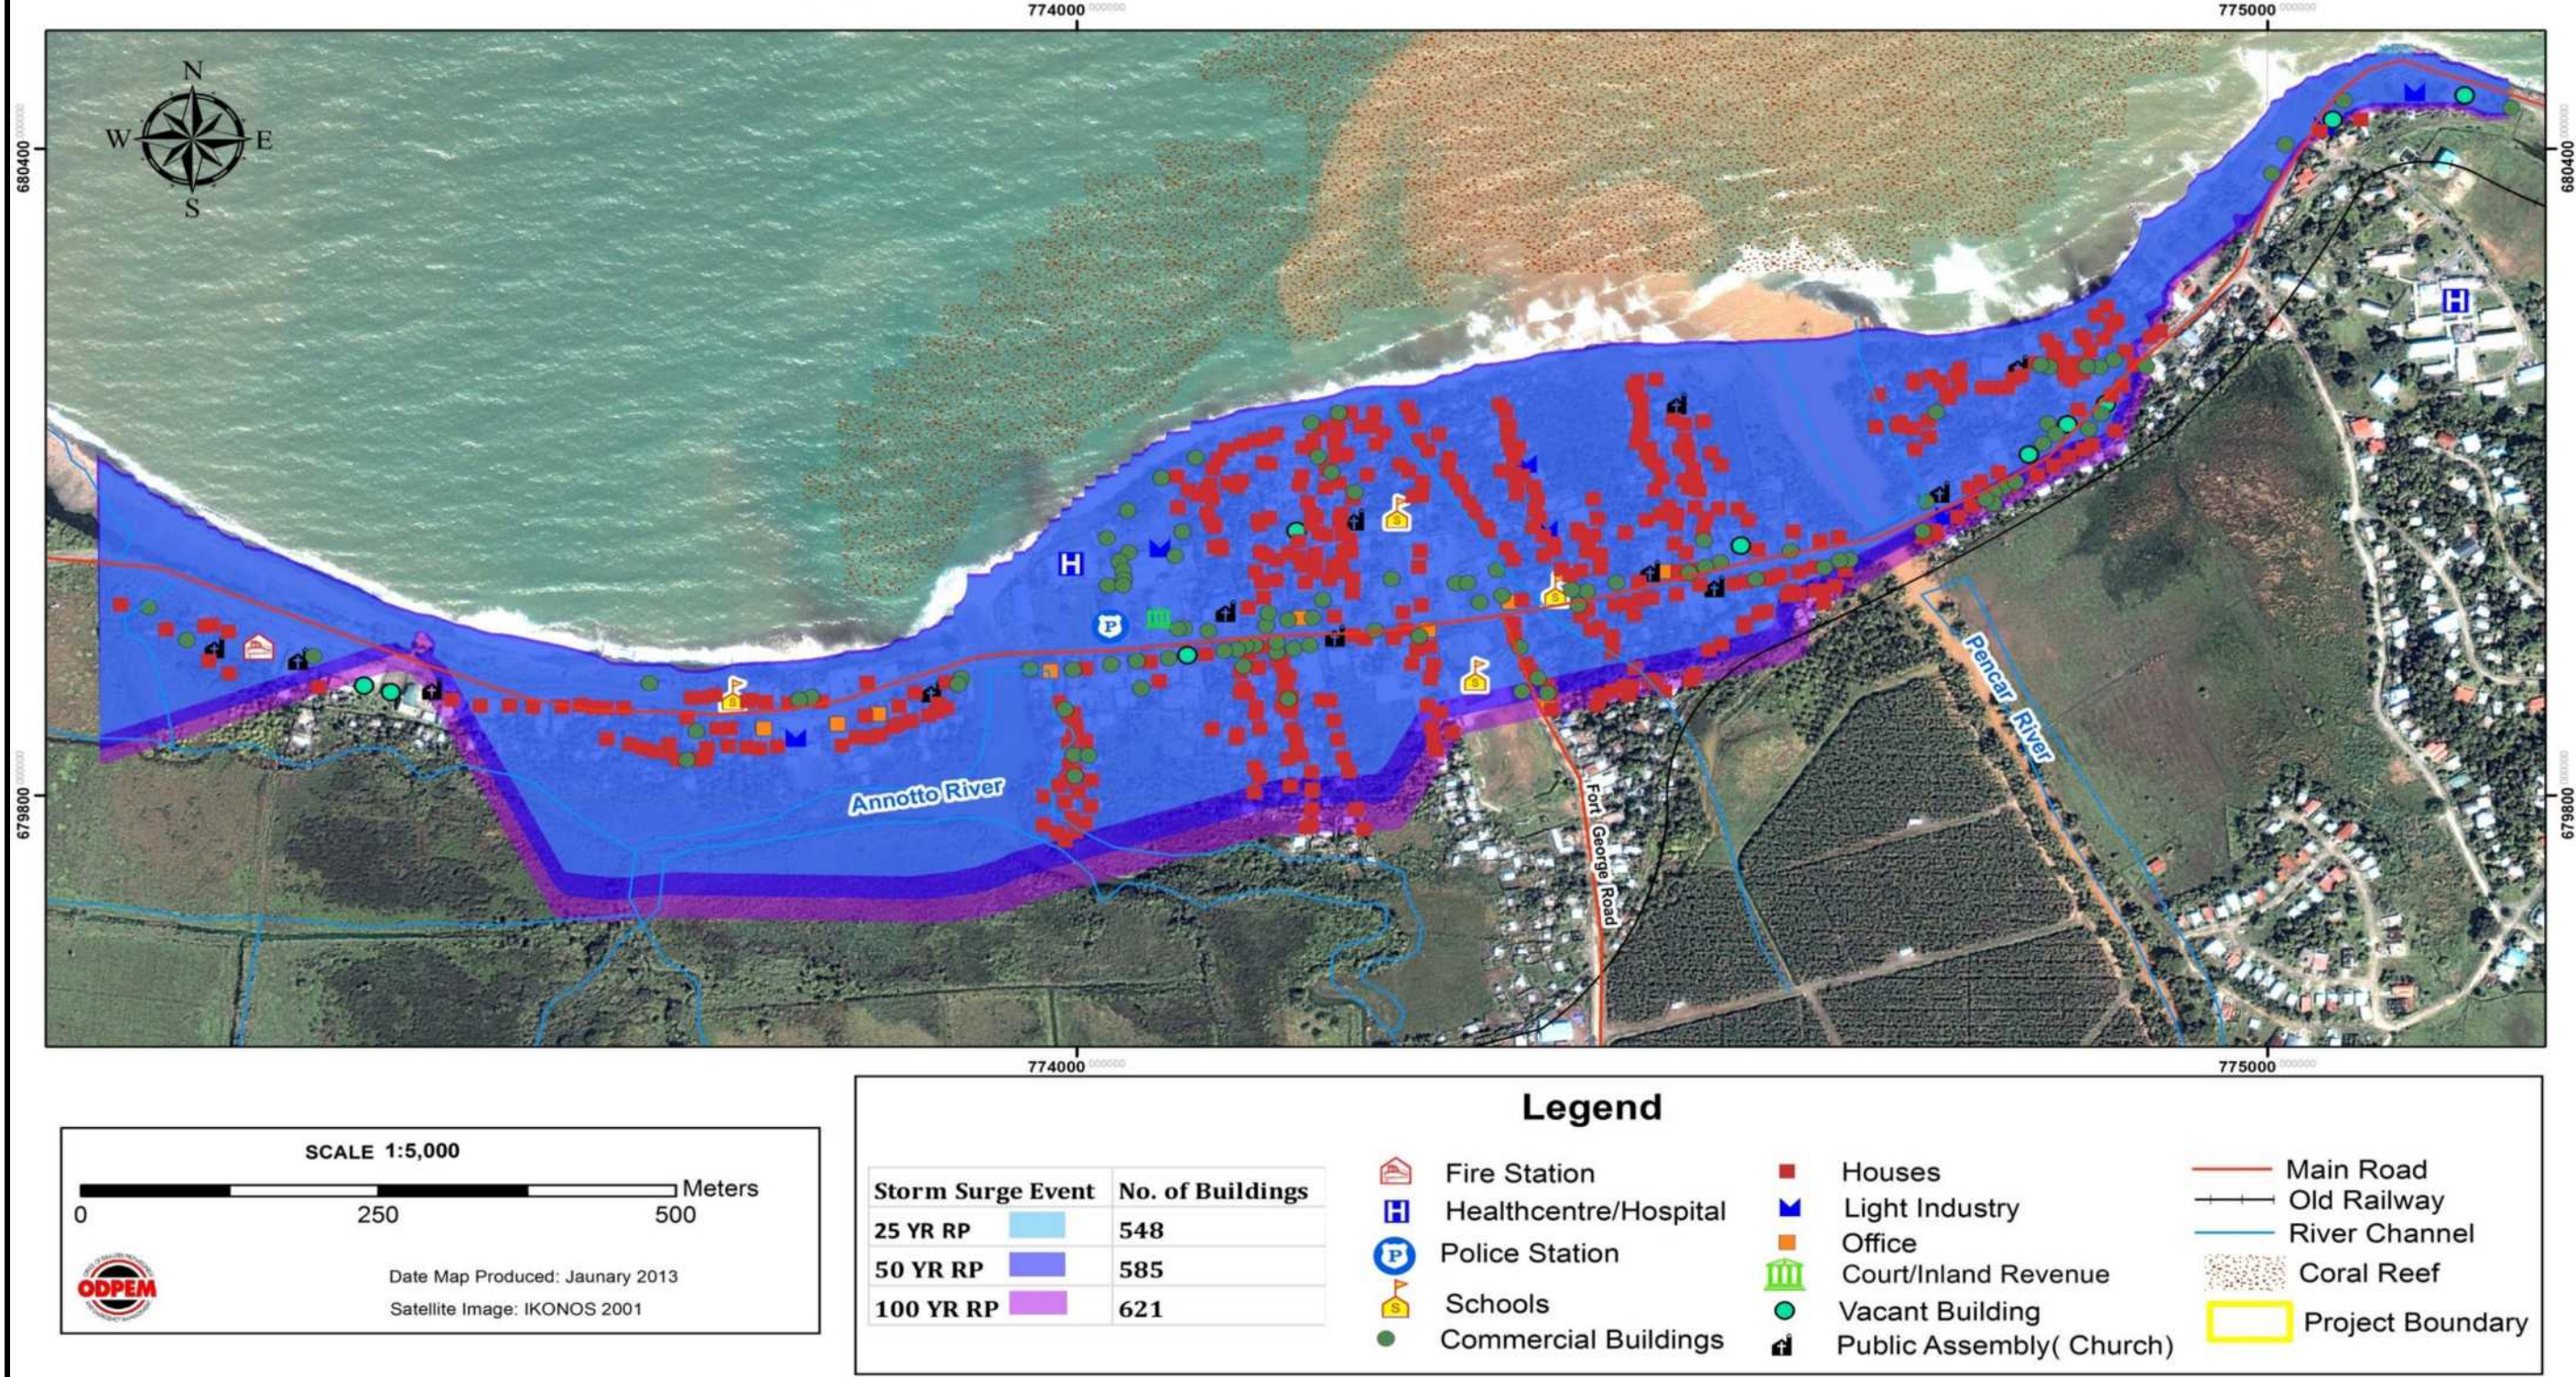
Figure 27: Buildings that are exposed to Storm Surge Hazard

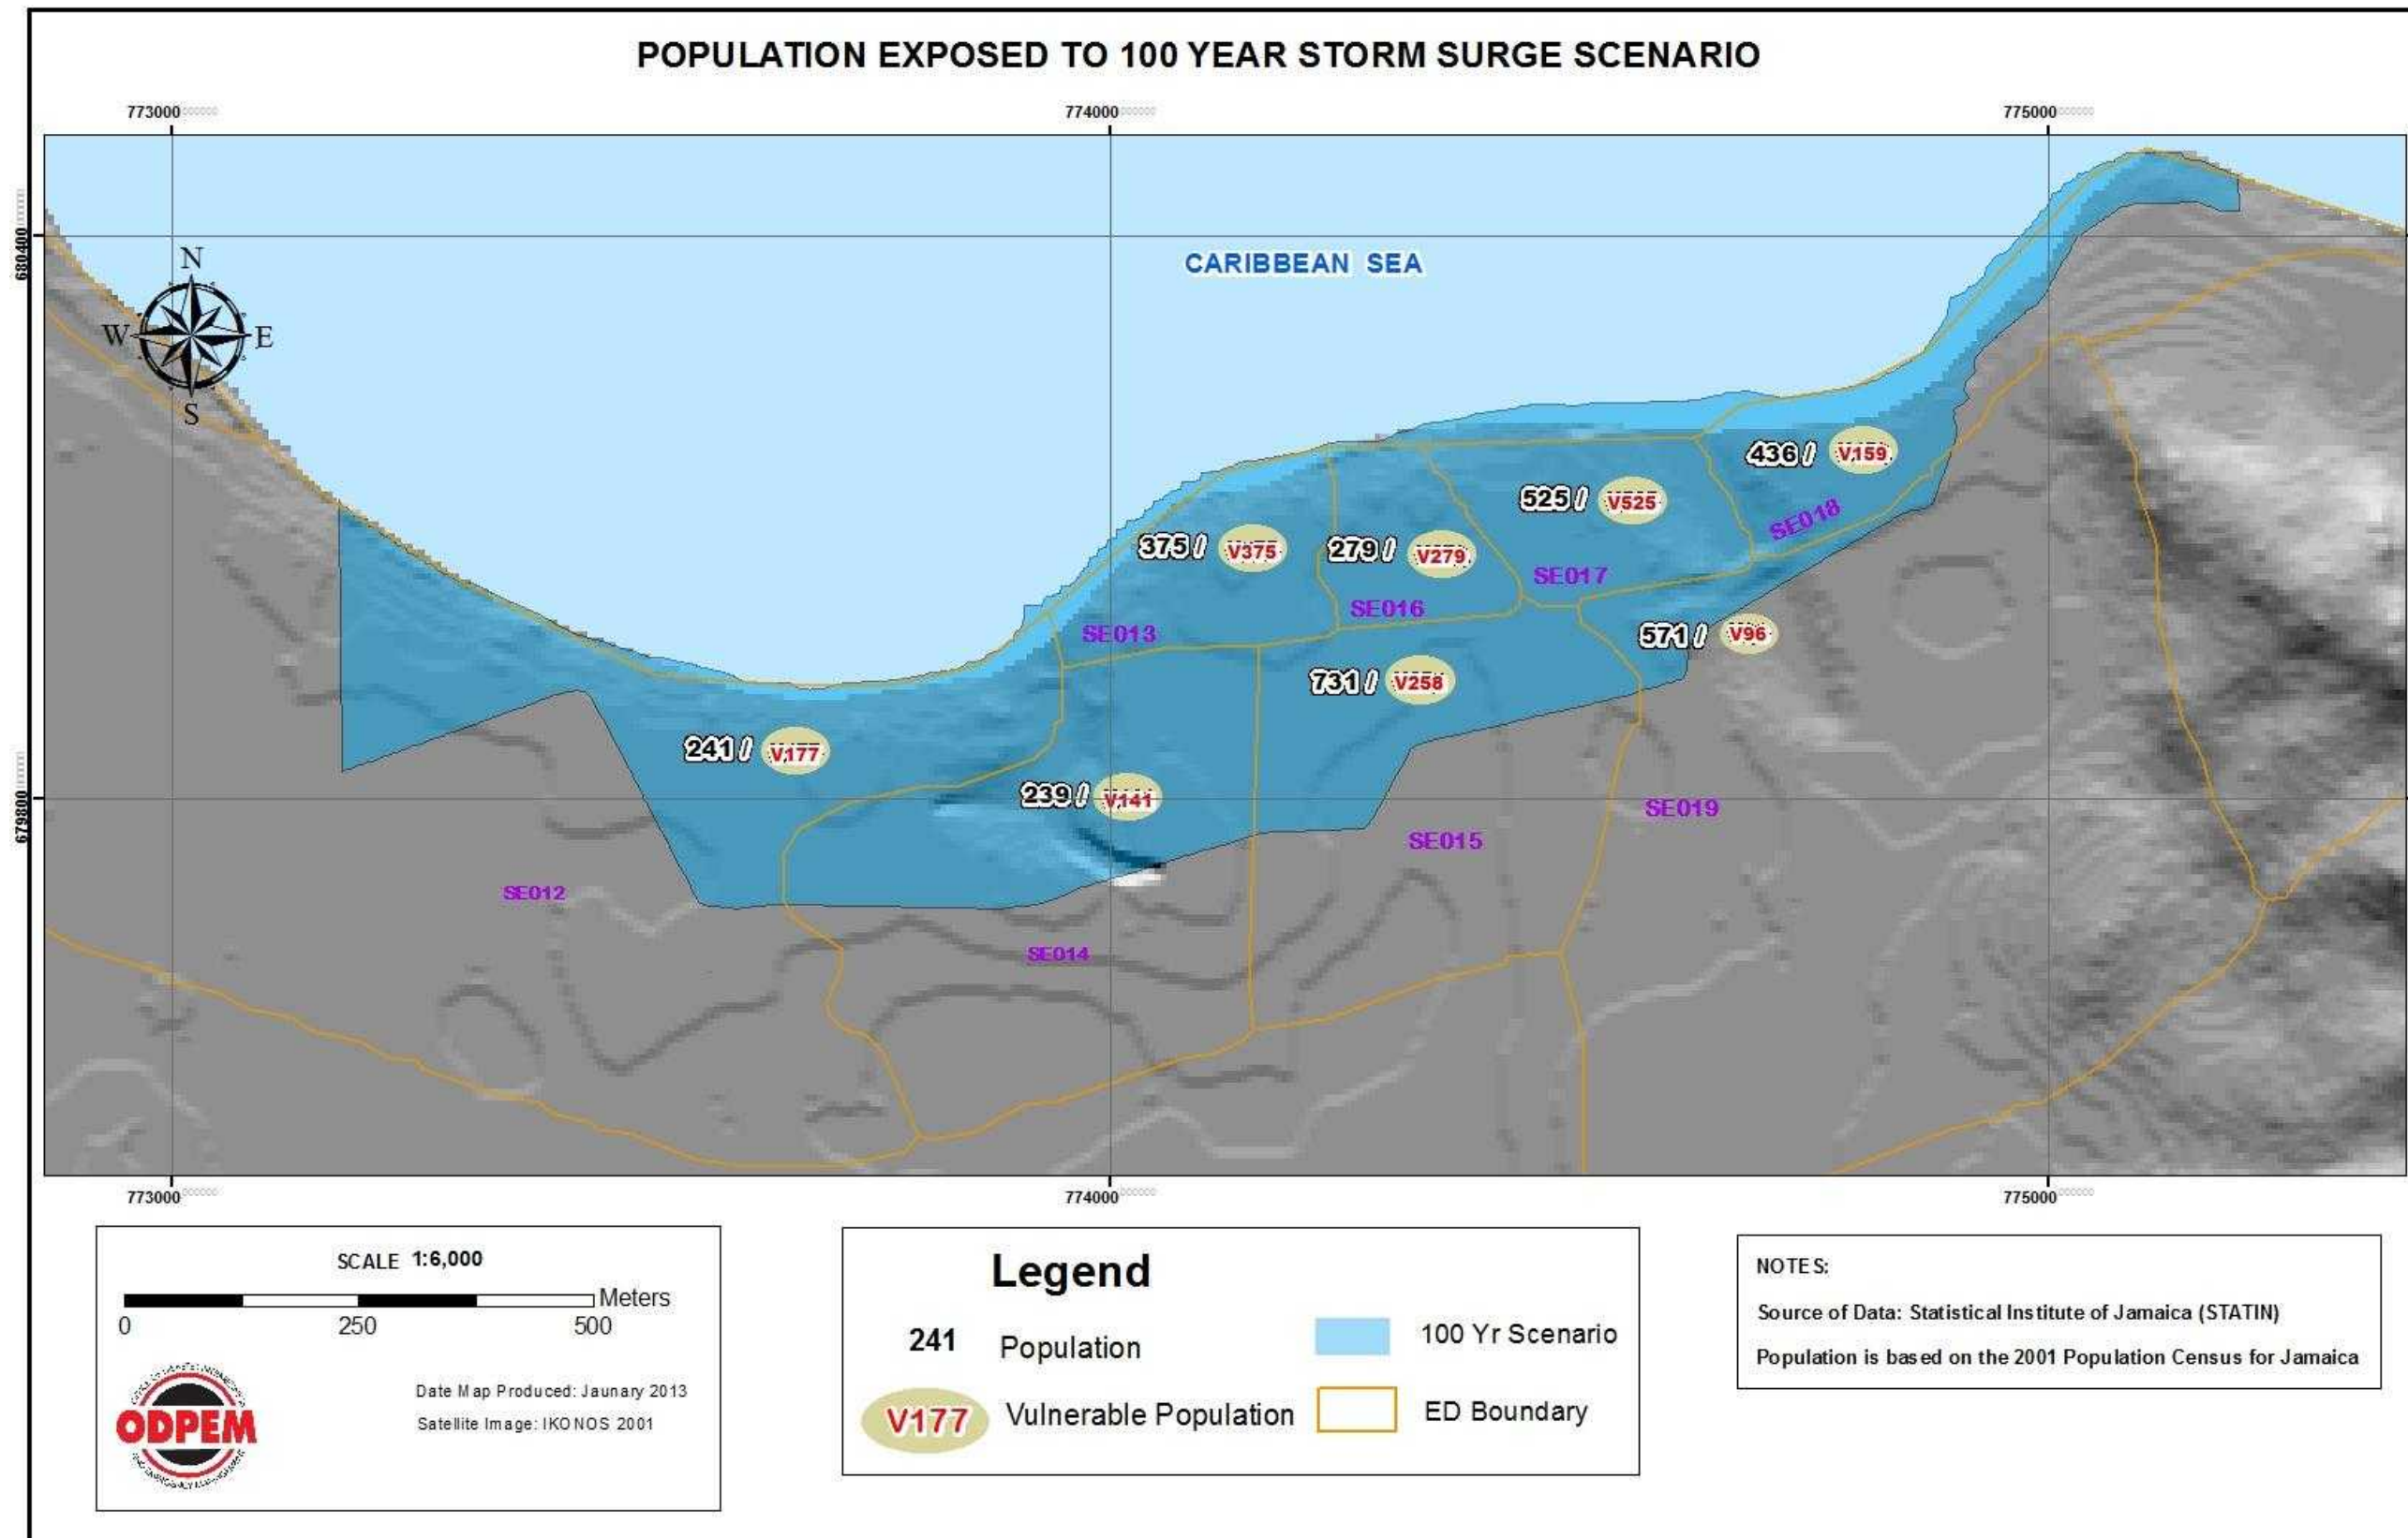
Figure 28: Number of Persons Exposed to Storm Surge Hazard

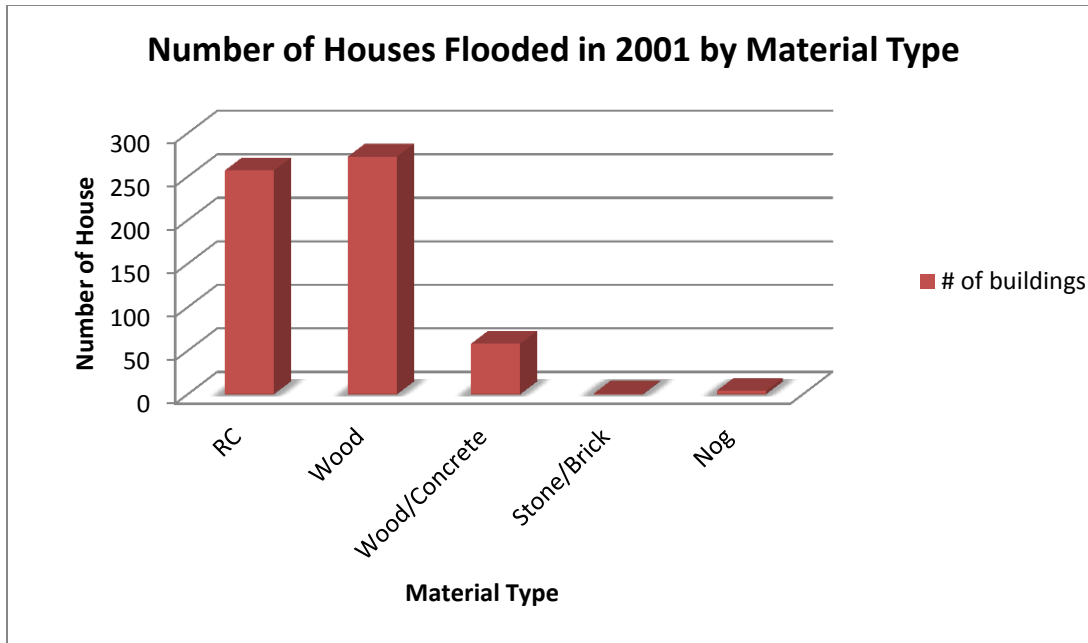
Figure 29: Number of Houses by Material Type Impacted by 2001 Flood Event

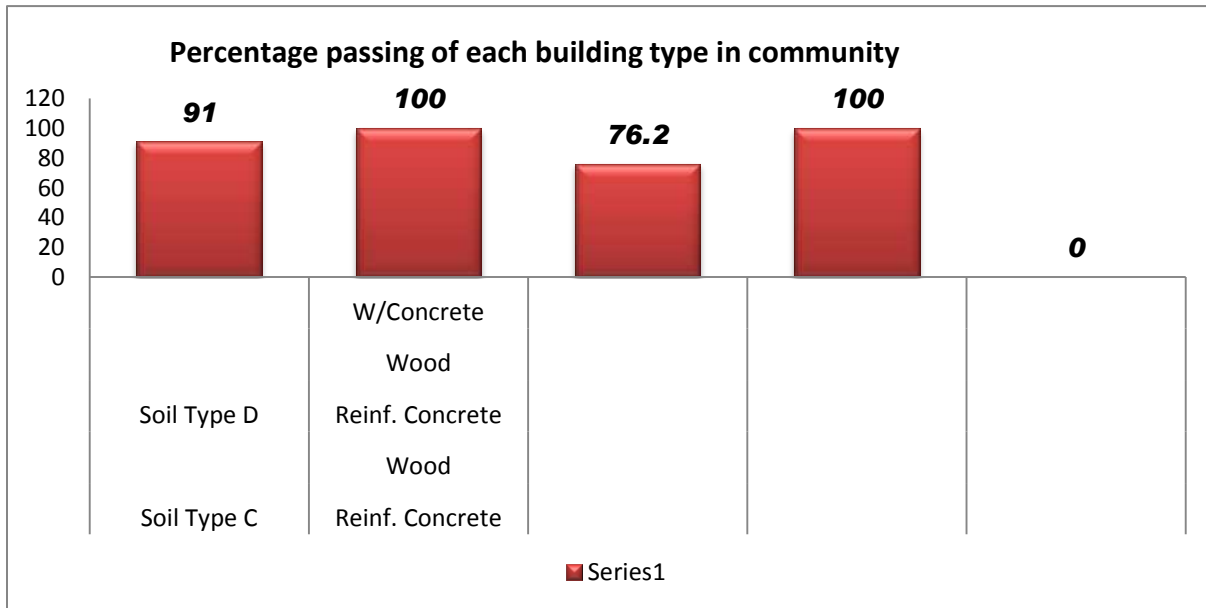
Figure 31: Bar Chart illustrating percentage passing of each building type in Iterboreale when modifiers are applied.

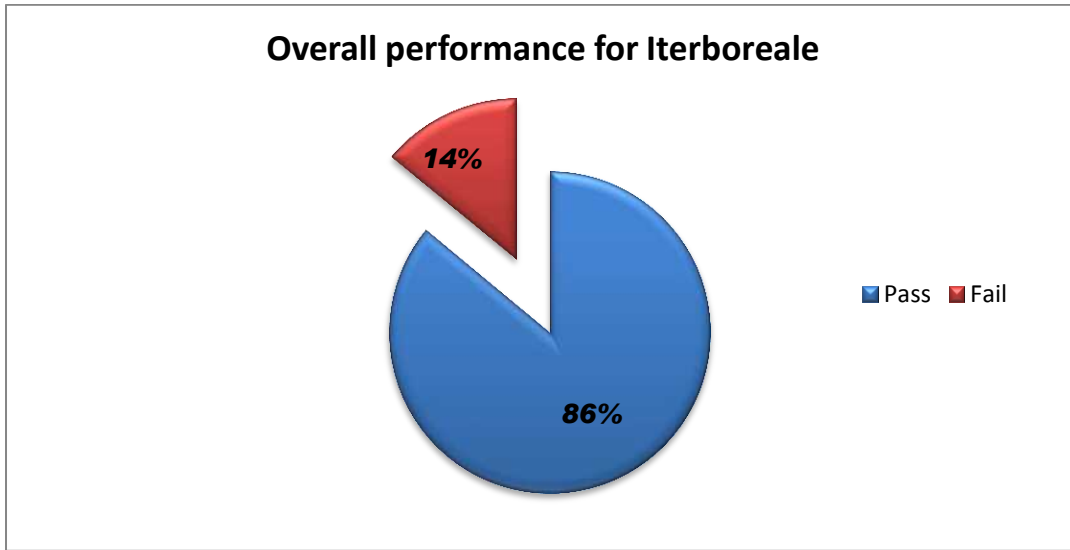
Figure 32: Pie Chart illustrating overall performance in the community of Iterboreale

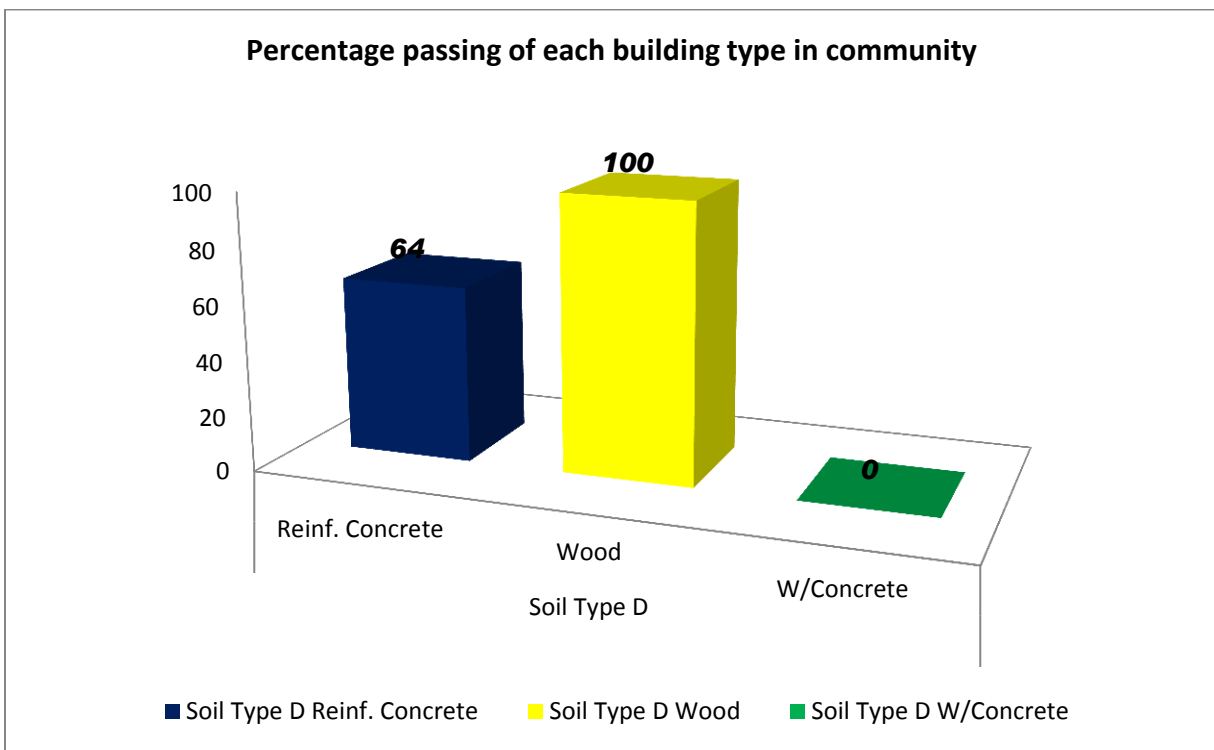
Figure 33: Bar Chart illustrating percentage passing of each building type when modifiers are applied

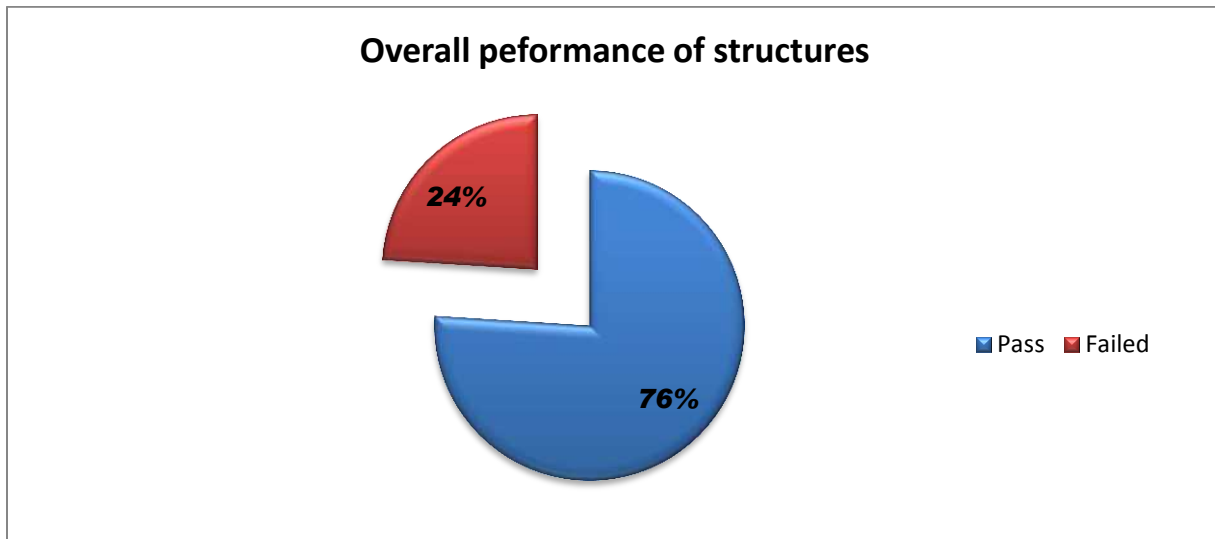
Figure 34: Pie Chart illustrating the overall performance of structures in the community

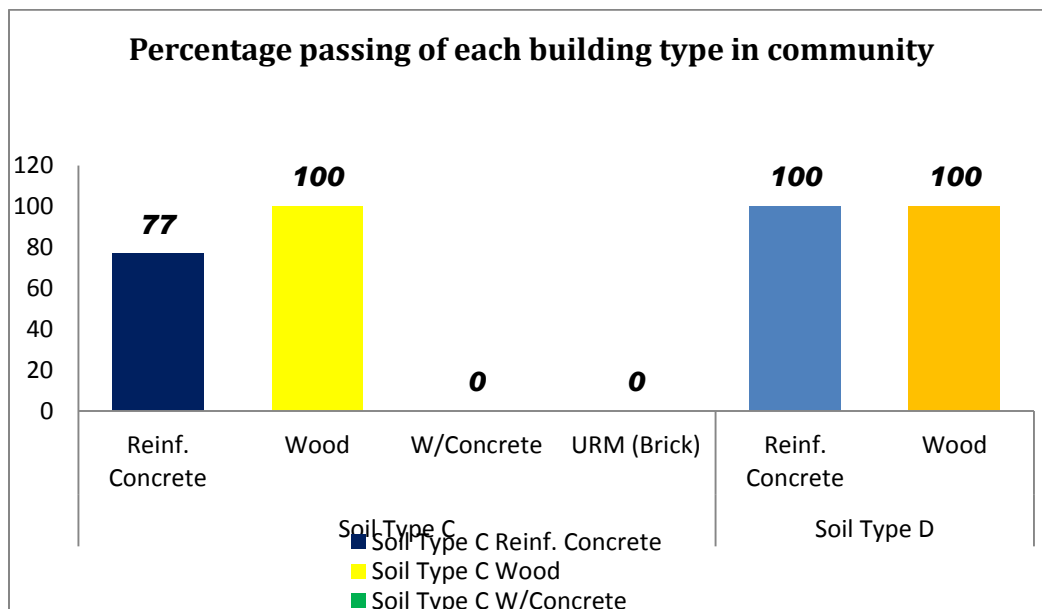
Figure 35: Bar Chart depicting percentage passing of each building between the hospital and Gibraltar Housing Scheme when modifiers are applied

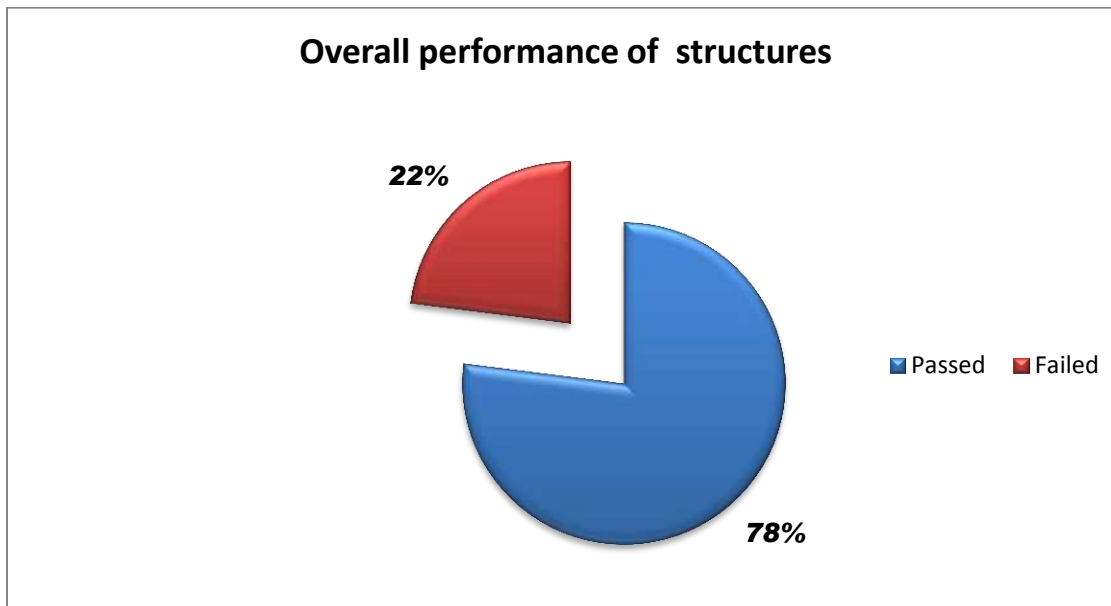
Figure 36: Pie Chart illustrating the overall performance of structures between Hospital and Gibraltar Housing Scheme.

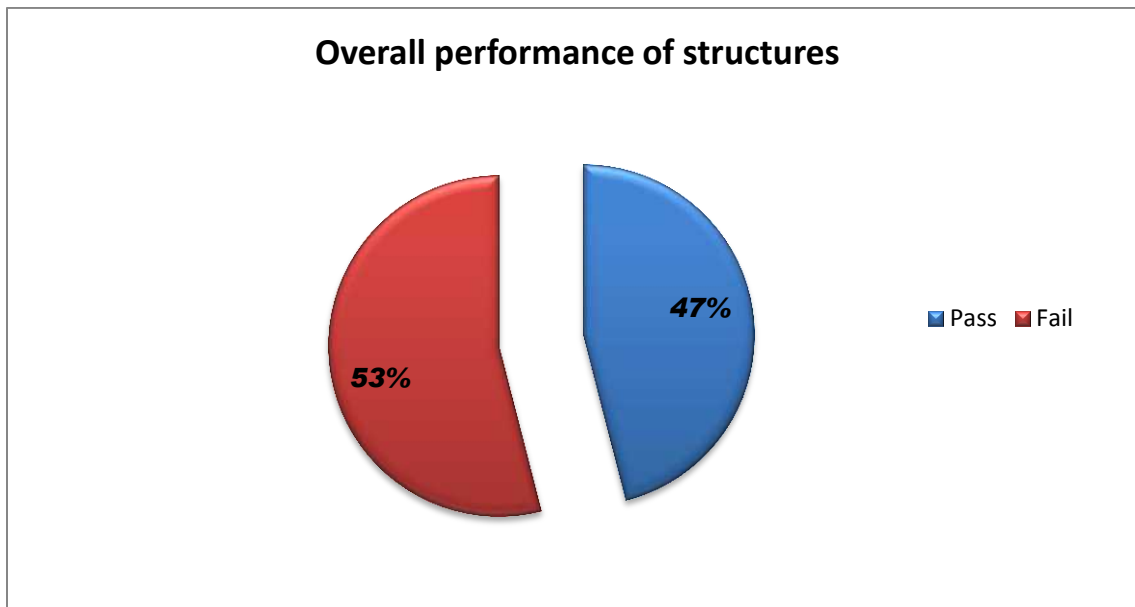
Figure 38: Pie Chart depicting the overall performance of structures between Gibraltar Housing Scheme Road and Pencar River

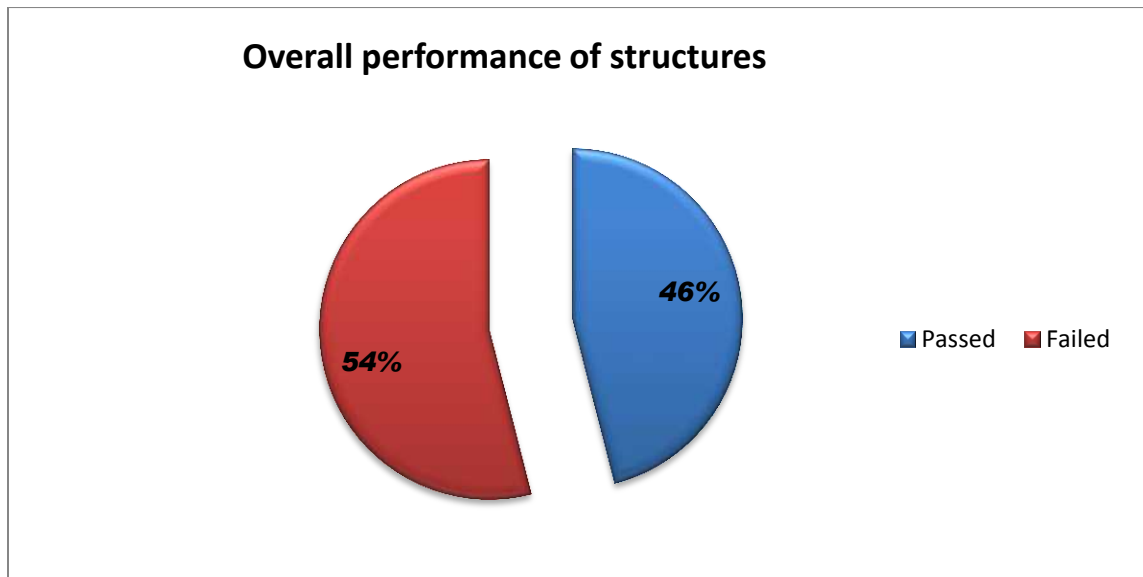
Figure 40: Pie Chart depicting the overall performance for the community between Pencar and Annotto Rivers

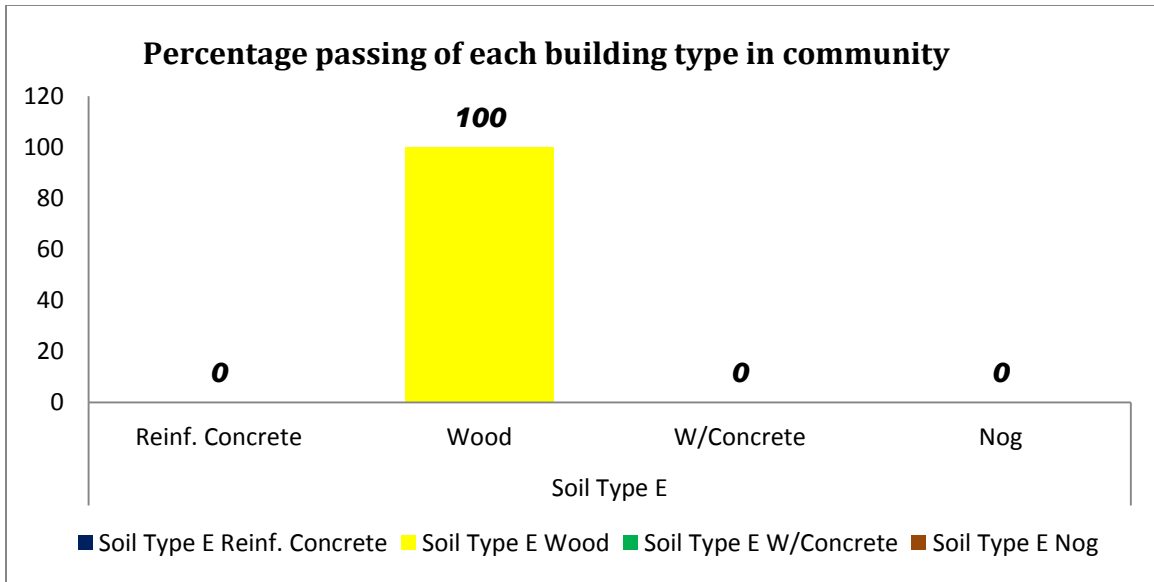
Figure 41: Bar Chart showing percentage passing of each building type from Annotto River to Fire Station End when modifiers are applied

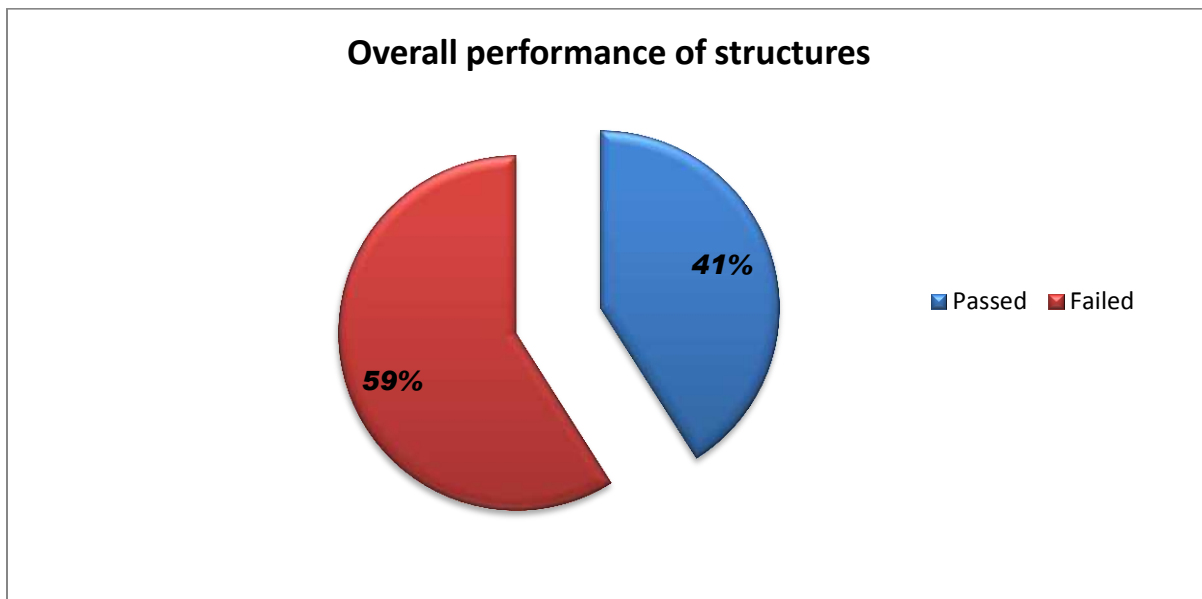
Figure 42: Pie Chart illustrating the overall performance of structures from Annotto River to Fire Station End

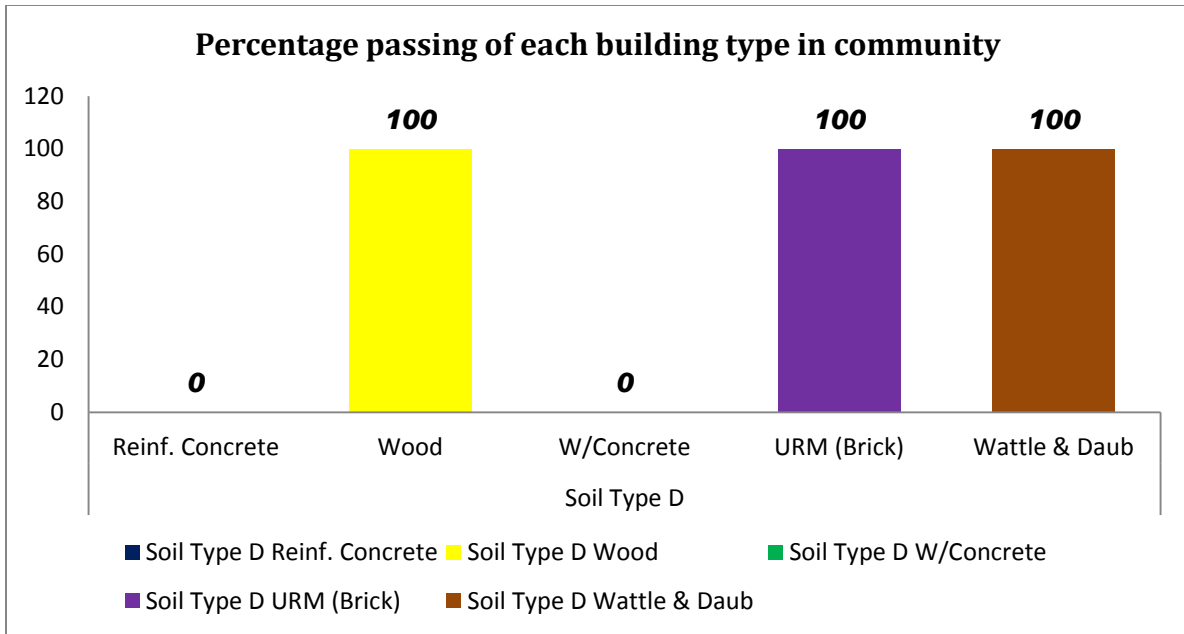
Figure 43: Bar Chart showing percentage passing of building types in the community of Grays Inn based on soil type

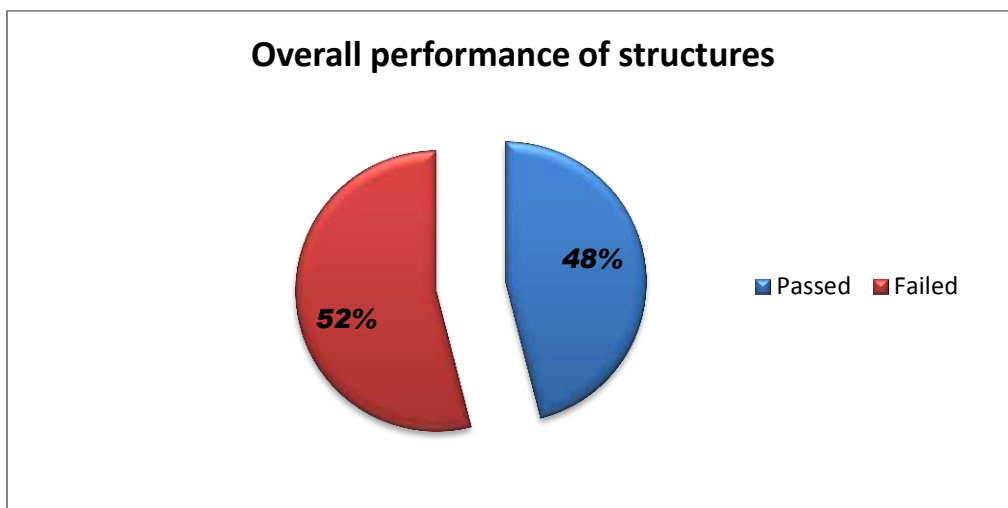
Figure 44: Pie Chart illustrating the overall performance of structures in Grays Inn

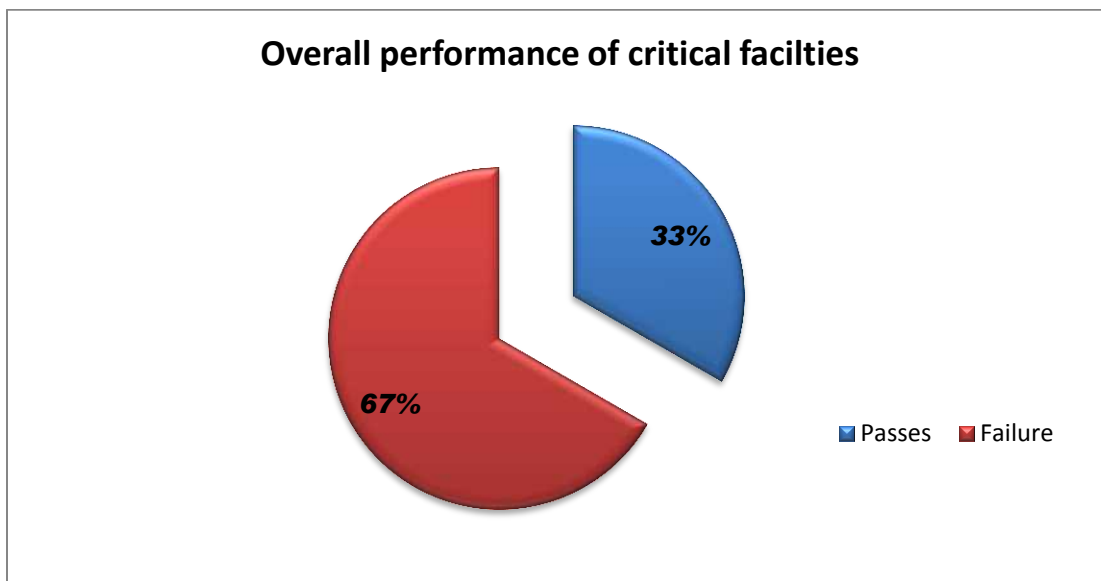
Figure 45: Pie Chart showing overall performance of critical facilities in Annotto Bay
