MITIGATION, PLANNING AND RESEARCH DIVISION

Funded by the Environmental Foundation of Jamaica

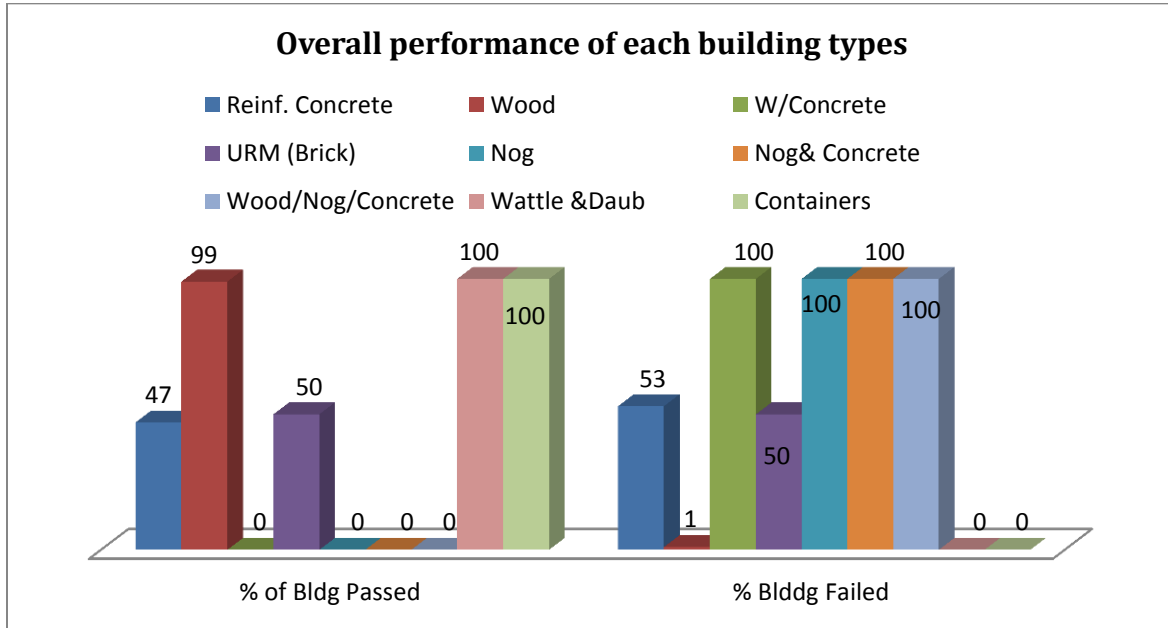
Figure 25: Column chart showing overall performance (% passes and failure) of building types in study area.

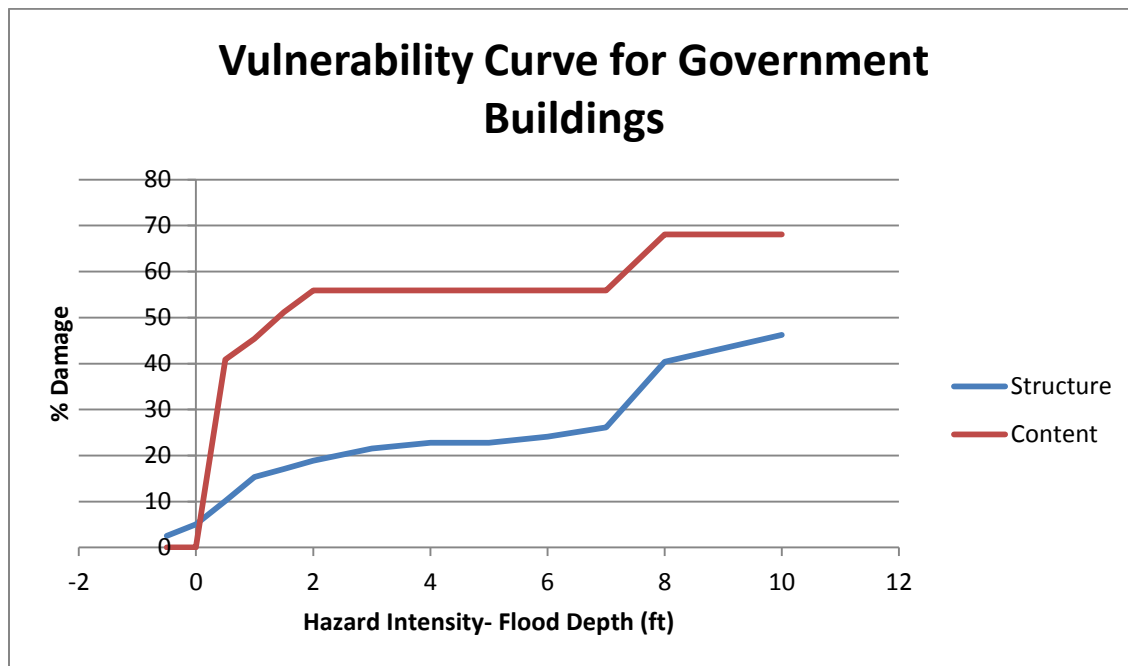
Figure 46: Vulnerability Curve for Critical Facilities

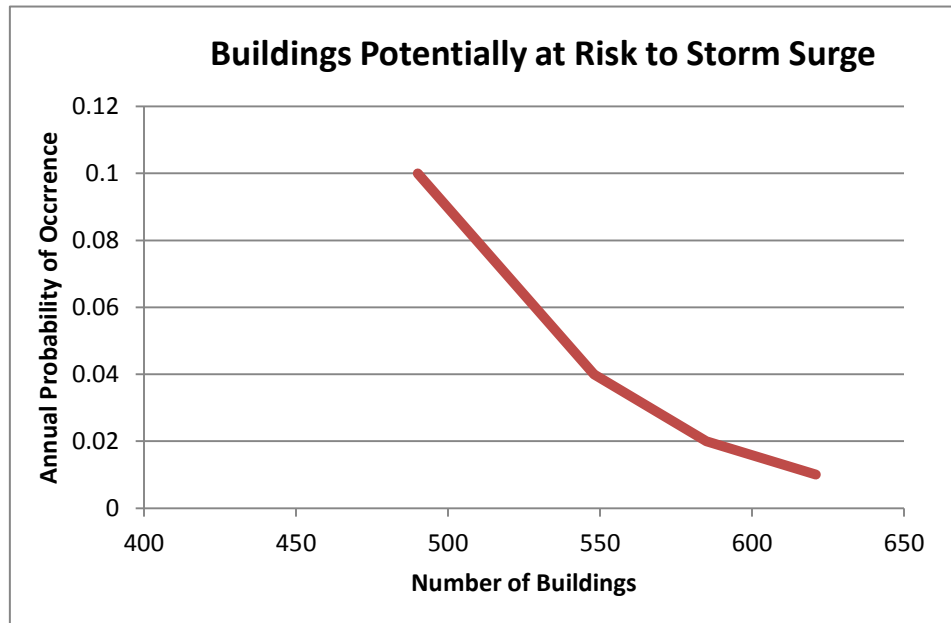
Figure 47: Buildings Potentially at Risk to Storm Surge Impact

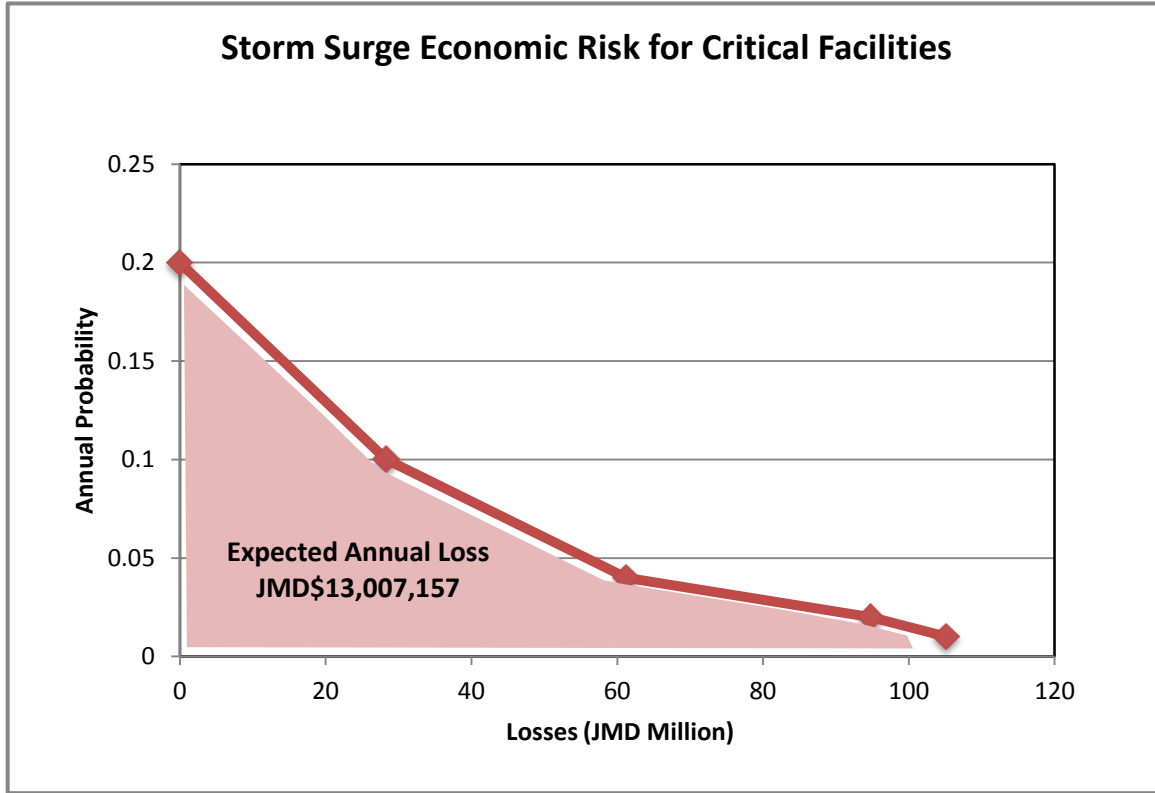
Figure 48: Economic Risk Associated with Storm Surge Hazard

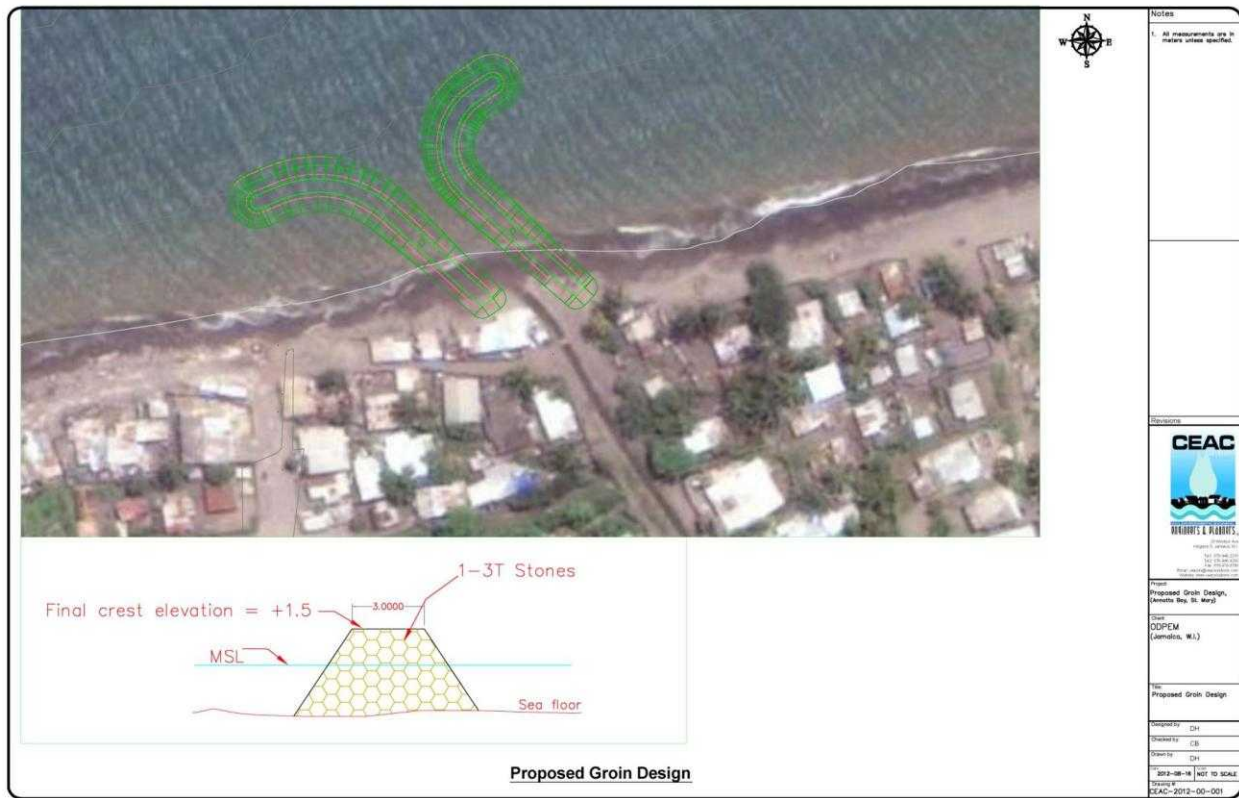
Figure 49: Schematic of proposed Groin Design

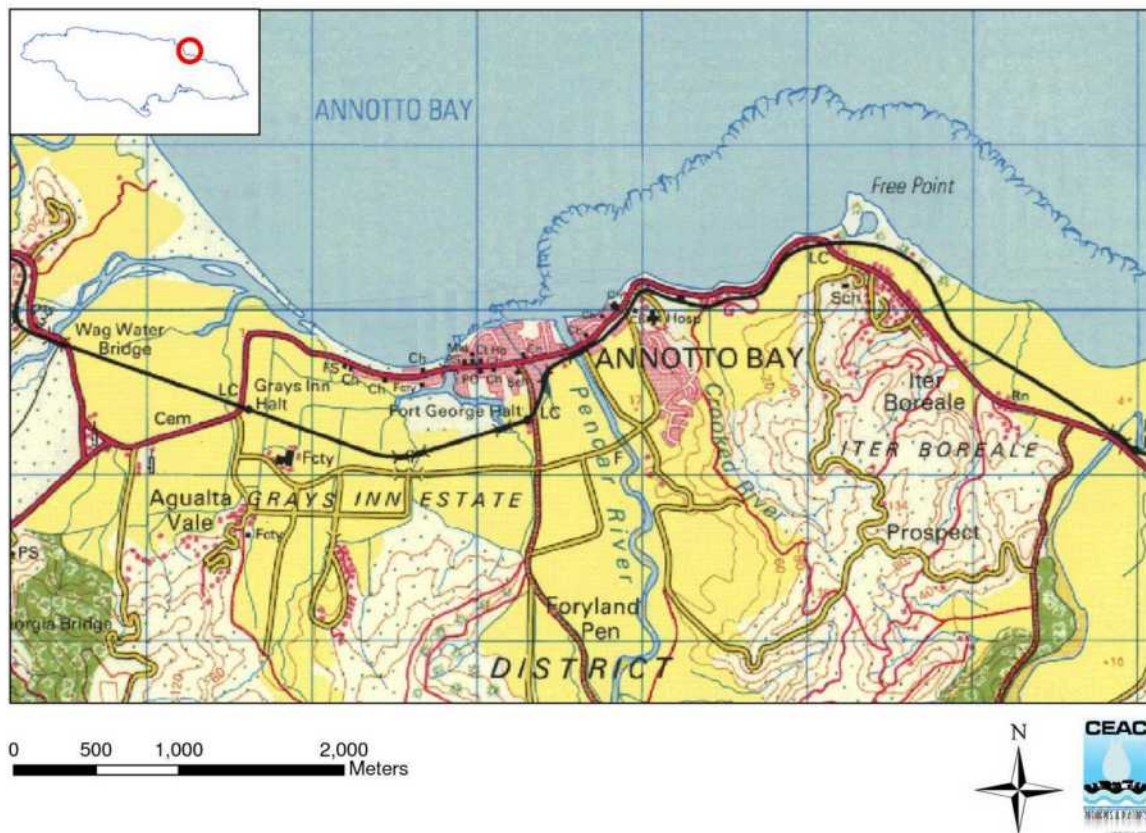
Figure 0.1 Location plan of Annotto Bay

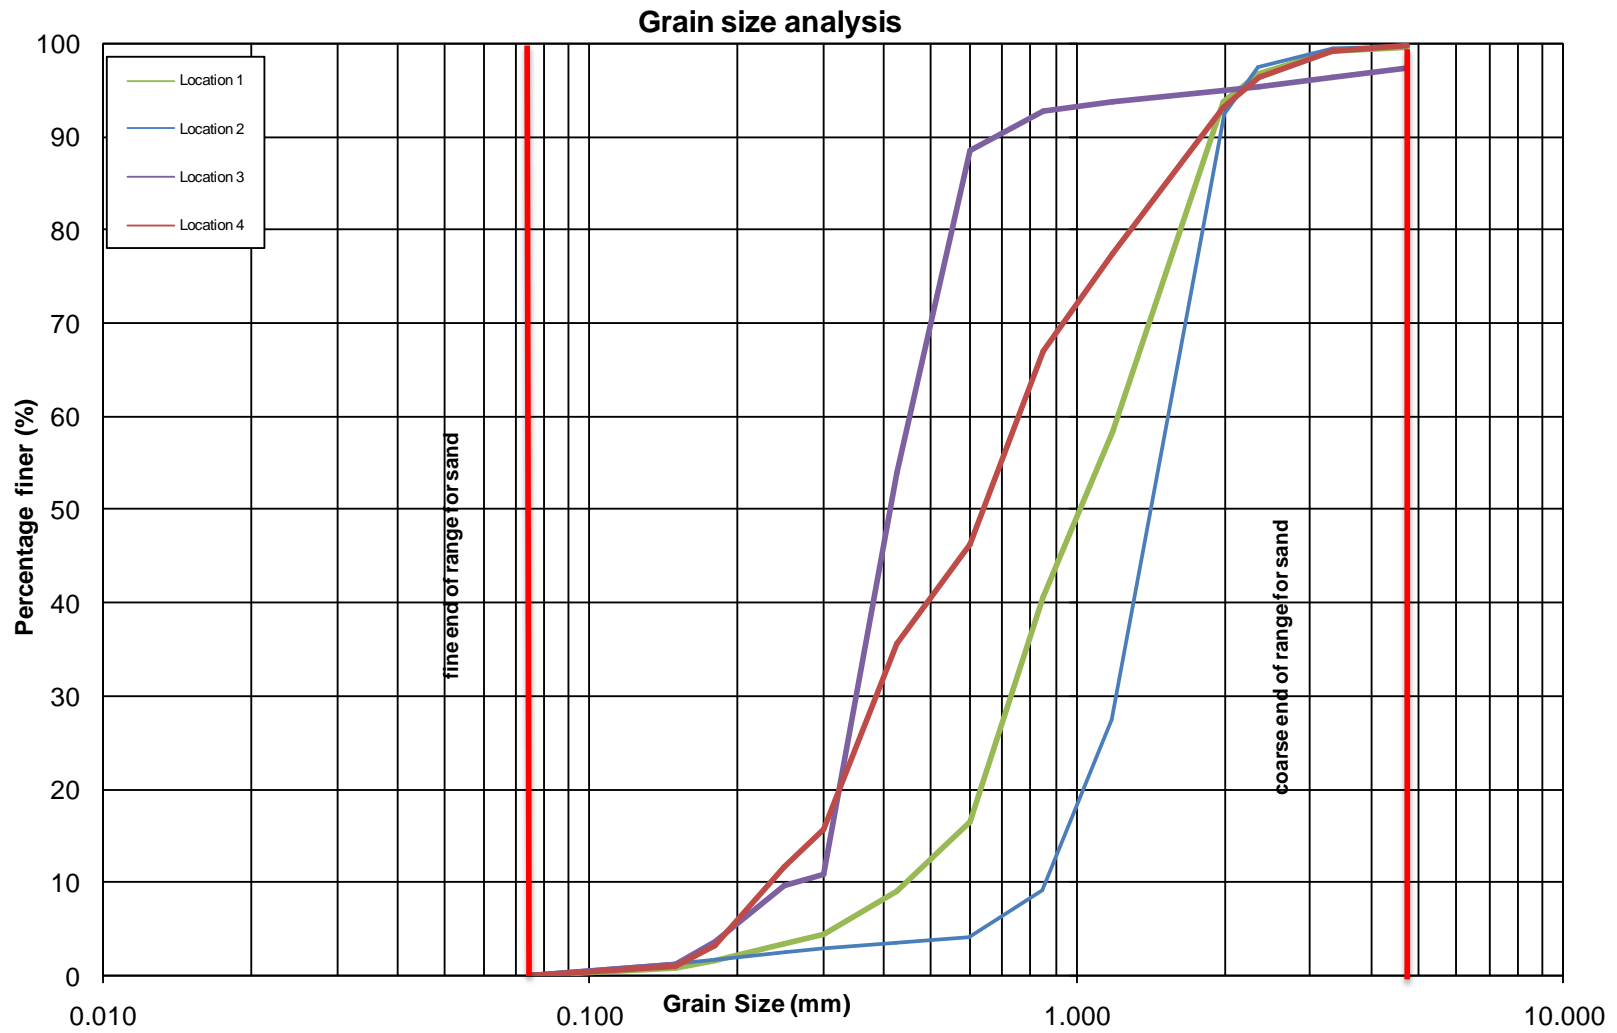
Figure 0.6 Results of Sieve Analysis conducted for project area

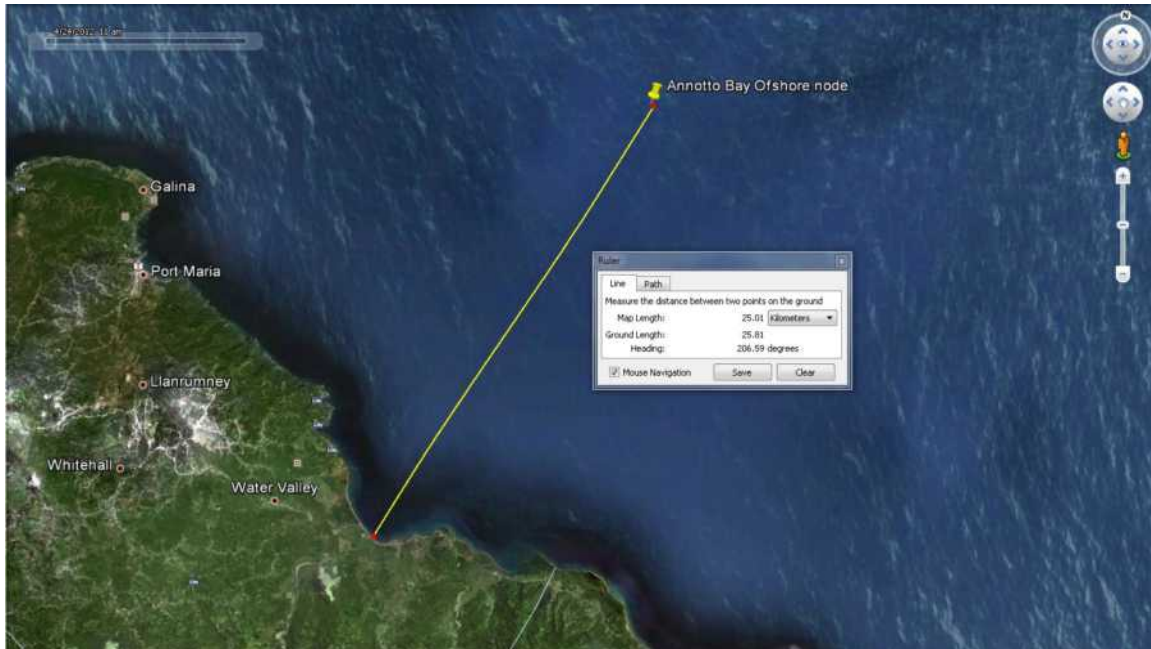
Figure 0.7 - Location of offshore point used for Extremal analysis, showing the track used in the analysis

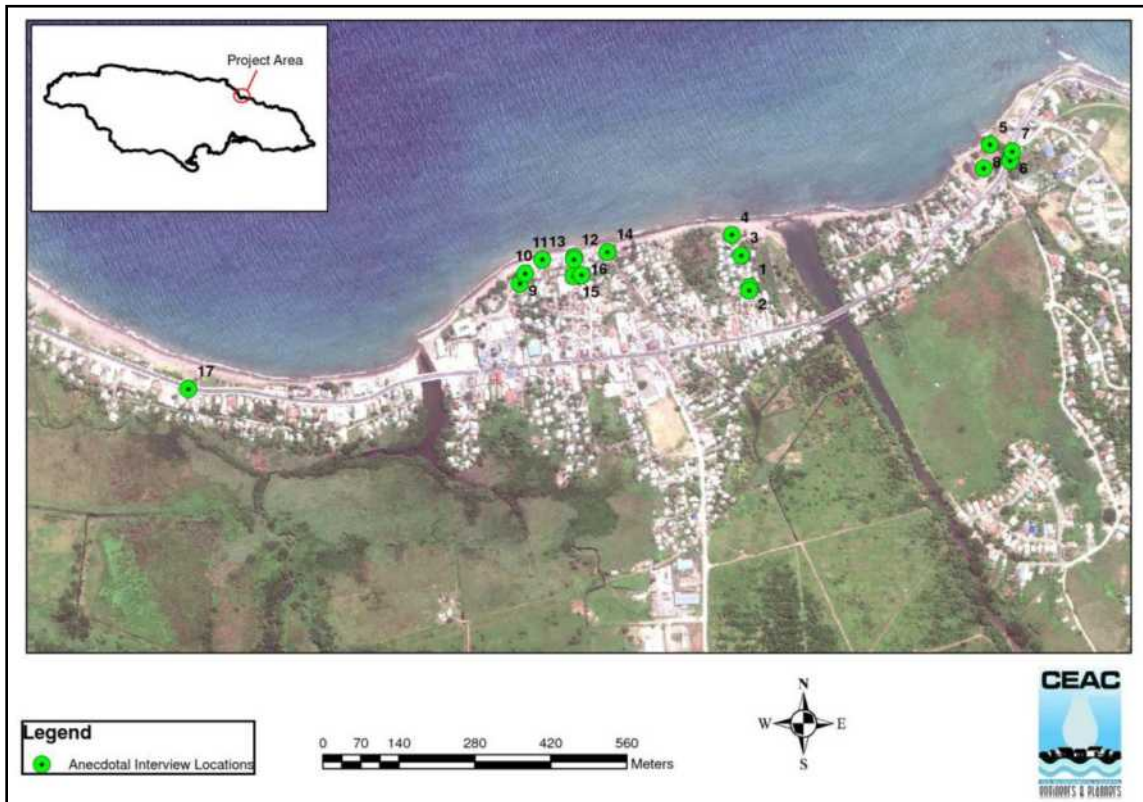
Figure 0.8 Locations in Annotto Bay where anecdotal interviews were conducted.

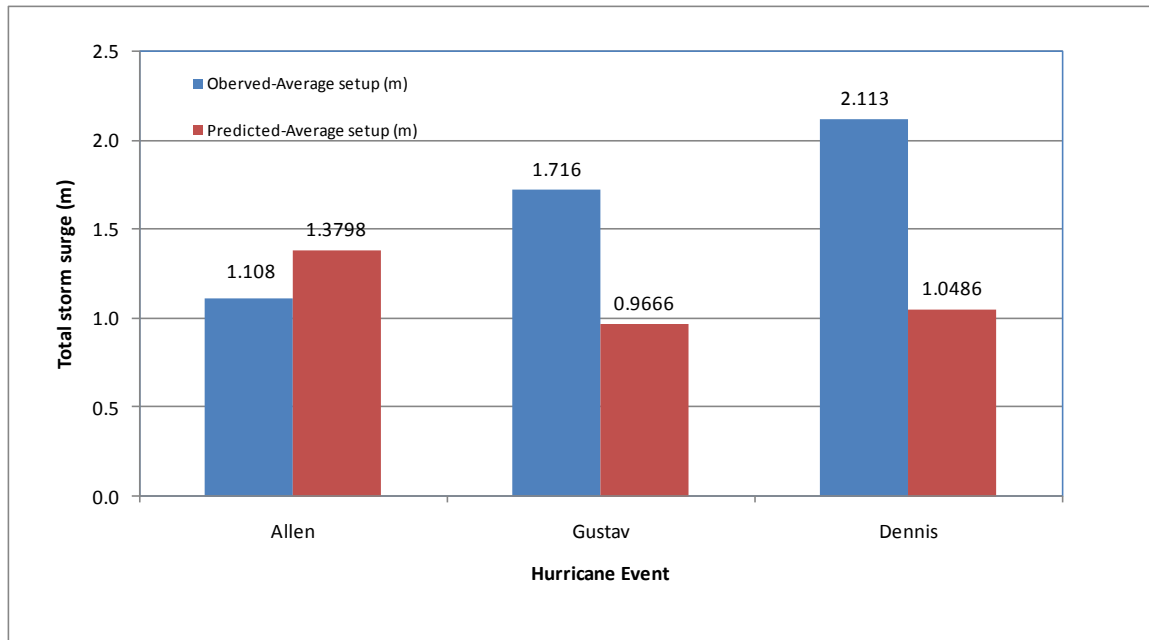
Figure 0.9 Observed average setup (based on interviews) versus model predicted setup

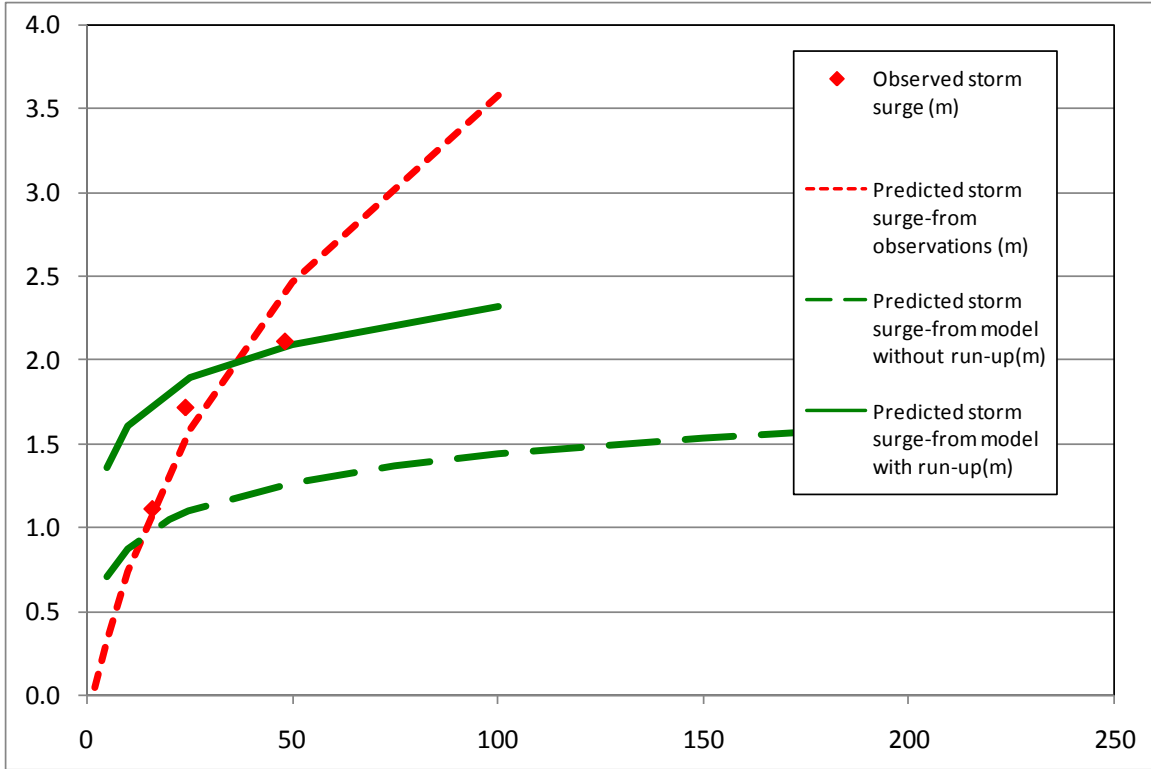
Figure 0.10 Plots of predicted and observed storm surge elevations over different return periods

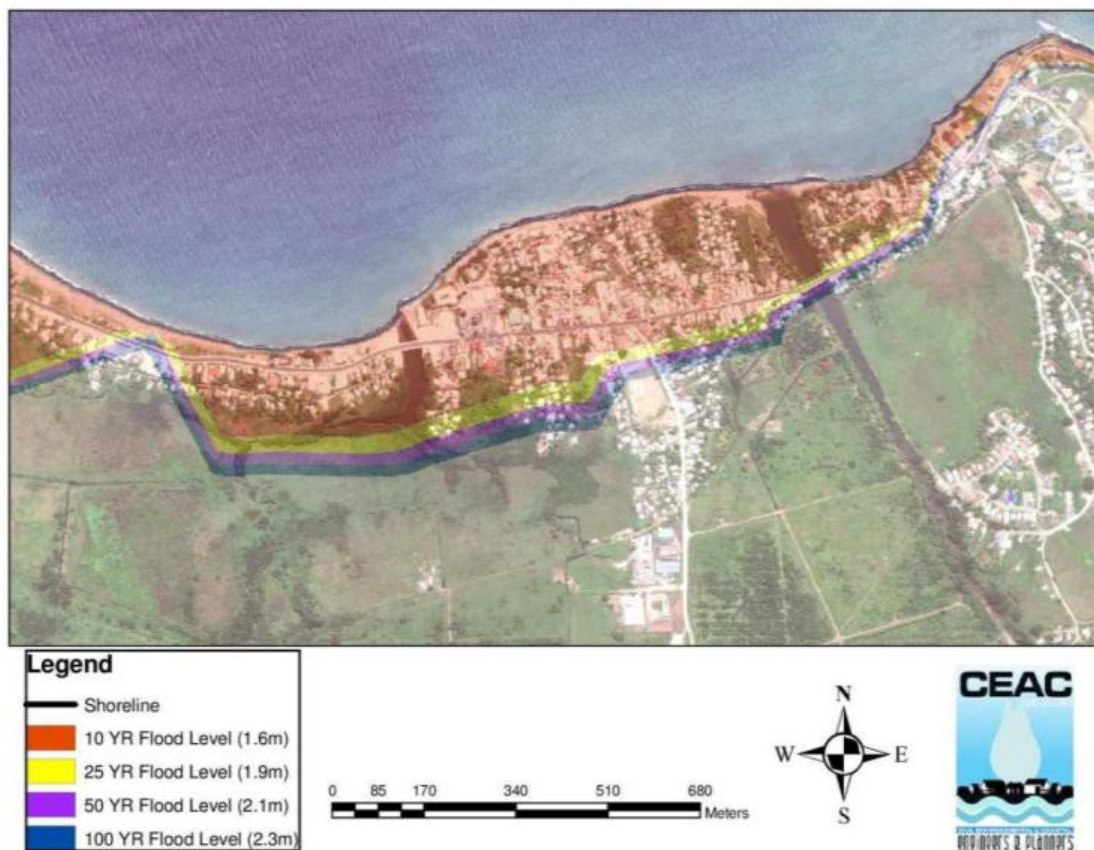
Figure 0.11 10, 25, 50 and 100 year return periods flood levels.

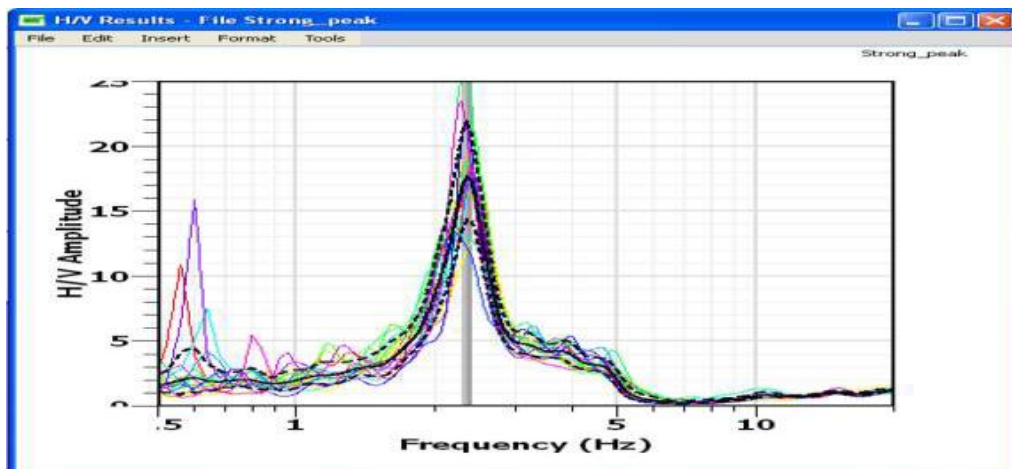
Figure 1: Typical output of the processed 3- component ambient ground motion signal to determine the fundamental frequency of a site. The period of the site is calculated by determining the inverse value of the fundamental frequency.

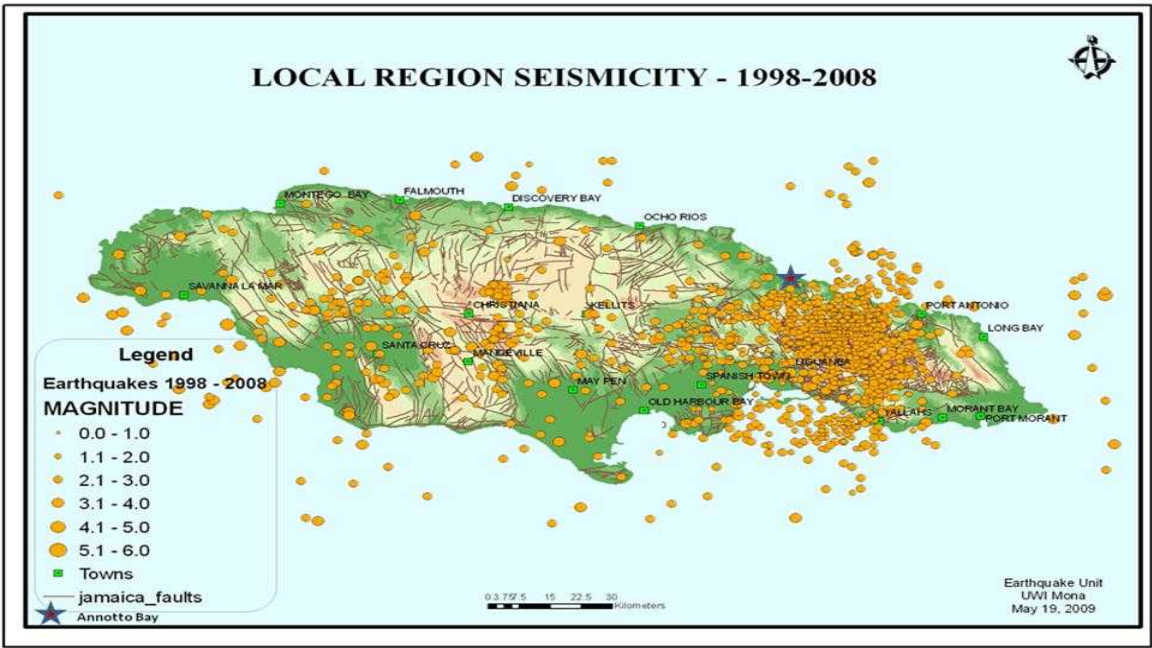
Figure 3: Epicentres of earthquakes in Jamaica during 1998-2008, highest frequency of events occurs in the north-eastern of the island in close proximity to study area.

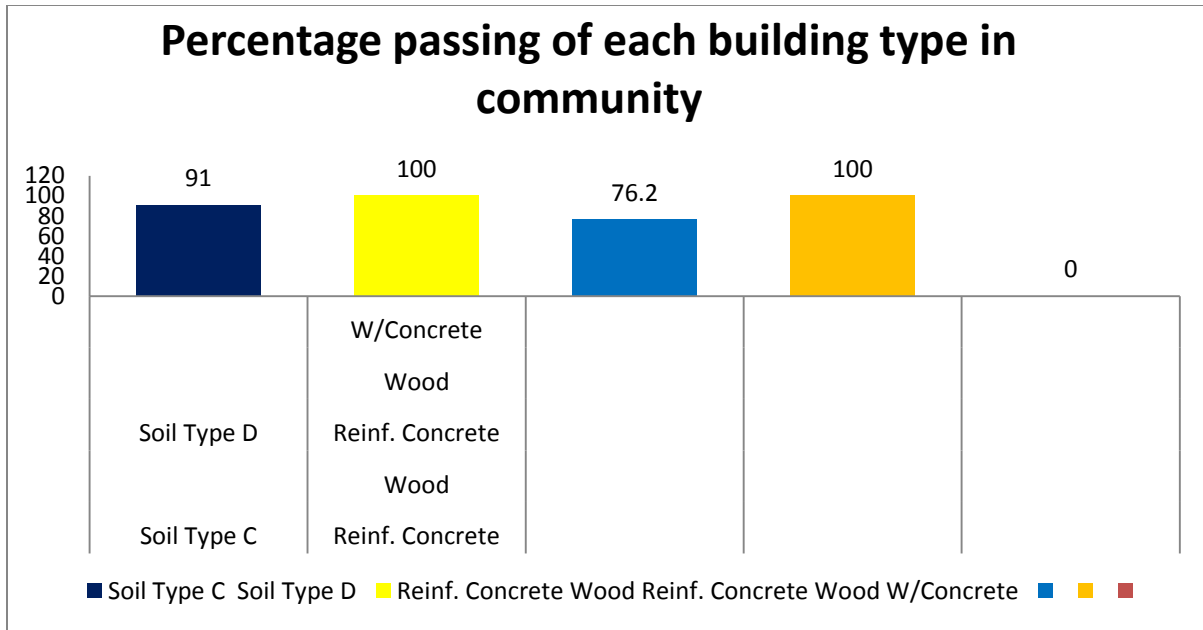
Figure 11: Column chart illustrating percentage passing of each building type when modifiers are applied.

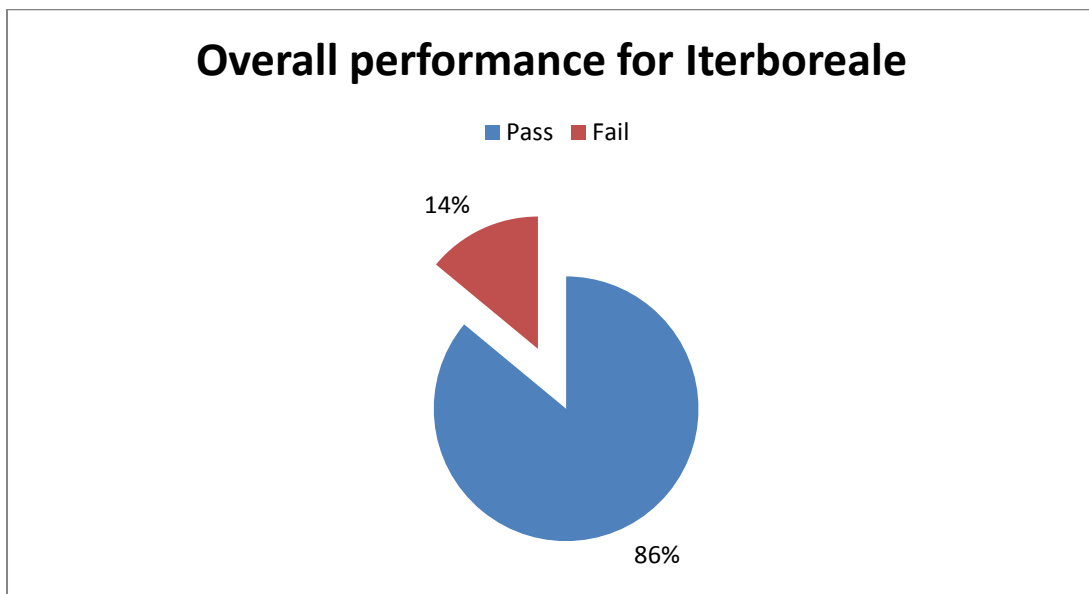
Figure 12: Pie chart illustrating overall performance of structures in the community of Iterboreale

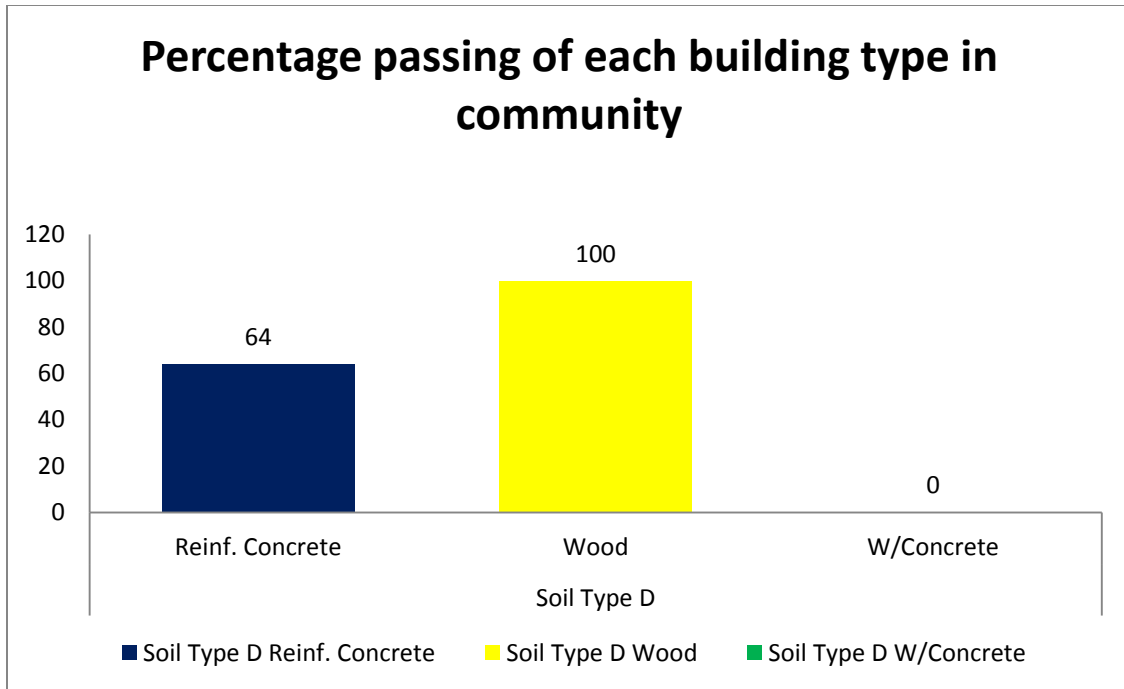
Figure 13: Column chart illustrating percentage passing of each building type when modifiers are applied.

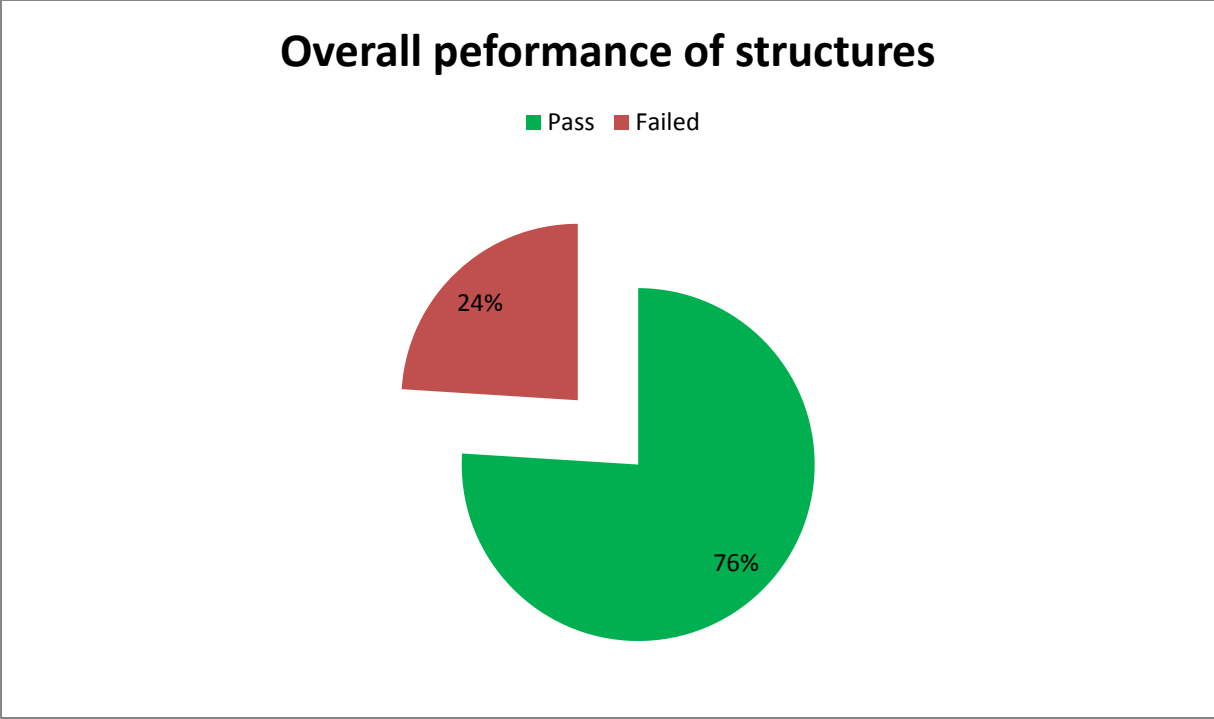
Figure 14: Pie chart illustrating the overall performance of structures in the community

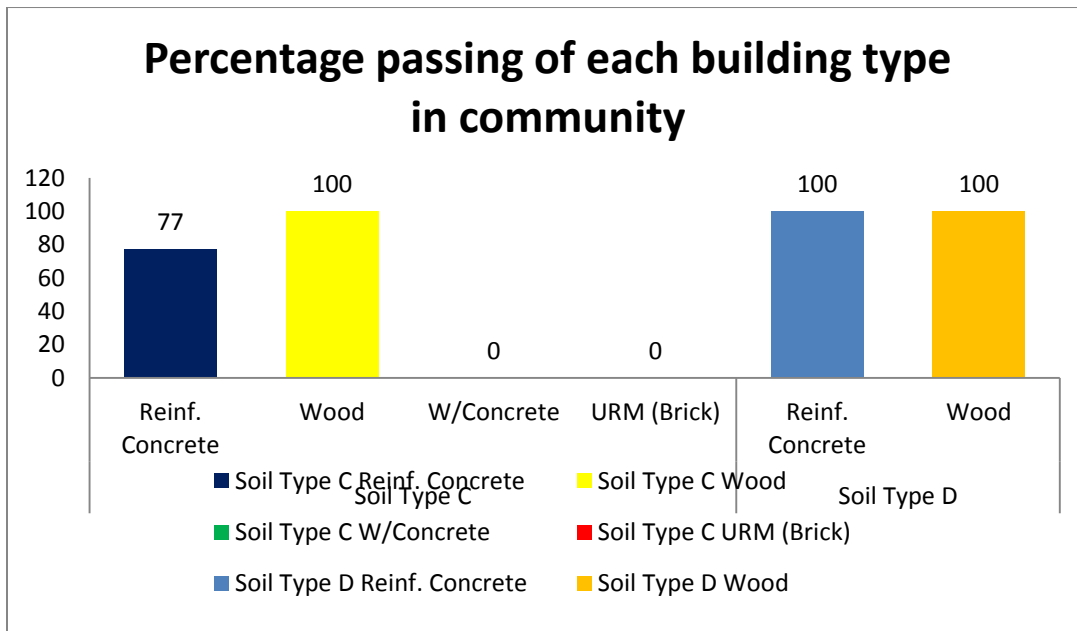
Figure 15: Column chart illustrating percentage passing of each building when modifiers are applied.

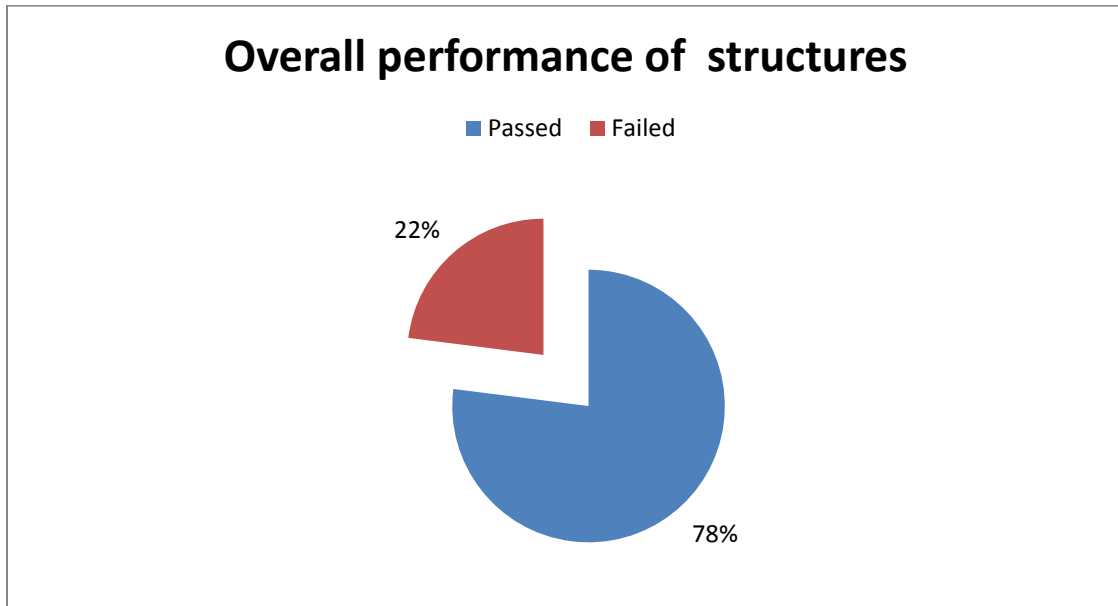
Figure 16: Pie chart illustrating the overall performance of structures in the community.

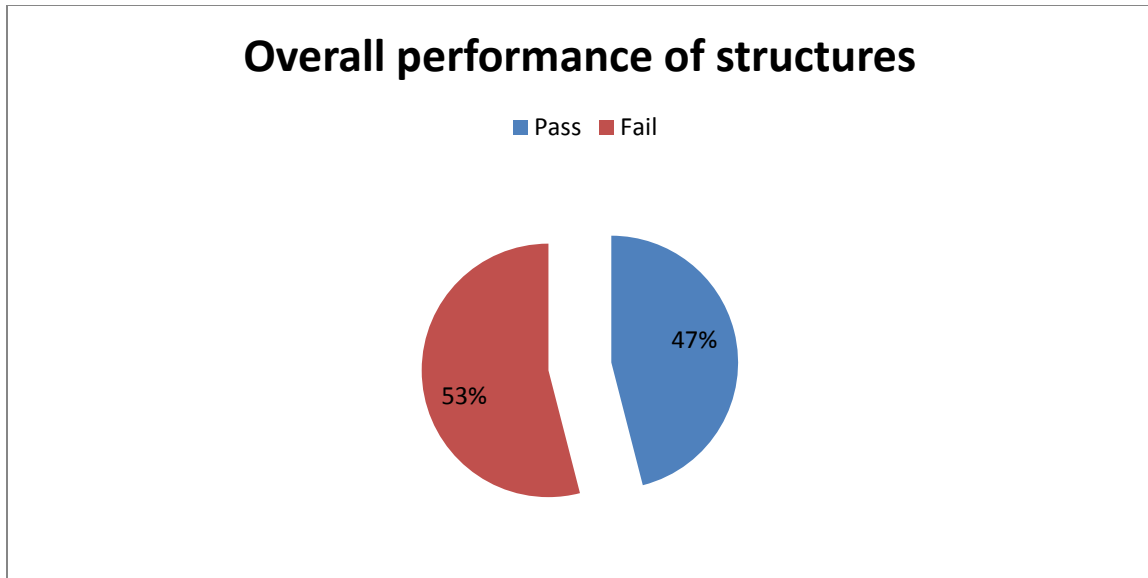
Figure 18: Pie chart illustrating the overall performance structures in the community

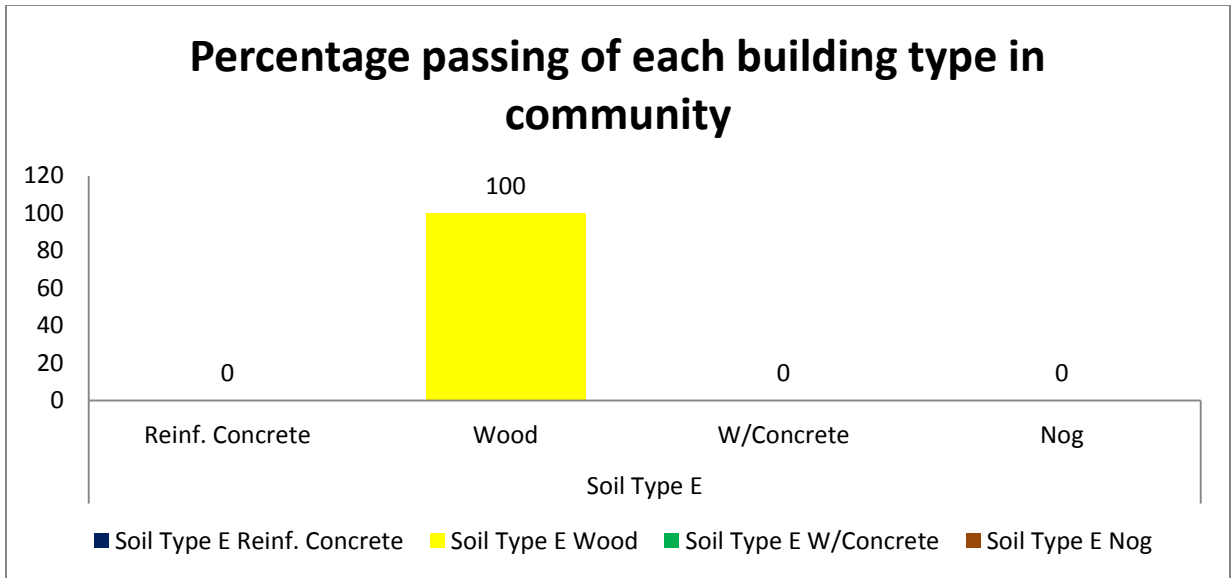
Figure 21: Column chart illustrating percentage passing of each building type when modifiers are applied.

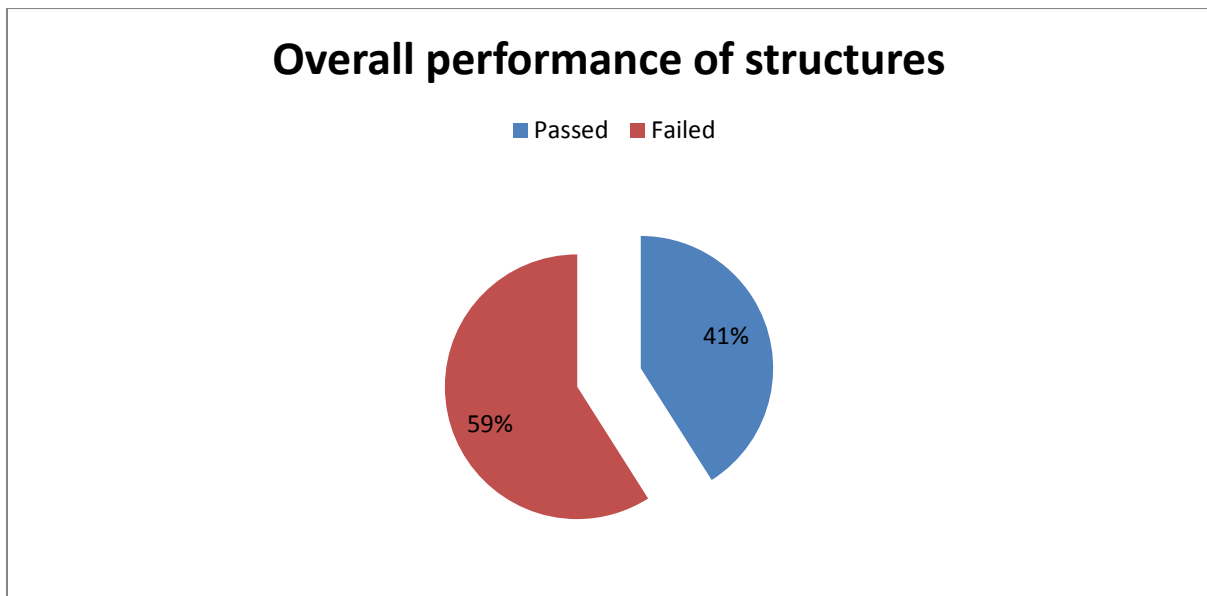
Figure 22: Pie chart illustrating the overall performance structures in the community

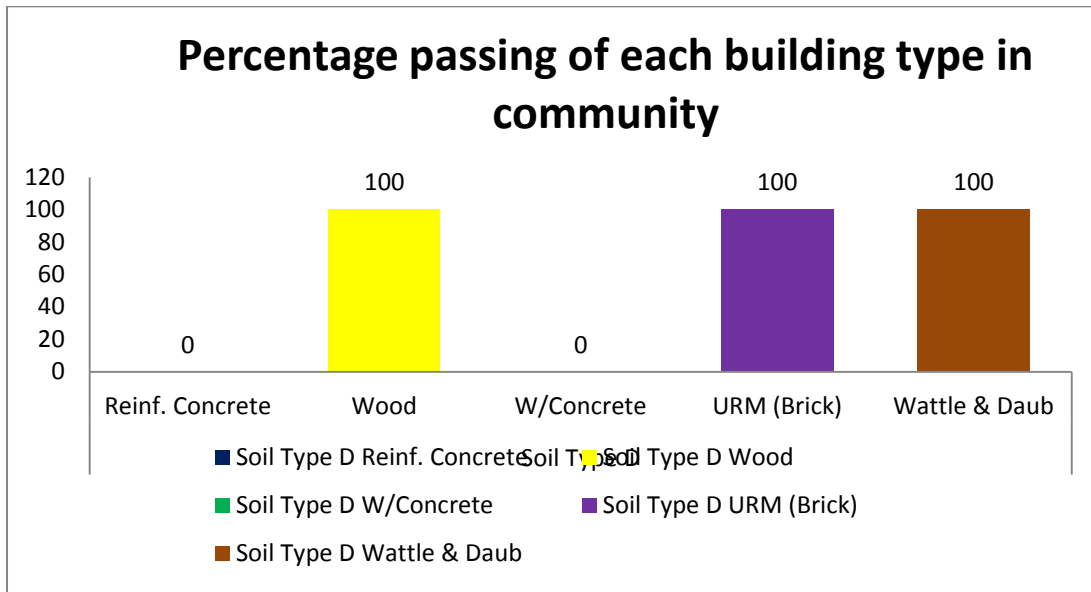
Figure 23: Bar chart illustrating percentage passing of building types based on soil type

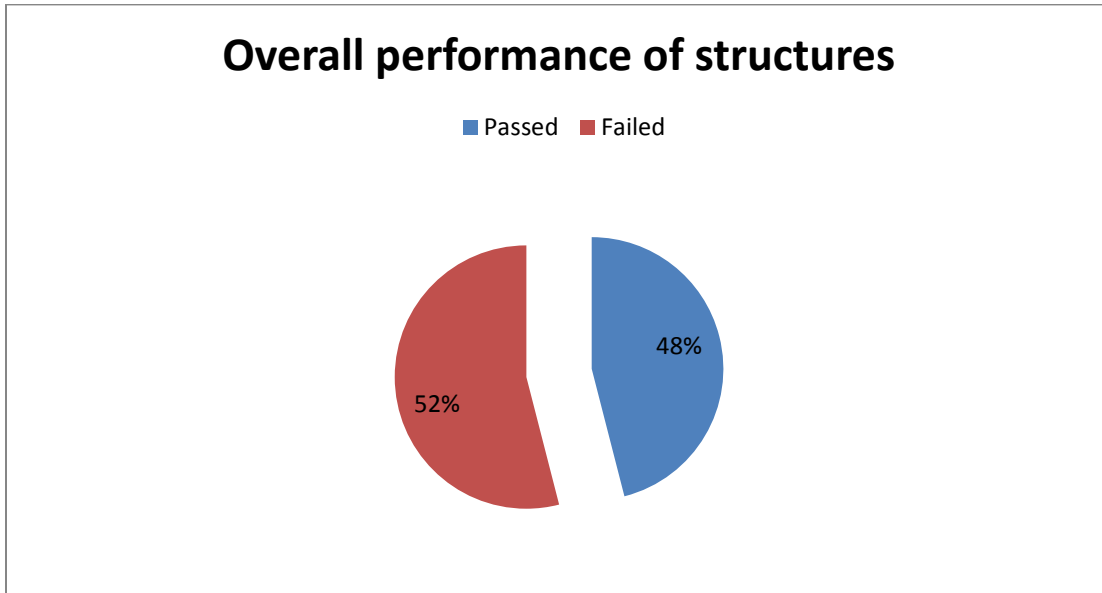
Figure 24: Pie chart illustrating the overall performance structures in the community

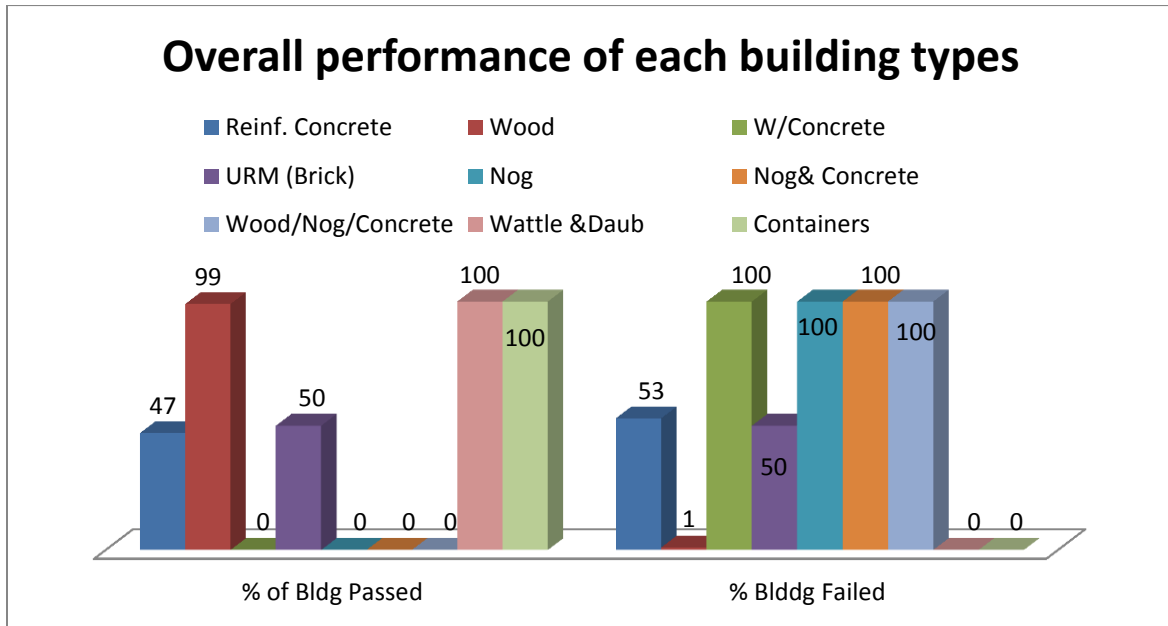
Figure 25: Column chart showing overall performance (% passes and failure) of building types in study area.

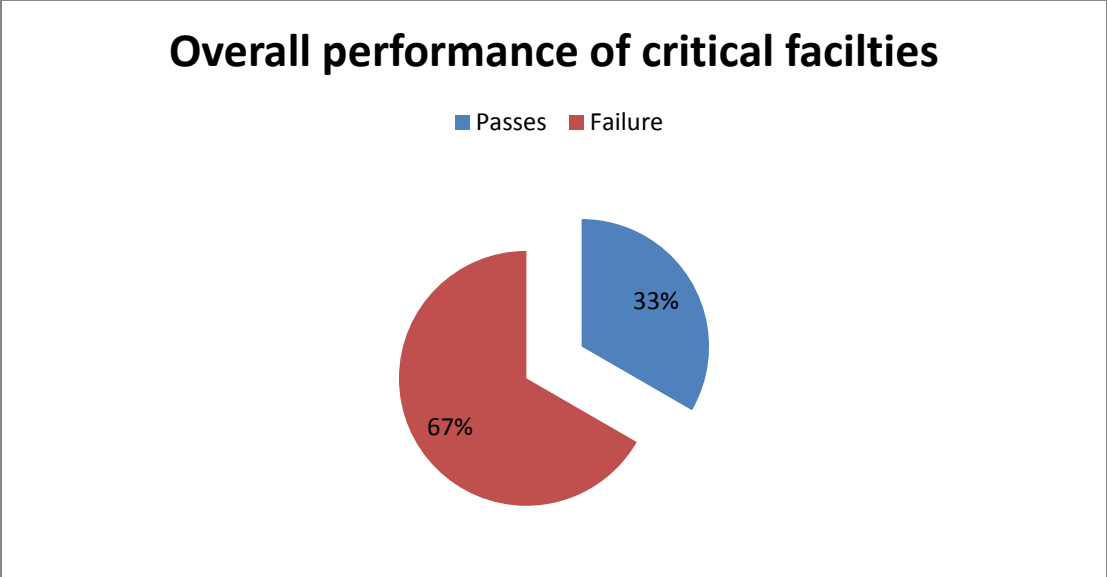
Figure 26: Pie chart showing overall performance (% passes and failure) of critical facilities in study area.

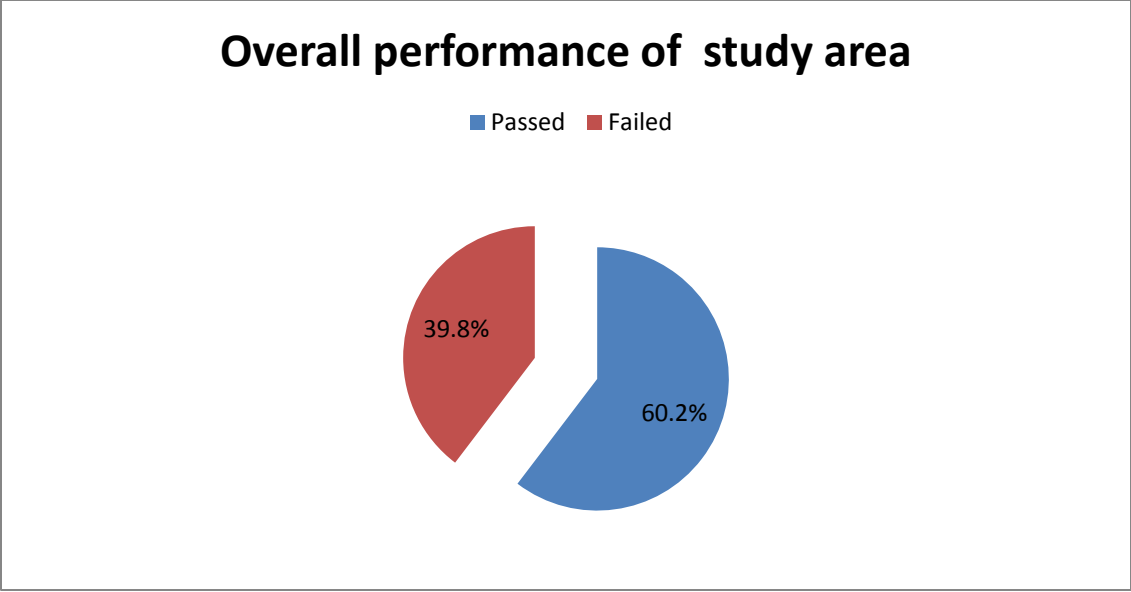
Figure 28: Pie chart showing overall performance (% passes and failure) of structures in study area.
