MITIGATION, PLANNING AND RESEARCH DIVISION

Funded by the Environmental Foundation of Jamaica

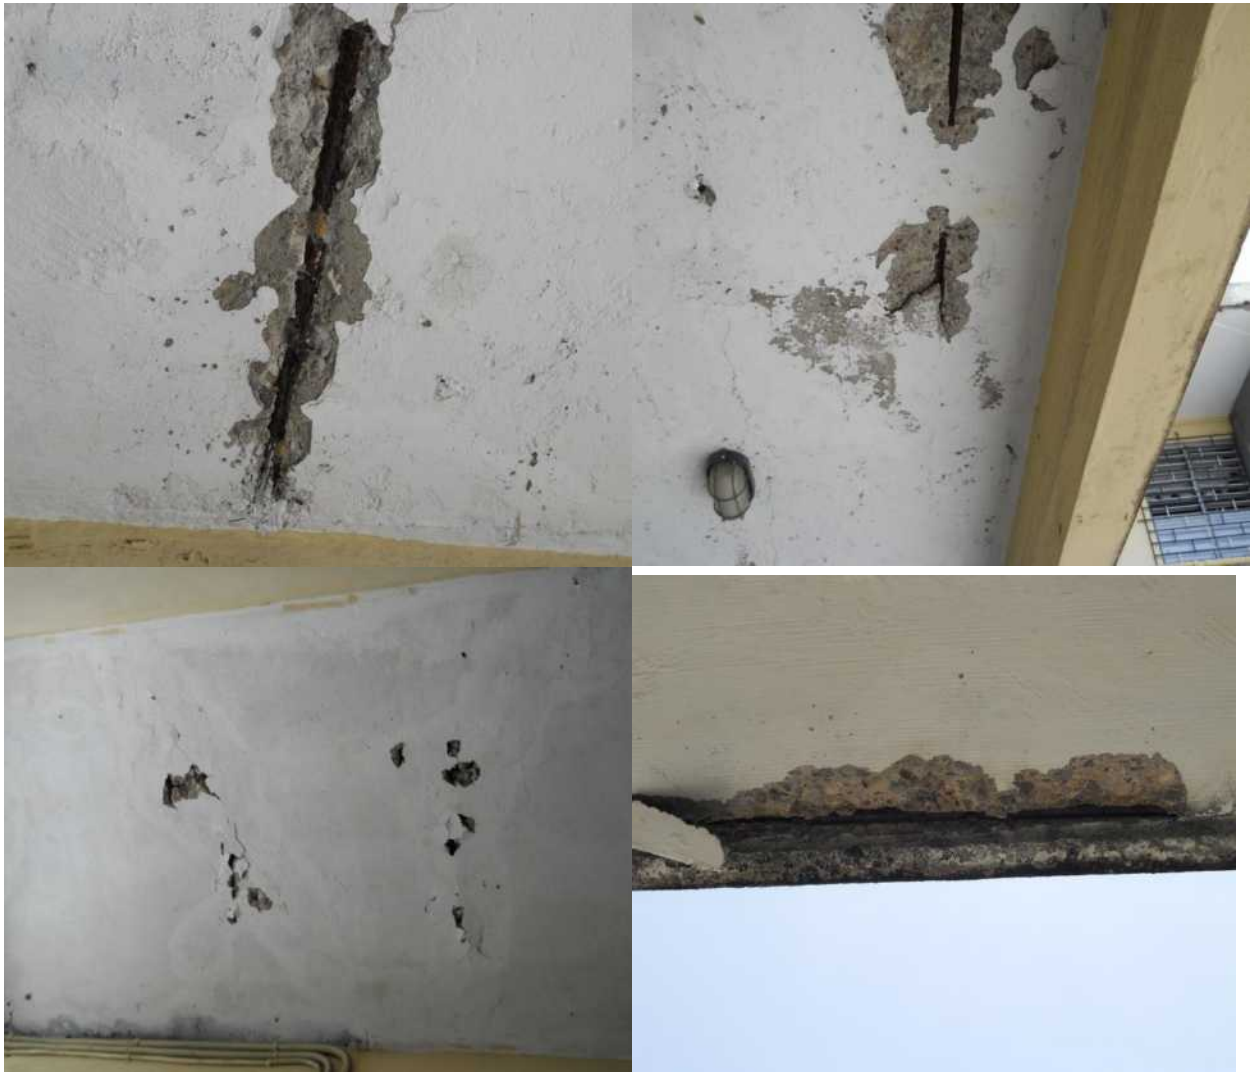
Figure A1: A group of pictures showing major defects to the Annotto Bay All-Age School, in the form of pop-outs and exposed reinforcement. Due to the exposure of these bars they have begun to rust and over-time will increase the risk of failure.

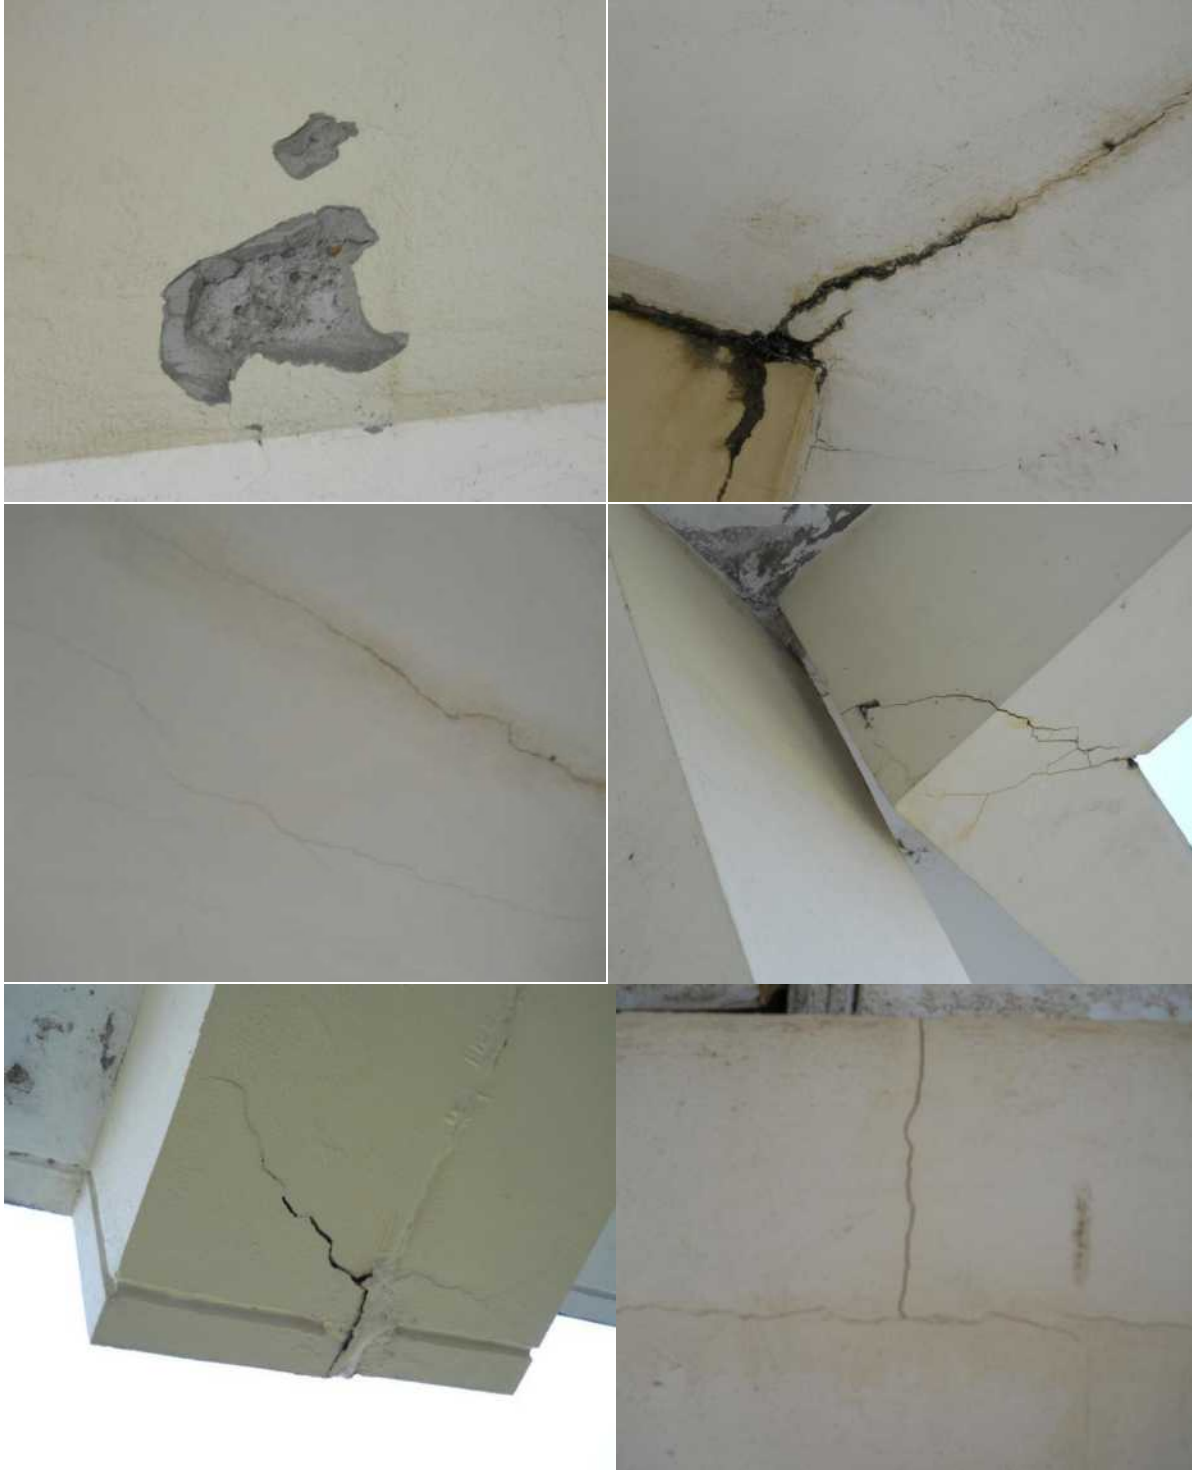
Figure A2: A group of pictures showing major defects to the Annotto Bay High School, in the form of major cracks in vital structural members (Beam) and also pop-outs. There is also evidence of water contact which suggests that reinforcements are being damaged (rust) which cause swelling of the bars, which reflect pop-outs and cracks.

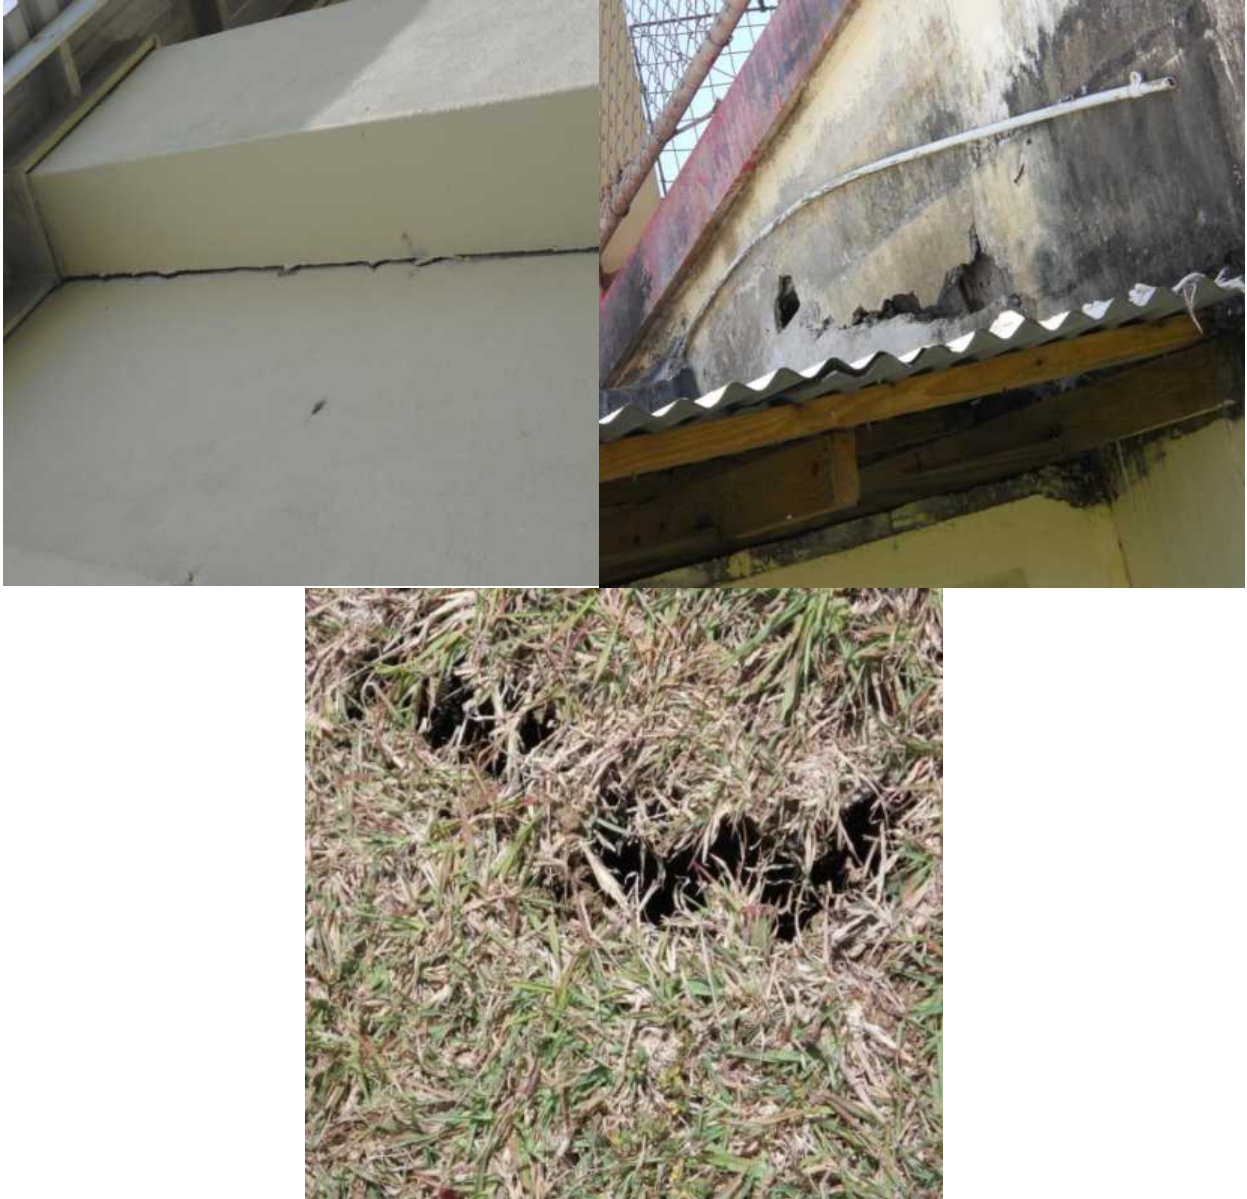
Figure A3: A group of pictures showing defects to the Annotto Bay Hospital in the form of major cracks and the moving away of a column from the building due to the presence of soil movement, which actually left large cracks in the ground.
