## THE PALISADOES: SAFE ACCESS TO THE AIRPORT? POSTSCRIPT AFTER DEAN

The Marine Geology Unit

Department of Geography and Geology

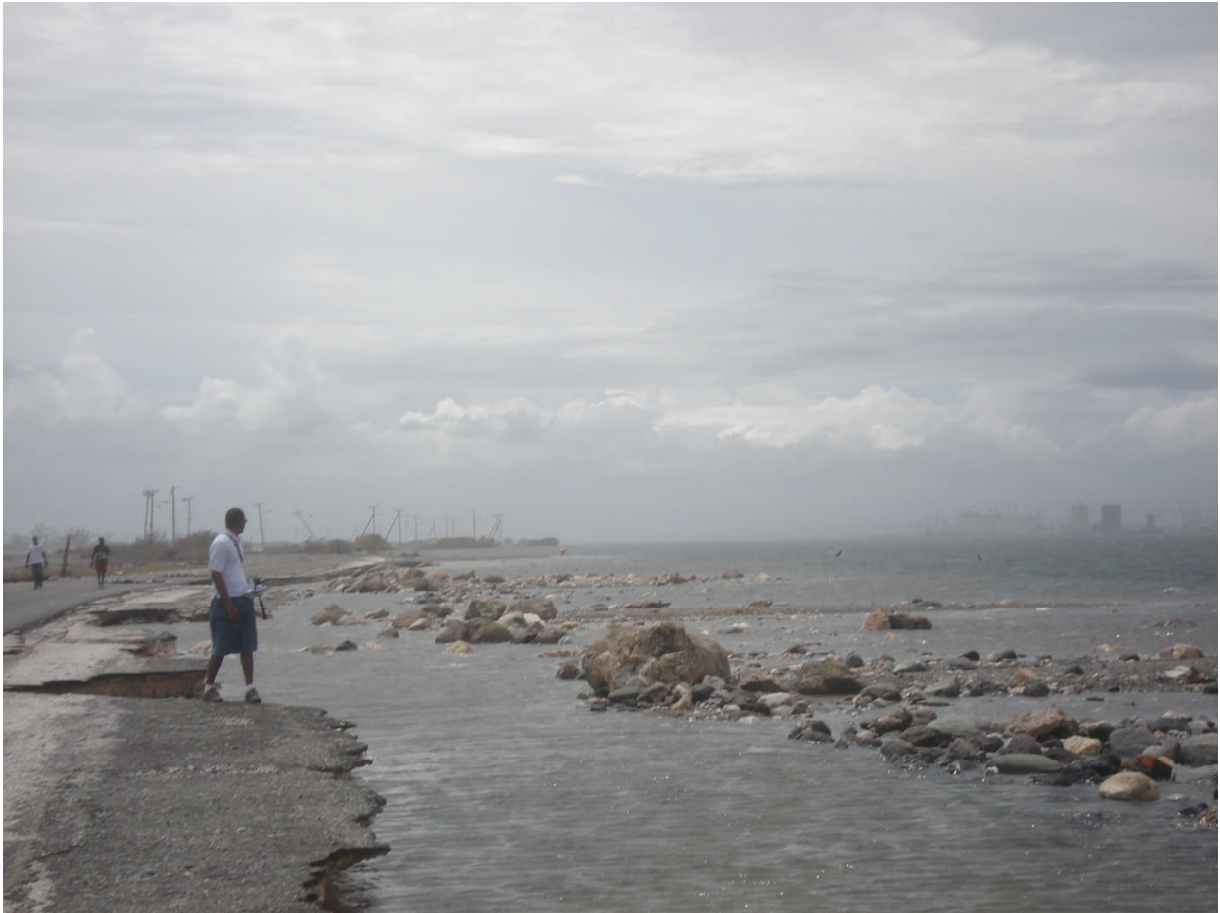
1) Photo of a section of the road badly damaged during Hurricane Dean

harbour, leaving bounce marks on the road. The road received some of its worst damage at exactly the places where the biggest and most numerous boulders had crossed it (photo 2).

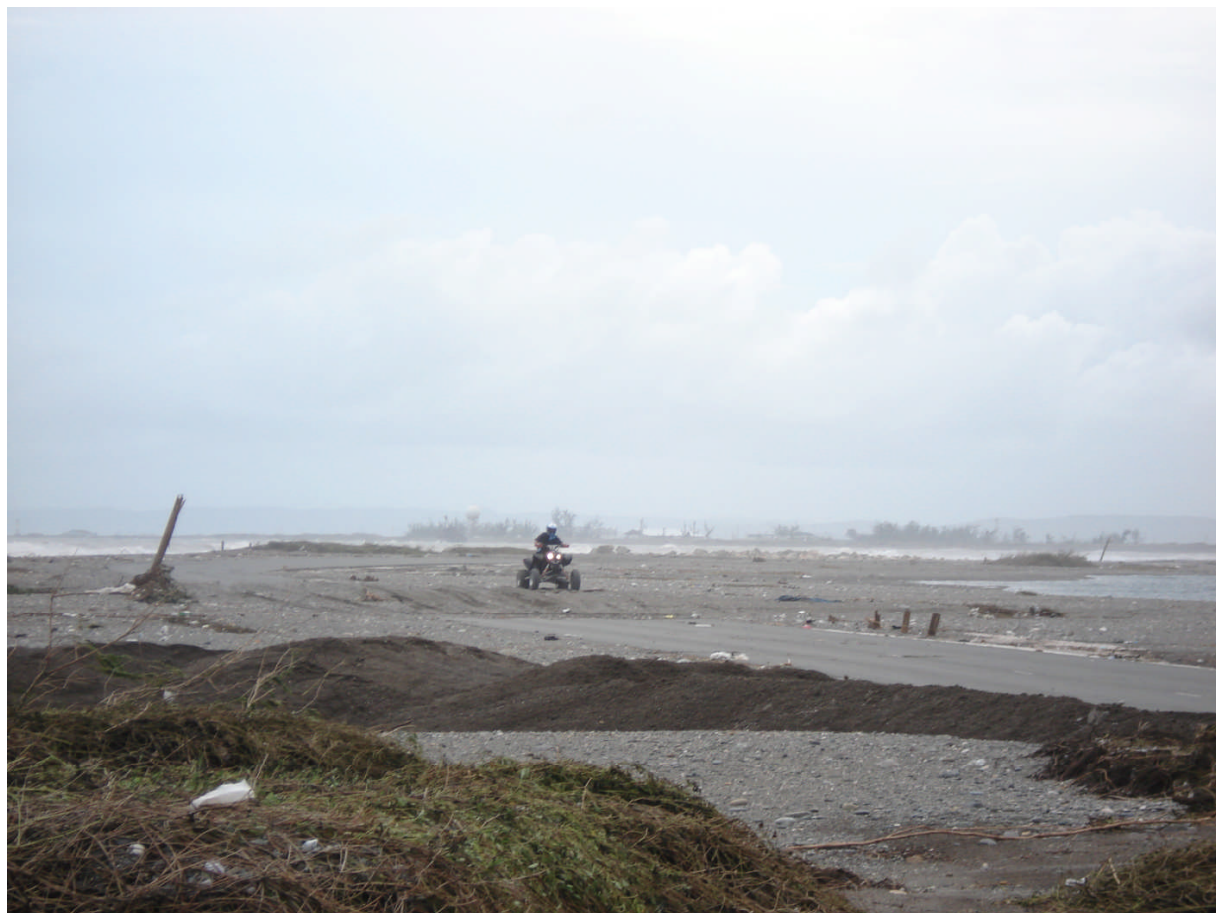
Section of the Palisades blocked by sand during Hurricane Dean

Was Dean worse than Ivan? For Palisadoes a definite “Yes”. Extensive sand deposits piled up against the rebuilt and re-collapsed wall surrounding the Gypsum Company’s stockpile. As we walked the peninsula on the Monday, we noted that the whole eastern end of the Palisadoes was completely flattened; hardly a trace of a sand dune(photo1). Ivan and, probably, Emily had already depleted this part of the Palisadoes of its protective dunes. When Dean arrived its higher surge and waves overtopped the remaining dunes, creating much broader washover channels. Everything was scoured almost down to sea level and whatever remained was pushed into the harbour. This onslaught resulted in exposure of the old water mains and complete destruction of power lines and disappearance of the poles for over a kilometer. The plucking action of the hurricane waves on the leeward (harbour side) had attacked and undermined the roadbed in places.

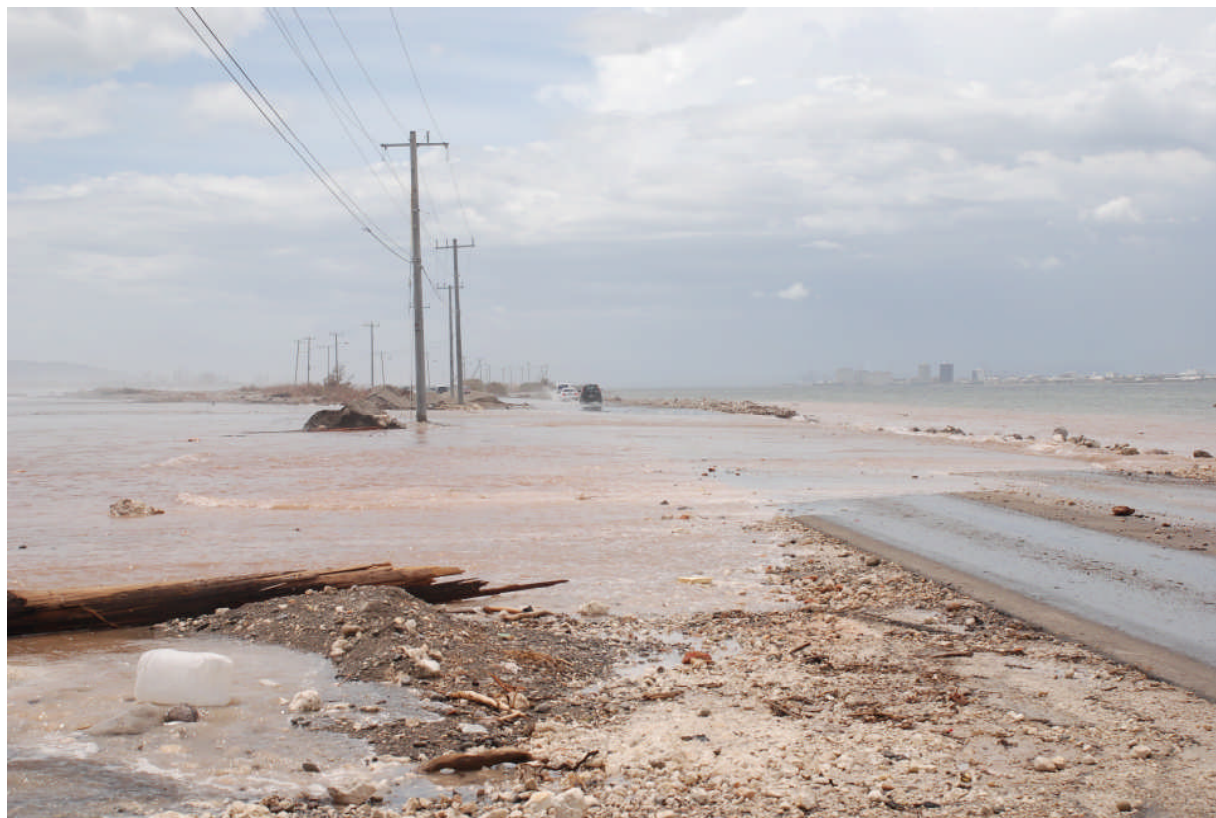
Photo of one of the areas affected by washovers during Hurricane Felix

Two weeks later on September 3, 2007, Hurricane Felix passed 450 km south of Jamaica, bringing a repeat of the wave activity experienced from Dean. Why did Hurricane Felix cause such havoc? Although far south of the island, Felix was a category 5 storm as it passed Jamaica. The gigantic waves generated by the 160 km/hr winds spread out in all directions, well beyond the focus of the storm itself, and inundated the road yet again. Since then, in calm weather, water has again flooded parts of the road (photo 3).
